# Characterization of the Stone Masonries and Evaluation of the Environmental Impact in Panamá Viejo: A Contribution for the Conservation of the Monumental Complex

**Abstract:** A fundamental step in the best preservation of heritage materials is investigating their chemical and physical characteristics, and understanding how they interact with the surrounding environment. For this reason, the stone masonry of the monumental UNESCO site of Panamá Viejo was subjected to a thorough study to characterize the materials and evaluate their state of conservation. Additionally, potential outcrops were explored in order to identify sites for the supply of raw materials. The methodological approach encompassed mineralogical-petrographic investigations using stereomicroscopy, polarized light microscopy (PLM), X-ray powder diffraction (XRPD), scanning electron microscopy and energy dispersive X-ray spectrometry (ESEM-EDS) and X-ray fluorescence (XRF). The results revealed that the masonries primarily consists of polygenic breccia, basaltic andesite, rhyodacite, tuffite, and rhyolite. In addition, at the potential quarries, breccia and basaltic andesite were identified. The porous structure wa

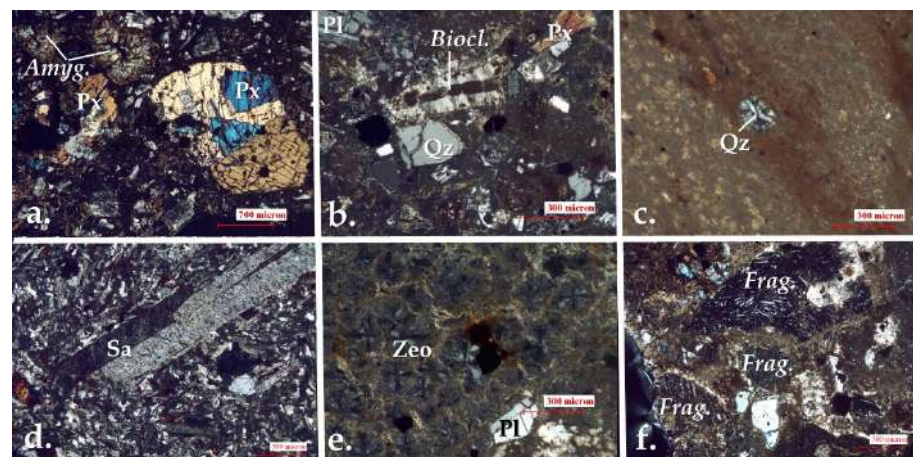
**Figure 4.** Micrographs of thin sections of samples observed by polarized light microscopy (PLM)-cross-polarized light (xpl): (a) PV FN 5 sample: altered pyroxene cluster, amygdale filled with secondary minerals, in a basaltic andesite; (b) PV FC 7 sample: foraminifera bioclast, quartz, plagioclase and pyroxenes fragments in a polygenic breccia; (c) PV FC 9 sample: a chalcedony filling an amygdale, surrounded by iron oxides in an altered volcanic rock; (d) PV CT 2 sample: sanidine and metal oxides in a rhyolite; (e) PV TC 4 sample: diffused zeolitization in a tuffite; (f) PV CC 4 sample: fragments of basaltic/andesitic lithoclasts in a breccia.

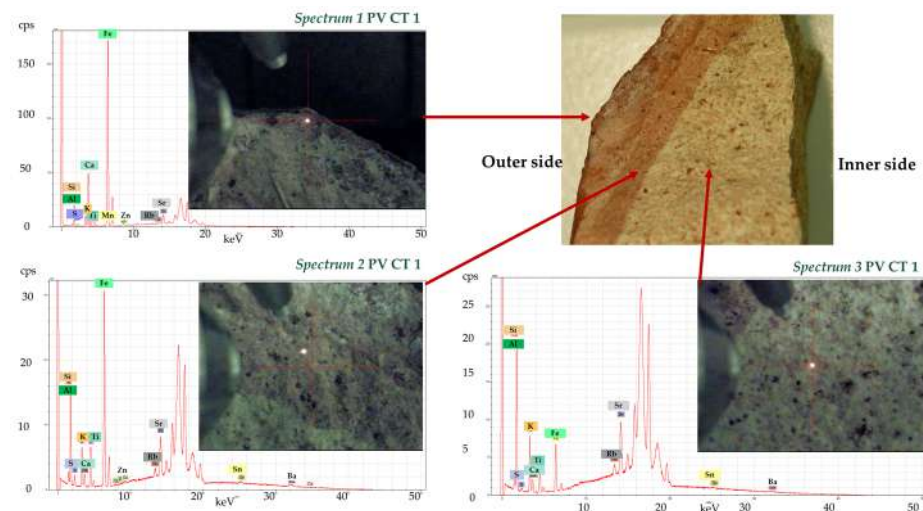
It was observed that this rhyolite was characterized by sanidine alteration and the presence of iron oxides and/or hydroxides. These formations have a reddish hue, which is often observed to be more concentrated in the external part of the specimens. These alterations were also detected in polygenic breccias and in rhyodacites (e.g., Figure 4c). In sample PV CT 1, a rhyolite fragment, different oxidation in the outer part and the inner part was clearly visible to the naked eye. Non-invasive X-ray fluorescence micro-analysis

showed the different intensity of the Fe peak, highlighting higher external oxidation (Figure 7).

**Figure 7.** Spectra obtained by X-ray fluorescence non-invasive micro-analysis ( $\mu$ XRF) of the PV CT 1 sample. From the outer side (spectrum 1) to the inner part (spectrum 3).

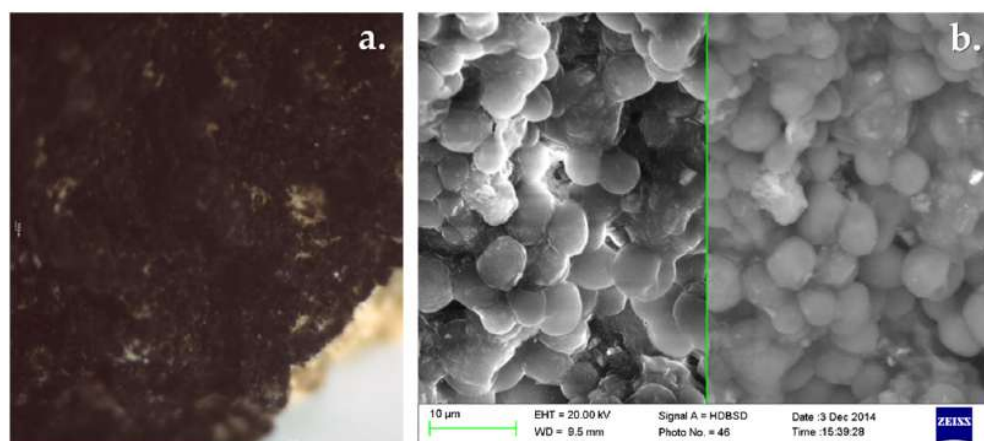
On tuffites and polygenic breccias of the masonries, and in an outcrop of basaltic andesite, black patinas were observed by the naked eye. Then, they were investigated under stereo and scanning electron microscopy, revealing bio-deterioration activity, ascribable to cyanobacteria colonization (Figure 9).

**Figure 9.** (a) Stereo photomicrograph of PV TC 4 sample, showing a superficial black algal patina; (b) Scanning electron microscopy (ESEM) photomicrographs (**left**: secondary electrons detector-SE; **right**: backscattered electrons detector-BSD) of PV TC 4 sample, detail of the superficial black algal patina.

The presence of black algae on these monuments was already observed in the work of Torres Montes [33], where “alga negra”, a cyanobacteria (*Oscillatoria* sp.) [49], was described. The algal presence is facilitated by the bio-receptivity of the substrate, determined by features such as porosity, surface roughness, and hygroscopicity [50]. These characteristics can also indicate a material prone to wettability. Considering the impact on the stone, the “alga negra” does not represent a direct danger for the material, but it can be a substrate for other bio-deteriogens, and it can trap and retain pollutants. Furthermore, it suggests the presence of high moisture.

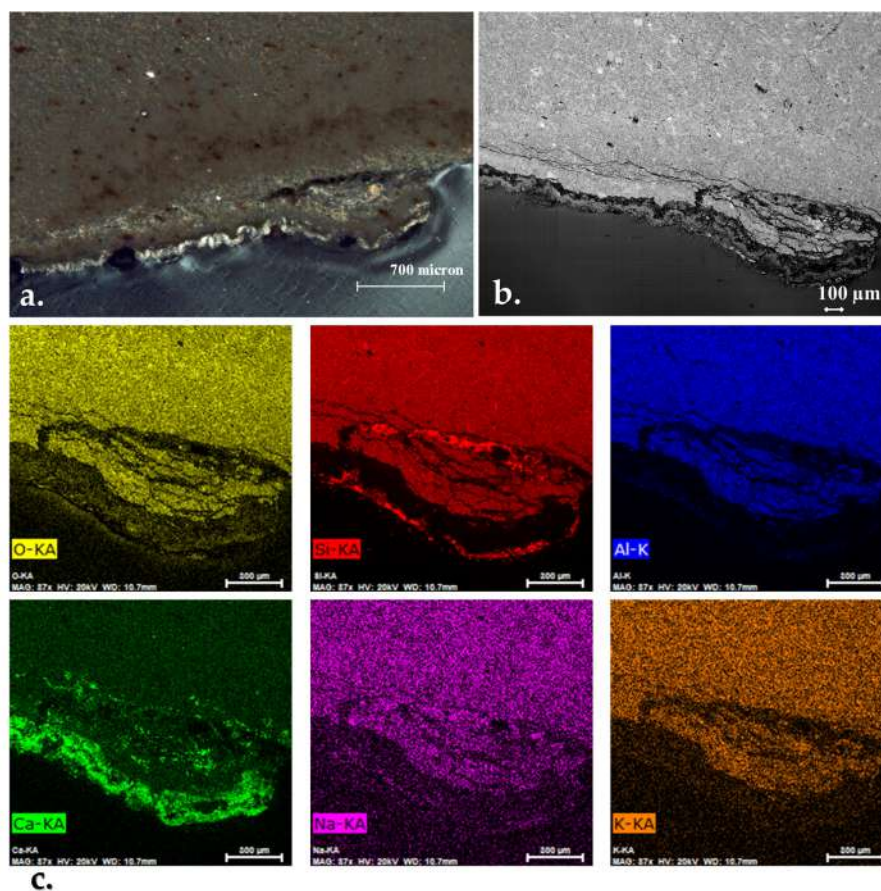
The rhyodacite of the PV SjdD sample, mainly formed by clinoptilolite— $M_{3-6}(Si_{30}Al_6)O_{72} \cdot 20H_2O$ , where  $M = Ca, K$  or  $Na$  [52]—showed a detached part. Along the internal surface, a whitish patina was identified as well (Figure 10). Under polarized light microscopy (PLM), the aspect was irregular, showing decohesion and a different thickness. The mechanical stress due to the reaction process, responsible for the patina formation, is clearly visible by scanning electron microscopy (ESEM) (Figure 10b). In addition, the microchemical investigation, performed by energy dispersive X-ray spectrometry (EDS), identified Ca as the principal element present in the patina, also with the presence of O, suggesting a composition mainly formed by calcium carbonate (Figure 10c). The development of calcite, as a precipitated secondary mineral, was also supported by its identification in the masonry mortars previously studied [13].

**Figure 10.** Thin section of the PV SjdD sample showing an altered patina: (a) PLM-xpl micrograph; (b) ESEM micrograph; (c) ESEM-energy dispersive X-ray spectrometry (EDS) microchemical compositional maps.
