2                   **ON THE DAMAGE MECHANISMS IN A CONTINUOUS CASTING MOLD:**

3                   **AFTER-SERVICE MATERIAL CHARACTERIZATION AND FINITE ELEMENT**

4                   **SIMULATION**

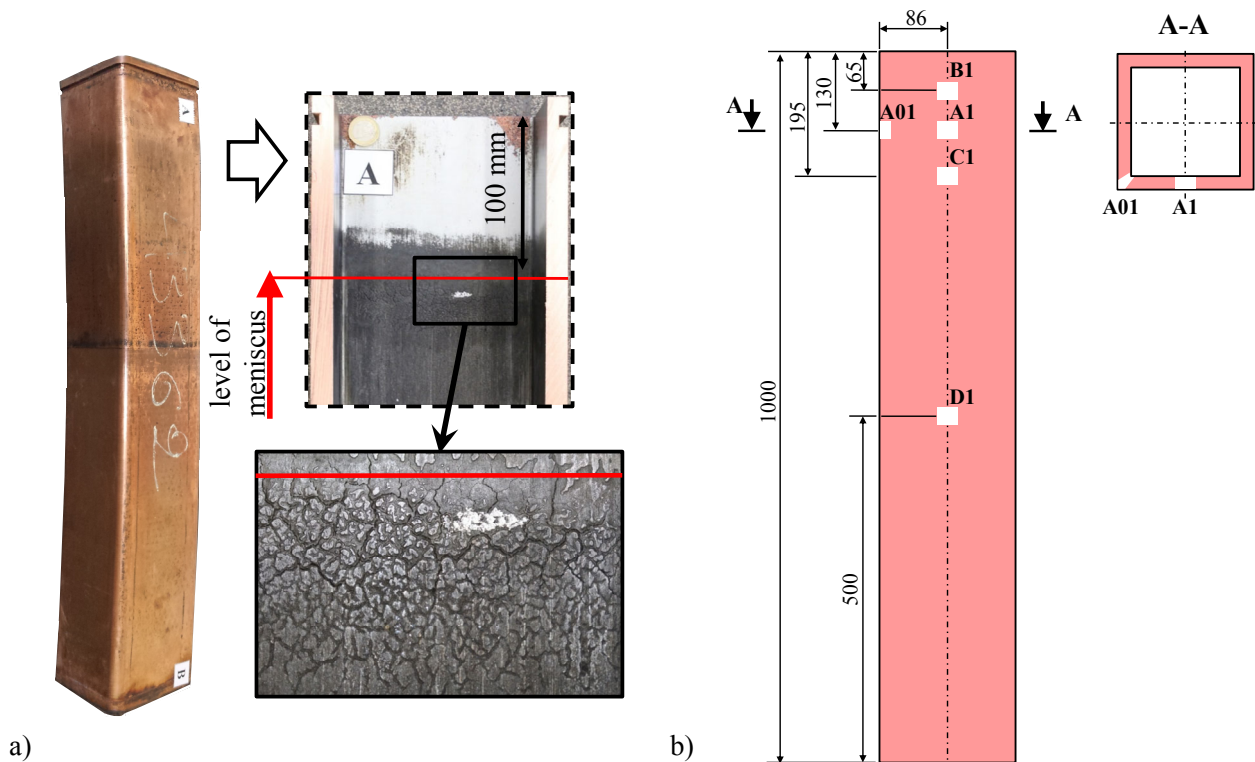
69 First, the copper mold was visually inspected to locate the most damaged areas, from which samples were  
70 subsequently extracted. As illustrated in Fig. 3a, the area near the meniscus is characterized by a wide network of  
71 cracks, while the surrounding parts seem to be unaltered.

Fig. 3. Mold under investigation with damaged inner surface (a), positions of extracted samples (b).

146 Visual inspection revealed that the mold was heavily damaged in the meniscus area, as indicated in Fig. 3a. A  
147 closer examination of the mold inner surface showed that a web of cracks was formed in the area within 100 ÷ 140  
148 mm from the top of the mold, i.e. beneath the level of the maximum thermal flux. In this location, the surface of  
149 the mold generally reaches the highest temperatures. Indeed, in this area the copper mold is in contact with the  
150 molten metal at high temperature, as indicated in Fig. 1. Representative SEM images of the samples A01, A1, B1,  
151 C1 and D1 are shown in Fig. 5 and Fig. 6. As highlighted in Fig. 5, the mold underwent a degradation mechanism  
152 linked to the cracking of the protective coating layer, which was completely detached in samples A01 and A1  
153 (samples extracted in the most thermally-stressed region). In the same region, a thick layer of altered material was

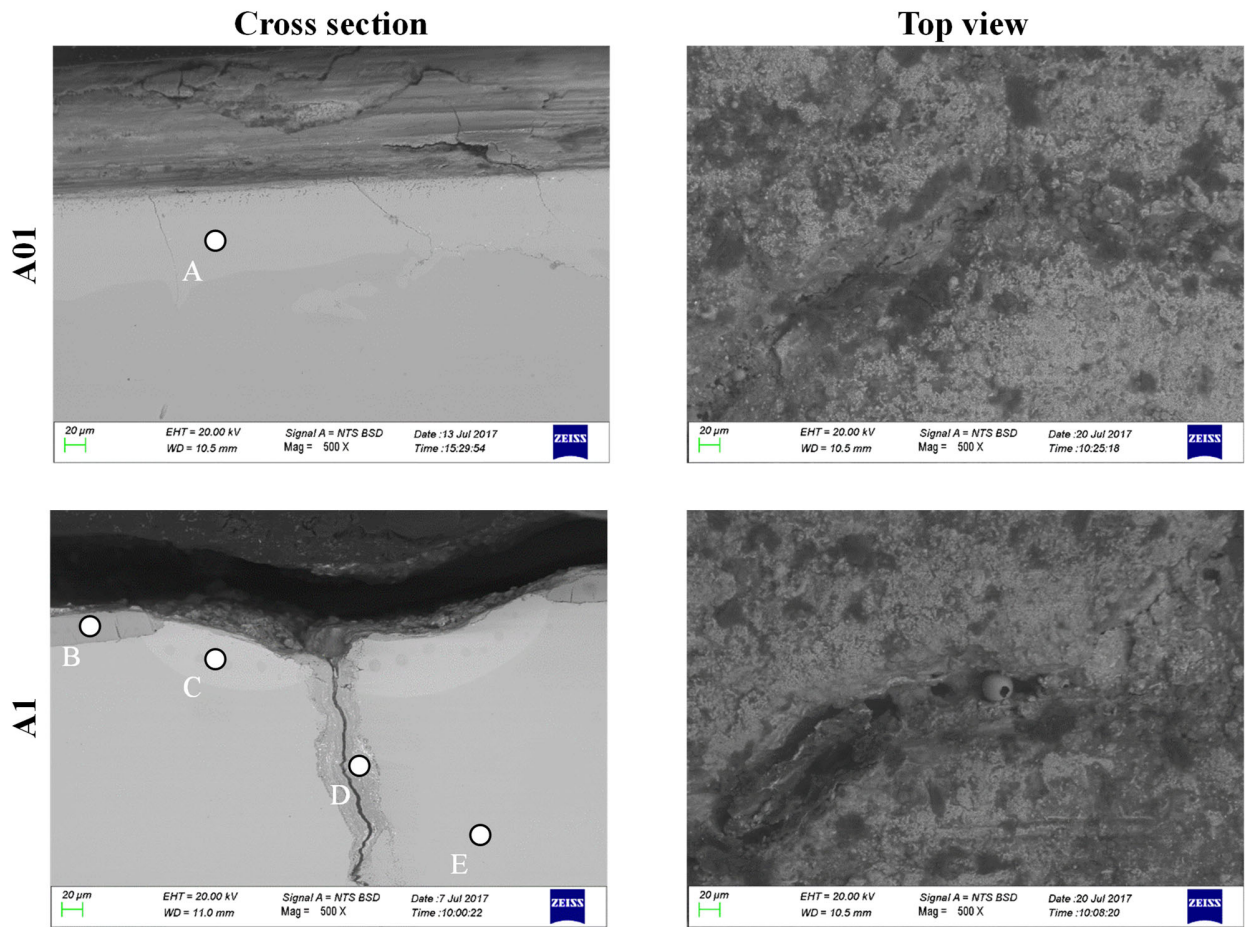
155 The EDXS analyses, see Table 3, showed that the Cu substrate was converted into a brass with a Cu/Zn weight  
156 ratio between 0.5 and 1, which corresponds to the formation of  $\beta'$  (ratio close to 1) and  $\gamma$  (ratio close to 0.5) brittle  
157 phases or a mixture of the two [2, 21, 22]. These phases were full of cracks, mostly in samples A01 and A1. In  
158 sample A1 the crack passed through the brass and continued in the underlying copper substrate. The crack was  
159 surrounded by another phase composed of Zn, S and Pb.

Fig. 5. SEM analysis of samples A01, A1 (top view and cross section). The letters indicate the areas analyzed by EDXS.

258 elements with a lower melting point temperature than Zn, as Pb and S (Fig. 5). In this case, probably because of  
259 the lower temperature inside the crack compared to the temperature of the internal wall of the mold, these elements  
260 infiltrate more in the crack than in the top surface. The result is a reaction of these elements with the Cu that  
261 produces brittle phases in the crack tip, which enhance the crack propagation of the thermal fatigue crack. The  
262 crack propagation in sample A1 was also favored by a possible grain growth of the Cu substrate that reduced

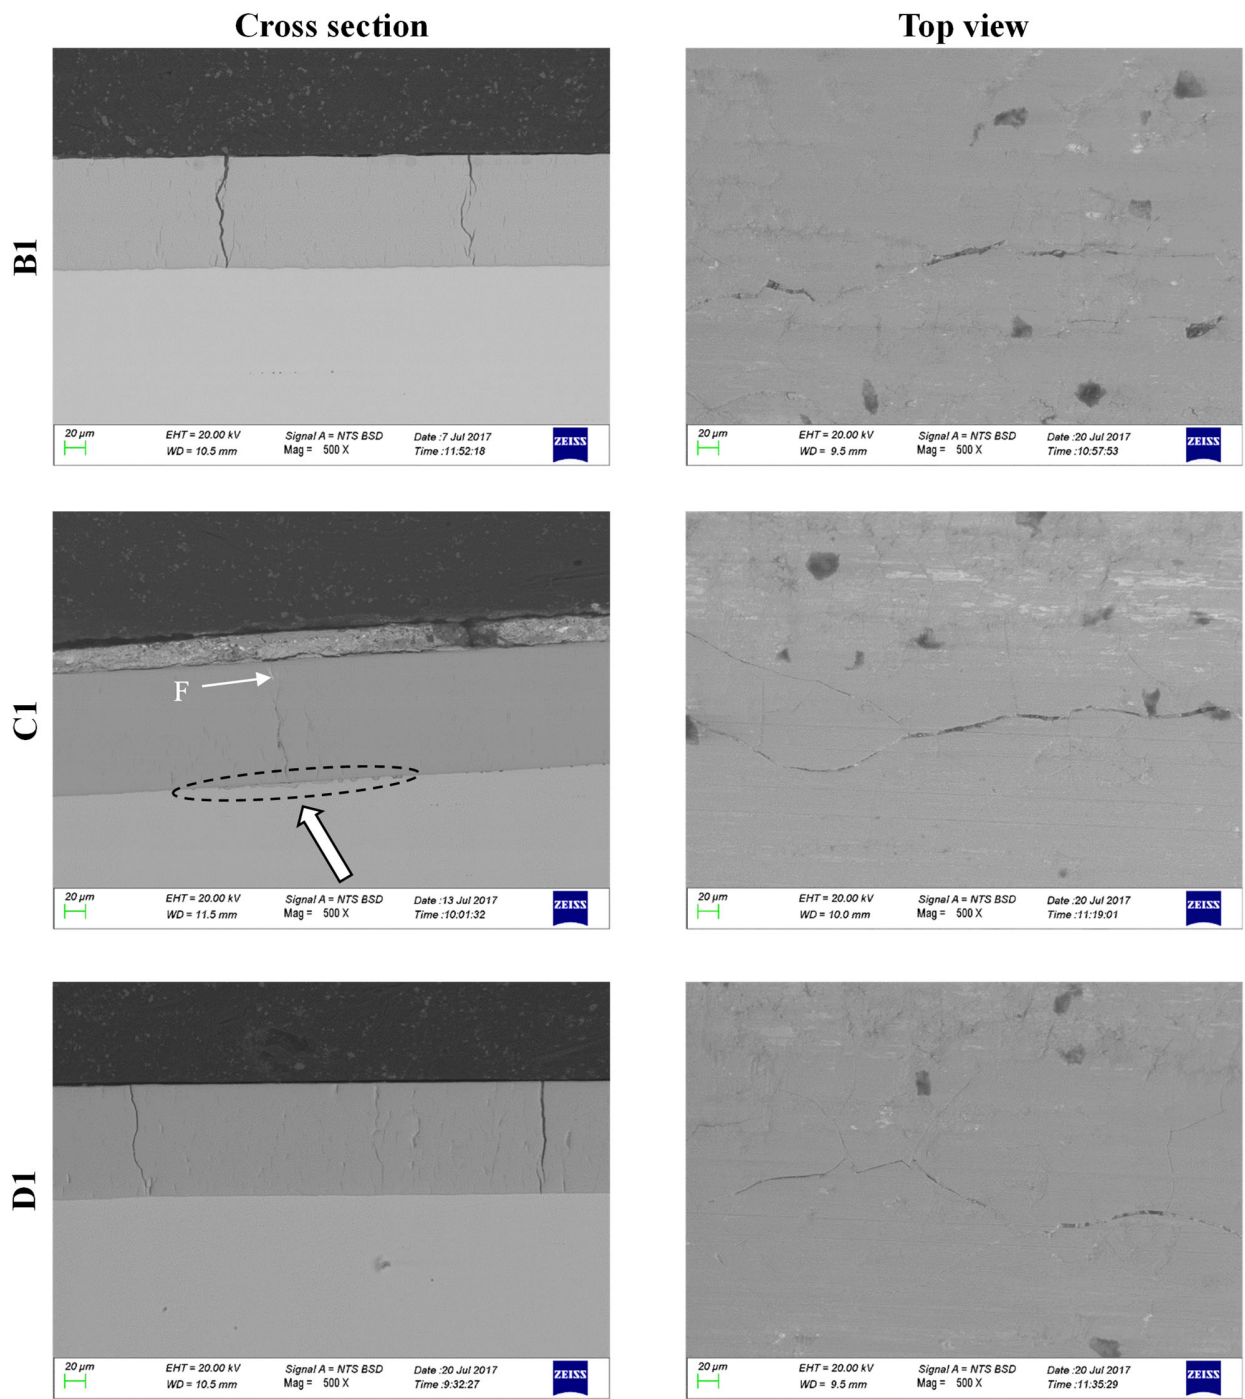
160 Samples B1 and C1, which are close to the meniscus area, presented a heavily damaged coating, while the Cu  
 161 material underneath was only slightly affected by chemical degradation, which was the most pronounced in sample  
 162 C1 (arrow), see Fig. 6. The detailed SEM analysis in sample C1 showed the infiltration of low melting point  
 163 elements through the cracks of the coating, see Fig. 7 and Table 4. These elements reached the Cu substrate and  
 164 reacted with it, producing a reaction layer.

Fig. 6. SEM analysis of the samples B1, C1, D1 (top view and cross section). The letters indicate the areas analyzed by EDXS.

268 The numerical thermal analysis identified the corners as the regions at the meniscus level that experienced a  
269 lower temperature (Fig. 12). Instead, specimens B1 and C1 (extracted in the areas away from the meniscus zone  
270 and exposed to the lower temperatures) showed a lower kinetics of infiltration (Fig. 7 and Tab. 4). This  
271 phenomenon is still present and linked to elements with a lower melting temperature than Zn (mainly S). The  
272 specimens D1 extracted from the coldest zone of the mold revealed the thermal fatigue cracking mechanism of the  
273 Cr coating quite clearly. In this case, because of the lower temperatures and the slowest infiltration of low melting  
274 point elements, the degradation mechanism was not completely developed as in the samples extracted from the  
275 meniscus.

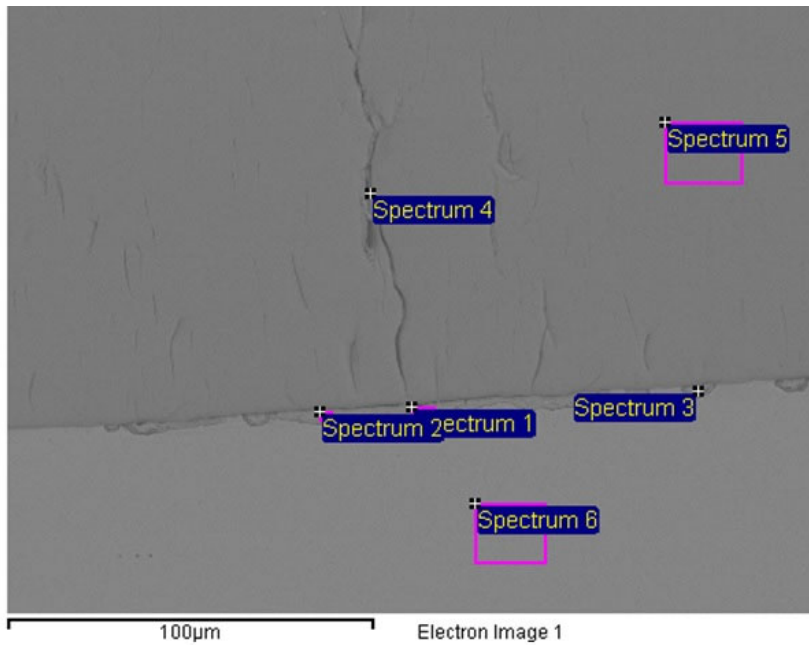
Fig. 7. Detail of the interface of sample C1 (circled area in Fig. 6).

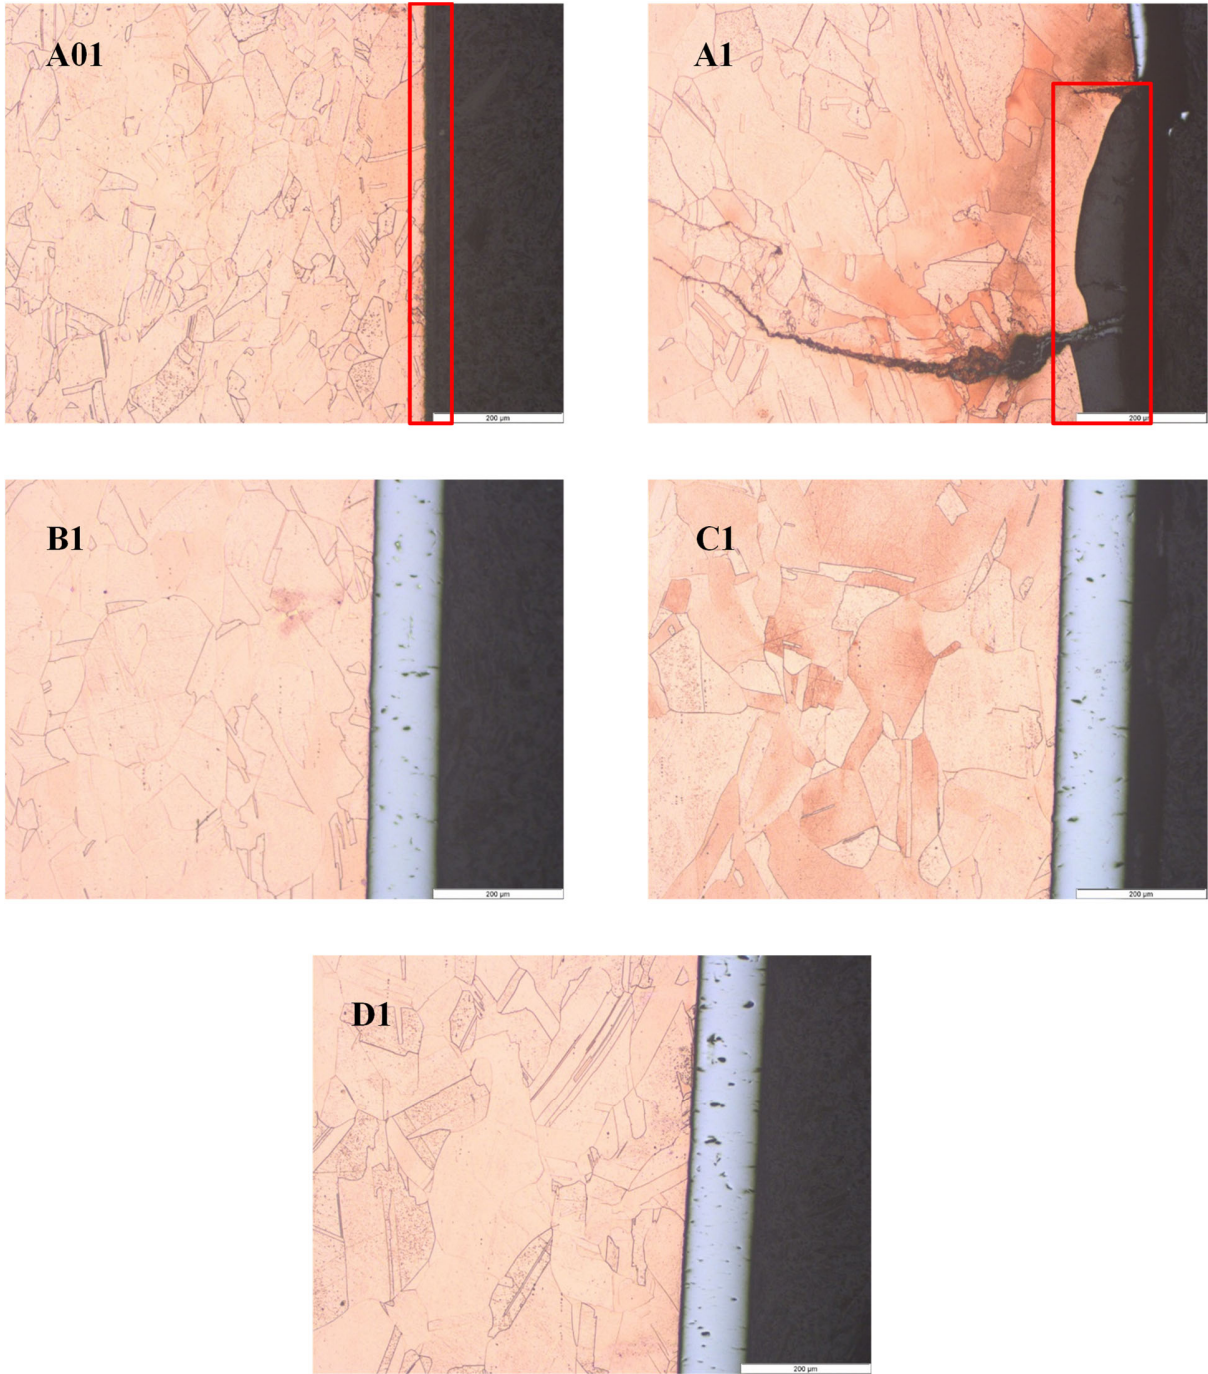
Fig. 8. Microstructural characterization of the analyzed samples.

172 The microstructure of samples A01, A1, B1, C1, D1 is shown in Fig. 8. As already observed by the SEM  
 173 analysis, the light microscopy results confirmed that the mold surface was composed of a Cu substrate coated with  
 174 a layer of hard chromium (0.1 mm thickness). The coating showed many micro cracks and had almost been  
 175 completely removed in the specimens extracted from the meniscus area (A01 and A1). The microstructure of the

176 substrate was composed of austenitic grains in the bulk material (range:  $\sim 70 \pm 30 \mu\text{m}$ ). The grains seem to be coarser  
177 in specimen A1 compared to the other samples. Specimens B1, C1, D1 did not show any microstructural difference  
178 between the core and surface. In addition, samples A01 and A1 presented a surface layer that reacted with the  
179 molten metal (indicated in Figs. 5, 8 and analyzed previously by EDXS), and some cracks that nucleated in the  
180 external reacted layer and propagated to the Cu substrate. The cracks were sharp with transgranular propagation,  
181 and contoured with a slight reaction layer that was previously identified by SEM analysis (Fig. 5 point D). The  
182 morphology of the crack nucleation was barely visible under a light microscope. The SEM analysis of the material  
183 surface (Fig. 9) showed an intergranular crack nucleation in proximity of the surface that had reacted with molten

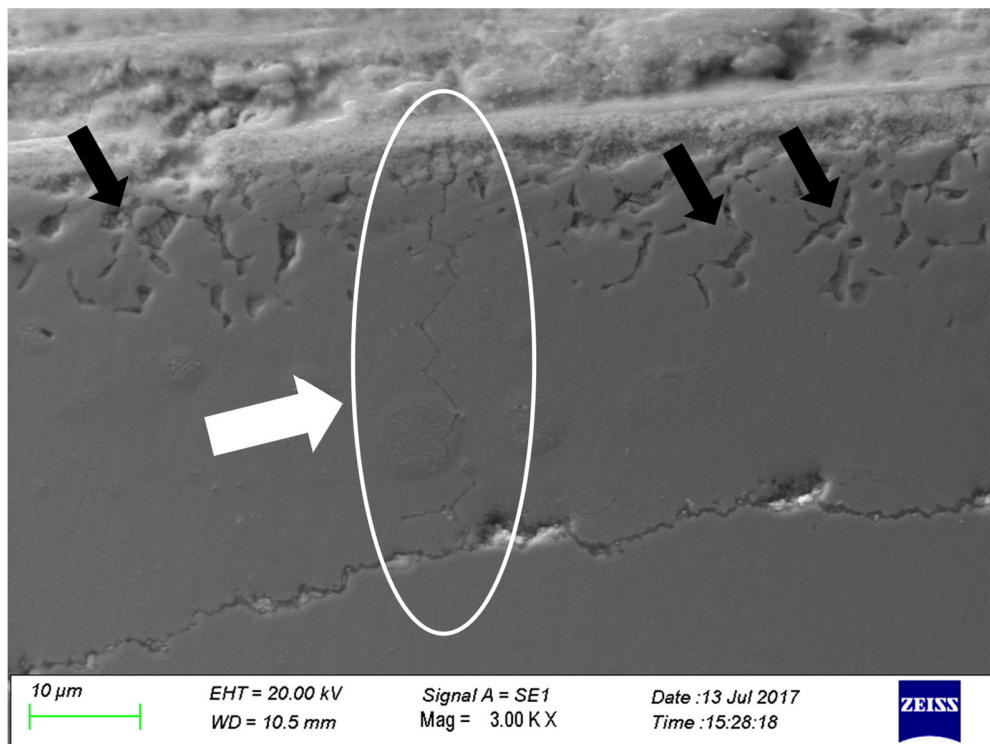
184 metal. In this region, the material presented some intergranular morphologies/phases (black arrows) that were  
185 likely to reduce the material toughness locally.

Fig. 9. Detail of the material surface that identifies the crack nucleation morphology. The black arrows indicate the intergranular features. The white circle indicates the intergranular fracture.

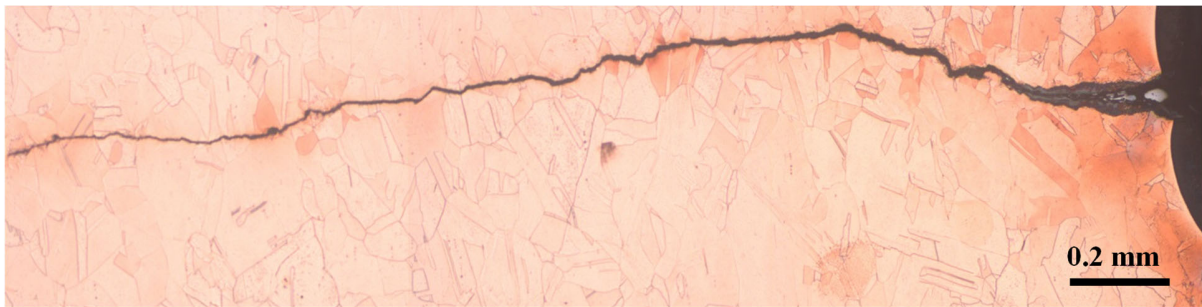
189 The samples extracted in proximity of the meniscus showed several transgranular cracks, as also highlighted  
190 by the microstructural examination. In the meniscus area, the average crack density and average crack depth were  
191 0.3 cracks/mm and 2.8 mm, respectively, in both directions (longitudinal and transversal with respect to the mold  
192 axis). An example of the crack length and morphology, obtained from sample A1, is shown in Fig. 10.

Fig. 10. Image of the crack extension in sample A1.

193 The crack was almost transgranular when it proceeded in the bulk material. The transgranular shape was  
194 maintained in all its length.

250 present a high affinity with Cu, infiltrate the cracks of Cr coating and generate a liquid metal infiltration, which  
251 presents a morphology similar to an undermining corrosion of the coating [2, 14, 21, 22, 25]. The coating is then  
252 detached and the bare Cu is exposed to the deleterious low melting point elements. In this case, the reaction of  
253 these elements with Cu is fast and controlled by the diffusion. In the meniscus zone, the Cu substrate reacts first  
254 with Zn, which forms brittle intermetallic phases ( $\gamma$  brass,  $\beta'$  brass or mixture of two). Furthermore, this brittle  
255 phase breaks, nucleating the thermal fatigue crack of the substrate, which propagates in the Cu alloy [2, 11]. The  
256 crack nucleation is intergranular (Fig. 9) and favored by the precipitation of intermetallic phases at grain  
257 boundaries. The crack propagation, instead, is transgranular (Fig. 10) and is enhanced by the infiltration of

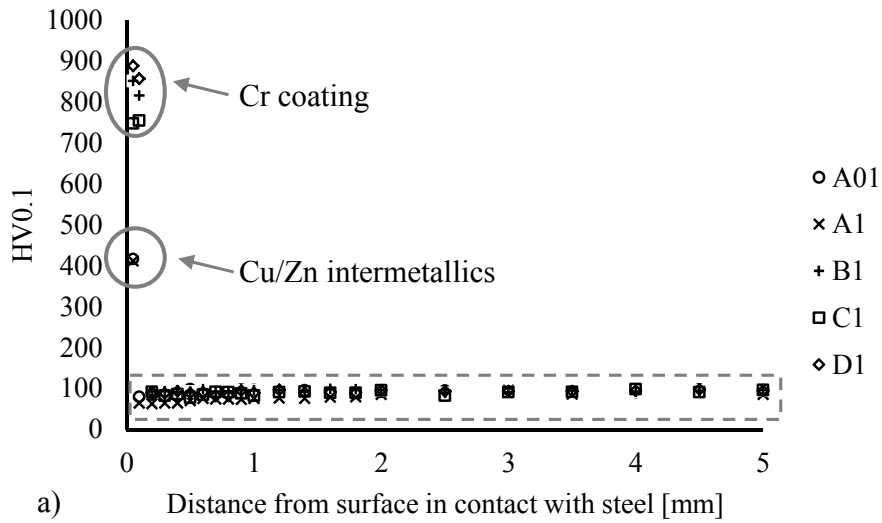
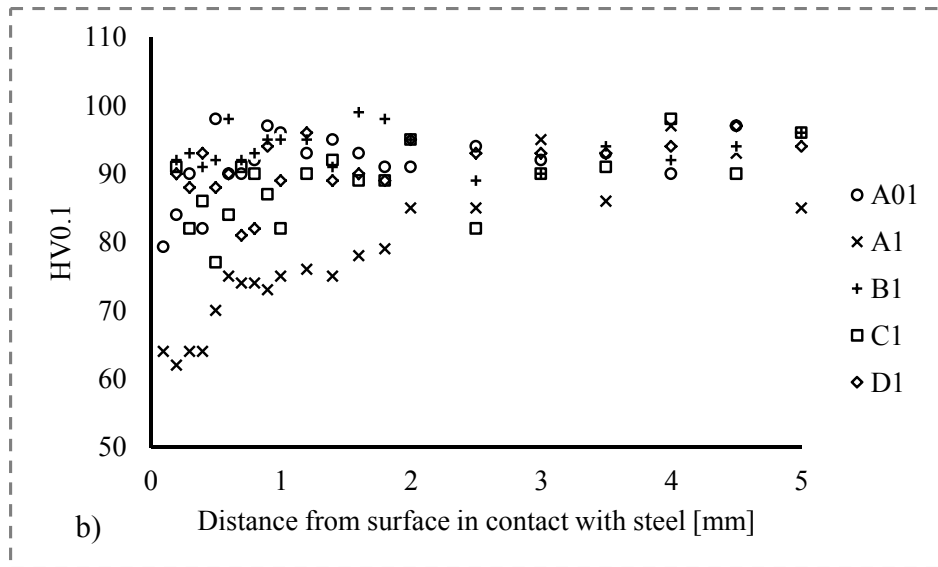
195 The micro-hardness profiles are shown in Fig. 11. As highlighted by Fig. 11a, the hardness was higher in  
196 proximity of the surface because of the presence of a hard chromium coating (samples B1, C1, D1) or due to the  
197  $\gamma$  Cu-Zn phase (samples A01, A1). On the other hand, the hardness of the substrate was constant for all the analyzed  
198 samples. Only specimen A1, which was extracted from the center of the mold surface in the meniscus area,  
199 presented a lower hardness value up to a depth of 1-2 mm. These results agreed with the microstructural material  
200 characterization that exhibited a coarser microstructure in sample A1 compared to the others.

Fig. 11. Micro-hardness profiles for the tested specimens: a) complete profile, b) zoom of the hardness between 50 and 110 HV0.1 (square area of Fig. 11a).

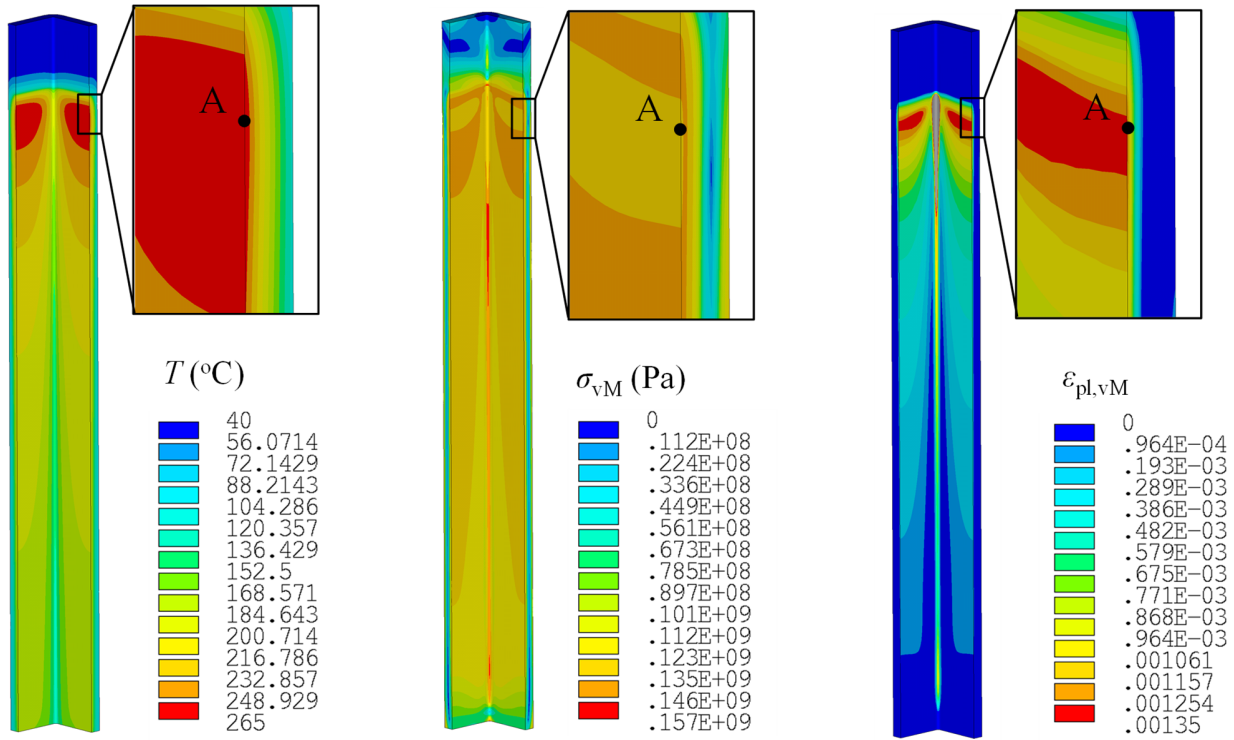
The temperature distribution obtained at the maximum thermal flux is presented in Fig. 12a. The highest temperature was observed at 30 mm below the position where the maximum flux was applied, at the point labeled with the letter “A”, where the largest through-thickness thermal gradient also occurred.

206 The von Mises stress distribution is shown in Fig. 12b. The stresses also exceeded the yield stress in those  
 207 regions of the inner mold surface in which the thermal flux attained its largest values. This is also evidenced in  
 208 Fig. 12c, which displays the von Mises plastic strain distribution. The maximum plastic strains were located where  
 209 the highest temperature occurred.

Fig. 12. Numerical model: a) temperature distribution at  $q_{\max}$ , b) von Mises stress distribution, c) von Mises plastic strain distribution.

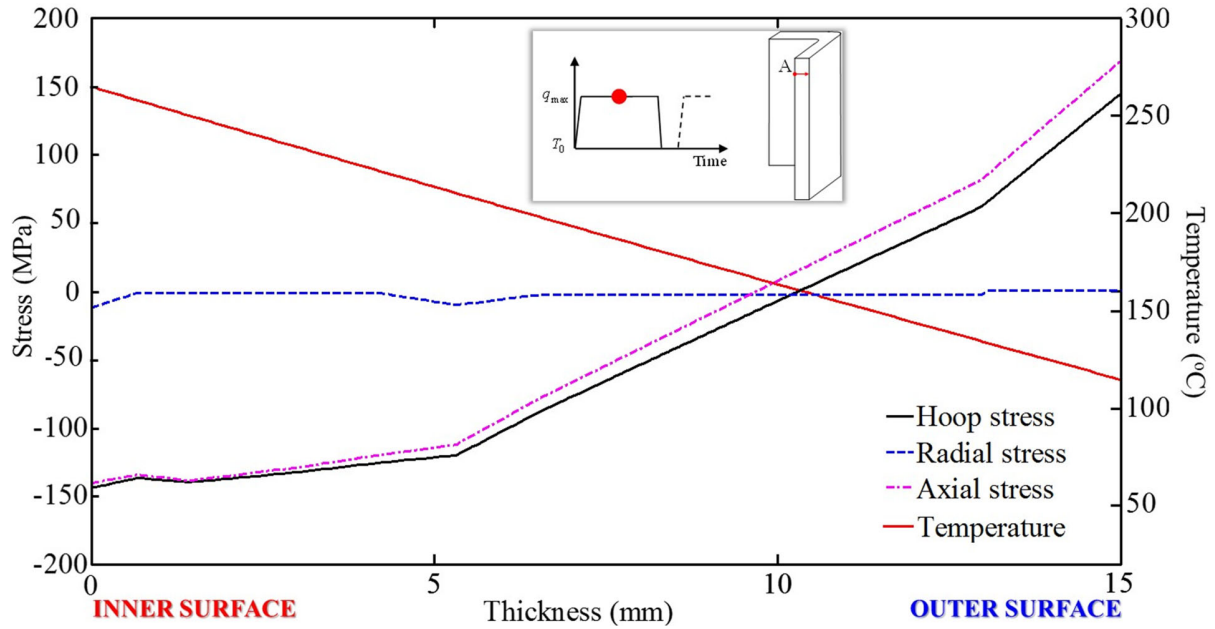
219 expand, but is constrained by the outer colder part. As a consequence, rather high compressive stresses occurred  
 220 inside the mold and in the hottest area they even exceeded the material yield stress, see Fig. 13.

Fig. 13. Stress and temperature distribution versus thickness at the critical point A – *Hot-phase*.

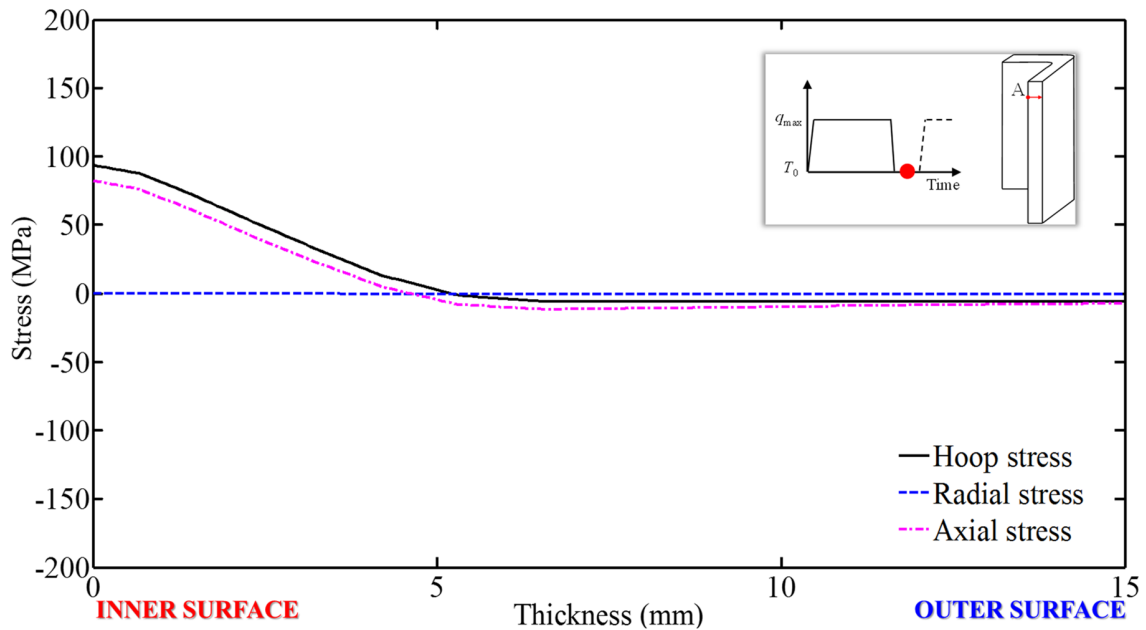
221 The opposite occurs when the plant is switched off (*cold-phase*). In the latter case, the mold is cooled down to  
 222 room temperature and consequently the zone plasticized during heating undergoes tensile stresses (Fig. 14).

Fig. 14. Stress distribution versus thickness at the critical point A – *Cold-phase*.

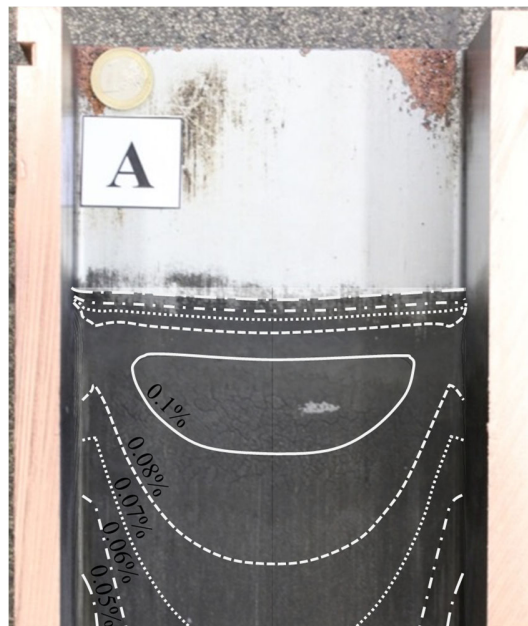
229 Owing to the plant being switched on/off continually, the stresses in the inner mold surface fluctuate from  
230 negative (compressive) values, approaching yielding, up to positive (tensile) values. These fluctuating stresses  
231 cause a thermal fatigue phenomenon, as demonstrated by several cracks mainly observed close to the meniscus  
232 area (i.e. in the position of sample A1 followed by A01), where temperatures are higher. According to O'Connor  
233 and Dantzig [8], the tensile stresses are responsible for damages that occur on the inner surface near the meniscus.  
234 Fig. 15 compares the inner surface of the real component and the distribution of the von Mises plastic strain,  
235 evaluated numerically in the same area. The most critical area (where the highest plastic strain values occur) is  
236 located where the cracks were observed with the metallurgical analysis.

Fig. 15. Comparison between the mold inner surface and the von Mises plastic strain distribution.

284 Alternative coatings to the hard chromium plating (e.g. thermal spray coatings, binary/ternary alloys deposited  
285 by electrodeposition) could be adopted in order to delay the coating detachment and thus increase the mold service  
286 life. It would also be beneficial to decrease the amount of low melting point elements in the steel.
