Study of the conservation state of European street furniture in painted cast irons

C. Soffritti, L. Calzolari, A. Balbo, F. Zanotto, C. Monticelli, A. Fortini, G.L. Garagnani

This work evaluates the state of conservation of four painted and partially corroded post-mounted luminaries in cast irons, dating back to the nineteenth and the twentieth centuries and coming from foundries located in Italy and France.

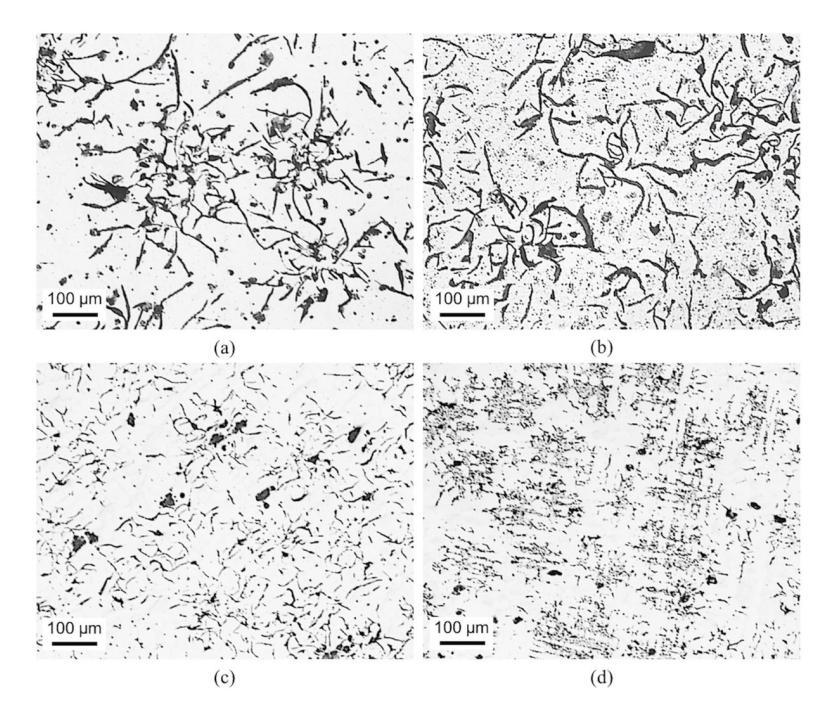
The optical micrographs of the microstructure observed on the cross sections of cast irons before chemical etching are shown in Fig. 1. In accordance with the standard EN ISO 945-1:2008, samples 1_Enna (Fig. 1a), 2_Bergamo (Fig. 1b) and 3_Imola (Fig. 1c) were characterized by lamellar graphite of Type B (rosette grouping with random orientation). For samples 1_Enna and 2_Bergamo, the graphite lamellae were between 0.12 and 0.25 mm in length, while on sample 3_Imola lamellae lengths in the range of 0.06 and 0.12 mm were measured. The sample 4_Nice (Fig. 1d) showed Type D lamellar graphite (fine, randomly oriented graphite flakes in the interdendritic position) with length shorter than 0.015 mm.

Fig. 1 – Optical micrographs of the microstructure observed on the cross sections of cast irons before chemical etching: (a) sample 1_Enna; (b) sample 2_Bergamo; (c) sample 3_Imola; (d) sample 4_Nice. / *Micrografie ottiche rappresentative della microstruttura delle ghise in sezione trasversale ed in assenza di attacco metallografico: (a) campione 1_Enna; (b) campione 2_Bergamo; (c) campione 3_Imola; (d) campione 4_Nice.*

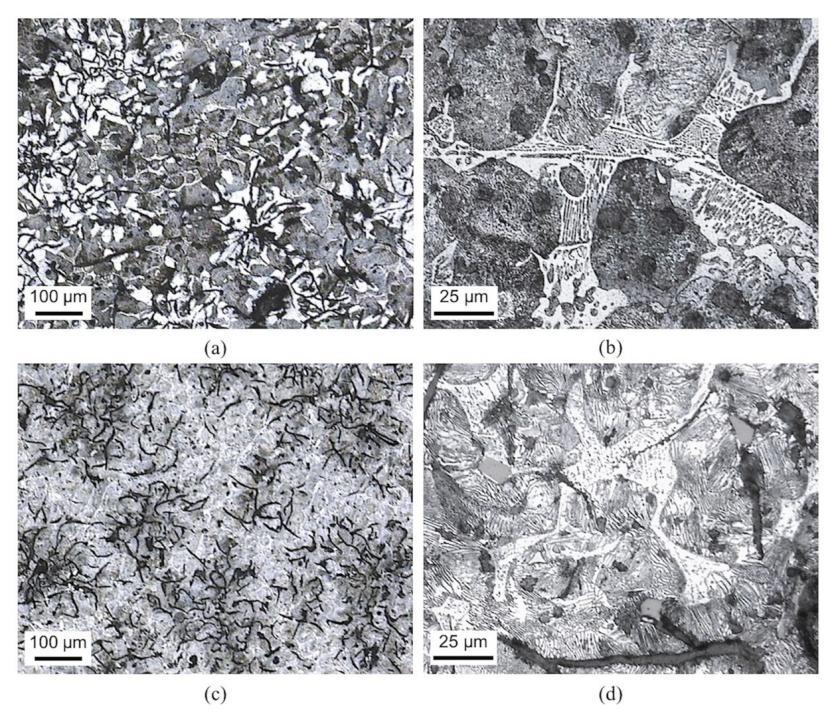
Fig. 2 – Optical micrographs of the microstructure observed on the cross sections of sample 1_Enna (a, b) and sample 2_Bergamo (c, d), after chemical etching. / *Micrografie ottiche rappresentative della microstruttura dei campioni 1_Enna (a, b) e 2_Bergamo (c, d) in sezione trasversale e dopo attacco metallografico.*

Fig. 2 shows the optical micrographs of 1_Enna and 2_Bergamo cross sections after chemical etching. In the first case (Fig. 2a and b), the microstructure was characterized by the presence of pearlite, ferrite close to the graphite rosettes (white areas in Fig. 2a), steadite (eutectic of iron phosphide Fe₃P and iron, Fig. 2b), and impurities in the form of polygonal shape particles. The semi-quantitative EDS analyses highlighted that the amounts of sulfur and manganese detected in these polygonal shape par-

ticles were higher than in the metal matrix. In the 2_Bergamo sample (Fig. 2c and d), characterized by a pearlitic microstructure with uniformly distributed steadite, a higher amount of impurities than that observed on the cross section of the sample 1_ Enna was detected. The microstructures of the cross sections of samples 3_Imola and 4_Nice were similar to that of the sample 2_Bergamo, but with very few impurities.

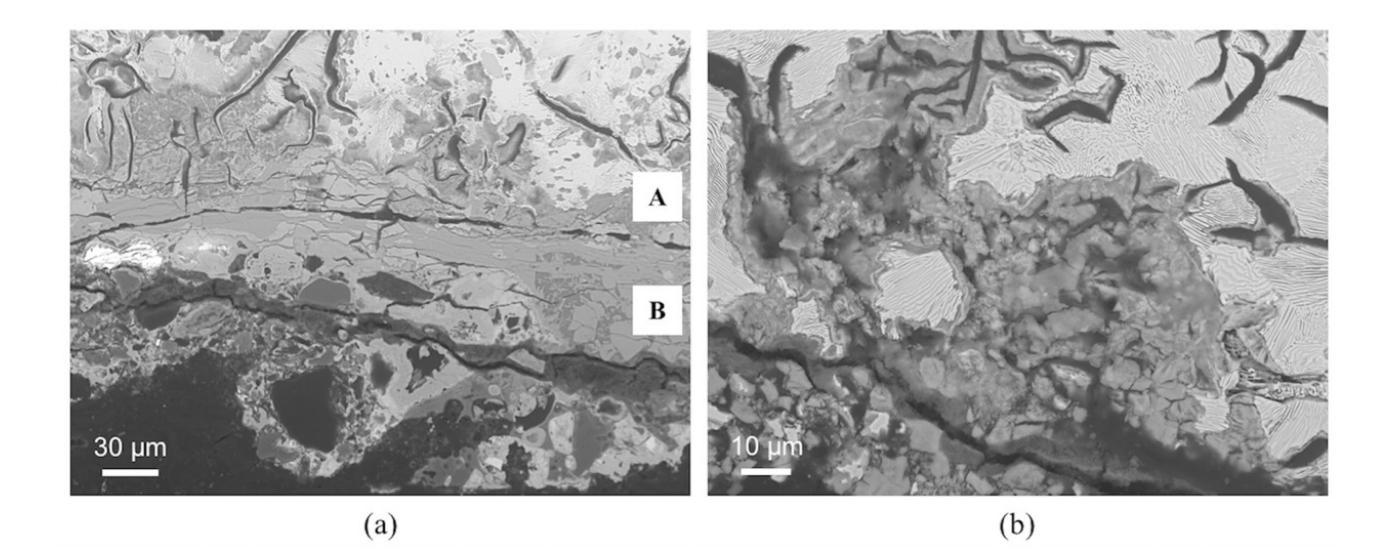
Fig. 3 – VPSEM backscattered electron images of the cross section of the corrosion patina, observed on the surface of the sample 2_Bergamo: (a) overview of the patina; (b) detail of the inner layer. / *Micrografie VPSEM in modalità elettroni retrodiffusi rappresentative della patina di corrosione osservata sulla superficie del campione 2_Bergamo: (a) visione generale della patina di corrosione; (b) dettaglio dello strato interno di corrosione.*

An example of the stratigraphy of the corrosion patina observed on the surfaces of the examined cast irons is shown in the VPSEM backscattered electron images of Fig. 3. Two distinct layers of corrosion products were recognizable: an inner layer (indicated by letter A in Fig. 3a) characterized by non-uniform penetration inside the less noble alloy phase (Fig. 3b), and an external one on the top (indicated by letter B in Fig. 3a).

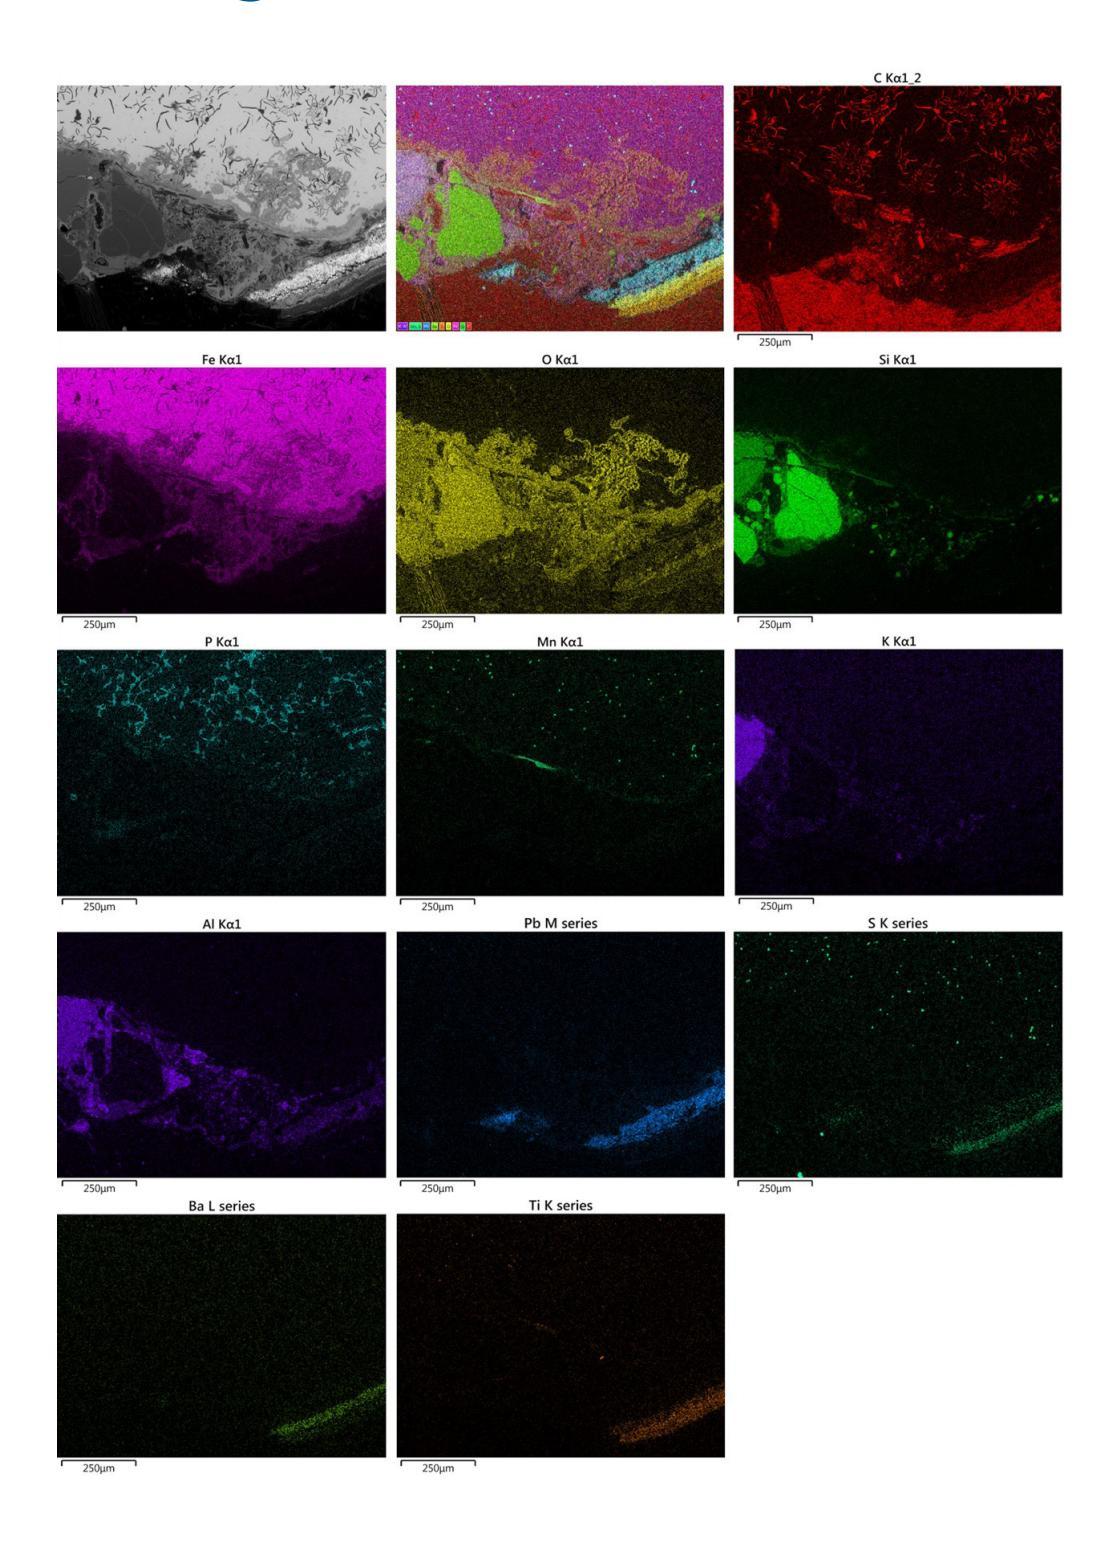
Fig. 4 – VPSEM backscattered electron images (upper left corner), layered image of X-ray maps (upper center) and maps of elemental distribution in the cross section of the sample 3_Imola. / *Micrografia VPSEM in modalità elettroni retrodiffusi (in alto a sinistra), so-vrapposizione di mappe di raggi X (in alto al centro) e mappe rappresentative della distribuzione degli elementi chimici nella sezione trasversale del campione 3_Imola.*

The VPSEM/EDS mapping of the corrosion patina and paint on the cross section of the sample 3_Imola is reported in Fig. 4. The EDS maps measured on the inner layer of corrosion suggested that the selective attack of the matrix essentially produced iron corrosion products. Inside the outer corrosion layer, iron oxides were visible, admixed with elements from the corrosive environment (e.g. K and Al from particulate matter). The EDS maps also highlighted that the corrosion patina was overlain by a multilayer paint. Beginning from the outer corrosion layer, the paint was composed of a Pb-rich layer, a S- and Ba-rich layer, and a Ti-rich layer. The VPSEM/EDS mapping performed on the sample 2_Bergamo showed that the stratification of the corrosion products and paint was similar to that observed on sample 3_Imola. In the 1_Enna and 4_Nice samples the EDS maps on the layers of corrosion products were similar to those in Fig. 4. However, in the paint layer of 1 Enna sample only Ba-, S- and O-rich particles (likely $BaSO_4$) were detected, whereas Zn-rich particles were identified in the paint layer of the sample 4_Nice.

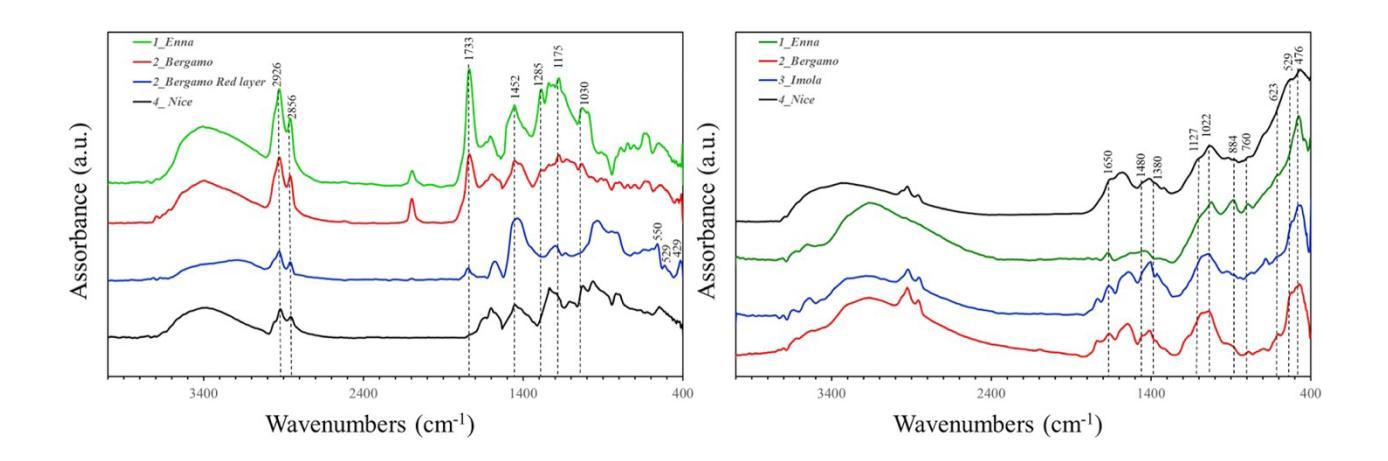
The FT-IR spectra of the paint samples are showed in Fig. 5a. The paints spectra were complicated by the presence of additional components in the paint formulation, such as the pigments, extenders and dryers that exhibited their specific absorption peaks, making the identification of the paints a complex task. In all spectra the typical vibration of aliphatic functional groups was present, related to symmetric and asymmetric C-H stretching and C-H deformation bands (occurring respectively at 2926 cm⁻¹ and 2856 cm⁻¹ and at 1452-1413 cm⁻¹) and a large band centered around 3400 cm⁻¹ related to OH stretching. The samples 1_Enna and 2 Bergamo showed a strong and intense peak at 1733 cm⁻¹ related to the stretching of the carbonyl group. In addition to a strong band present in the region 1285-1175 cm⁻¹ involving the stretching of the carboxylic group bonds, a further IR band near 1030 cm⁻¹, related to the stretching of O-C bond in the O-CH₂ group, was observed. These findings suggested that these coatings were alkyd resins. The sample 2_Bergamo Red Layer collected from the layer beneath the paint, showed, in the low energy portion of the spectrum, three peaks at 550, 529 and 429 cm^{-1} related to the presence of minium (Pb₂O₄).

Fig. 5 – FT-IR spectra of (a) paints and (b) corrosion products collected on post-mounted luminaries exposed outdoor. / Spettri FT-IR relativi alle vernici (a) e ai prodotti di corrosione (b), visibili sulla superfice dei lampioni oggetto di studio.

In Fig. 5b, the FT-IR spectra collected on the corrosion products scraped from the post surfaces are reported. All the spectra appeared quite similar: the peak at 1022 cm⁻¹ and the shoulder at 1127 cm⁻¹ were related to the in plane Fe-O-H bending, while the peaks at 760 and 476 cm⁻¹ were related to the out of plane Fe-O-H bending. All these characteristic peaks indicated the presence of lepidocrocite (γ -FeOOH) [21,22] in all the samples. The peaks at 884 and 623 cm⁻¹ also suggested the occurrence of a small amount of goethite (α -FeOOH) [21,22]. The large band in the range 3100-3600 cm⁻¹ was related to OH stretching of hydroxyl groups of both goethite and lepidocrocite, but it was also probably related to the vibration of water in crystal structure, as confirmed by the presence of a shoulder at 1650 cm⁻¹. The shoulder detected at 529 cm⁻¹ on the samples 1_Enna, 2_

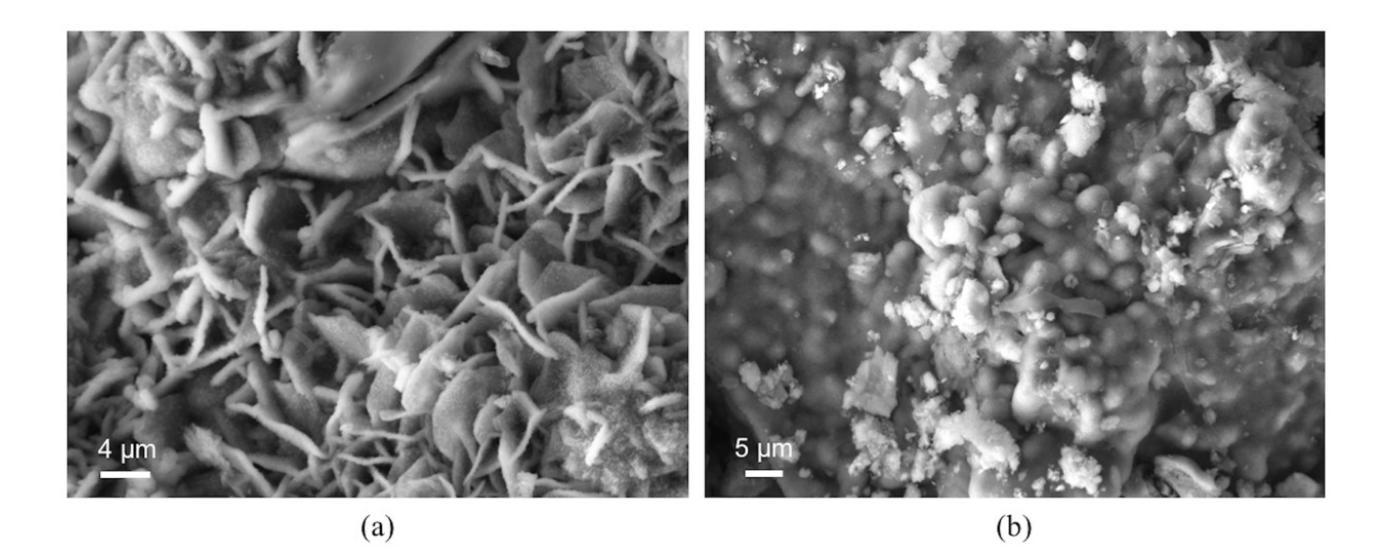
In all samples, the VPSEM/EDS observations highlighted the presence of both flower-like pattern and the foam-like morphology of the lepidocrocite (Fig. 6a), and the cloudy or cotton-ball-like microstructure associated to the goethite (Fig. 6b).

Fig. 6 – VPSEM images of the corrosion products observed on the surface of the examined samples: (a) detail of lepidocrocite; (b) detail of goethite. / *Micrografie VPSEM rappresentative dei prodotti di corrosione osservati sulla superfice dei campioni indagati: (a) dettaglio della lepidocrocite; (b) dettaglio della goethite.*

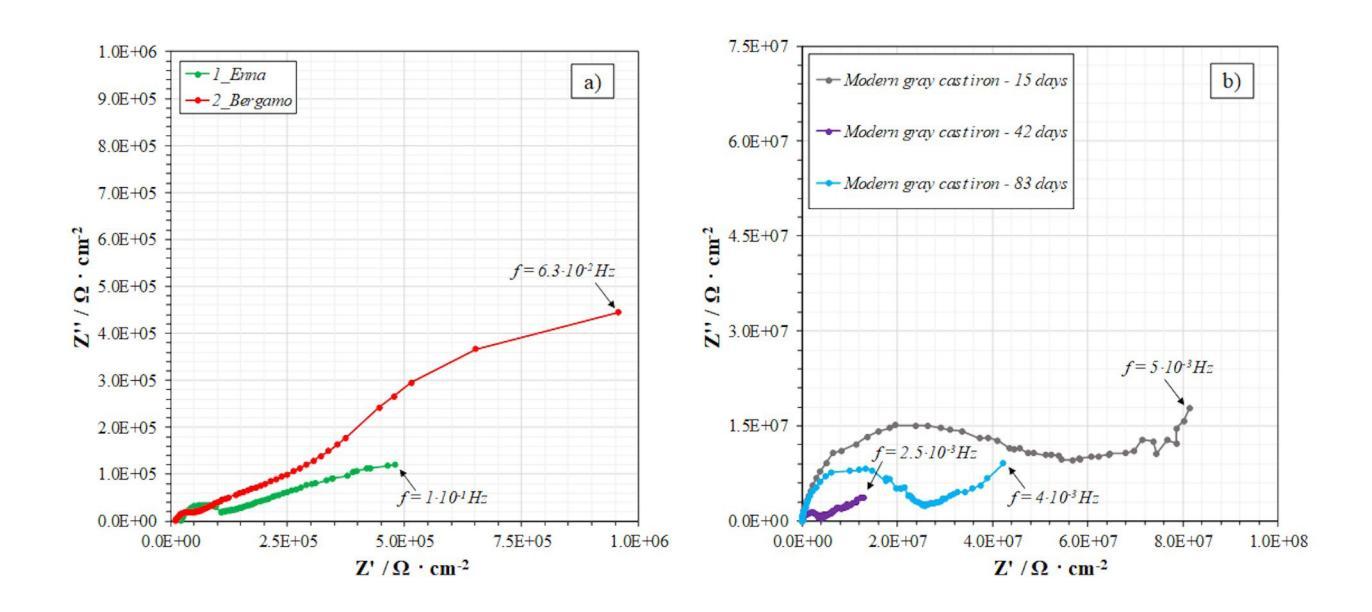
Fig. 7 shows the EIS spectra in Nyquist format, recorded on 1_ Enna and 2_Bergamo samples (carrying the original paint layers, Fig. 7a) and on the plates in modern gray cast iron with the standard Neri S.p.A. coating (Fig. 7b), the latter after 15, 42 and 83 days of exposure to the salt spray test.

Fig. 7 – EIS spectra in Nyquist format, recorded on (a) 1_Enna and 2_Bergamo samples and on the plates in modern gray cast iron (b). / Spettri EIS, sotto forma di diagrammi di Nyquist, registrati (a) sui campioni 1_Enna e 2_Bergamo, e sulle lastrine in ghisa grigia moderna (b).

R_{nore} values of the coating on the modern gray cast iron remained higher than $10^7 \Omega \cdot \text{cm}^2$ until the end of the exposure to the salt spray test. The corresponding C₂ values only slightly increased during the test indicating that it offered a high barrier effect against water absorption [27]. R_{pore} values of the ancient paints were more than two orders of magnitude lower than those of the modern one, suggesting that they were affected by many pores and cracks. The C₂ value of 1_Enna sample was smaller than those measured on the modern paint, while that of 2_Bergamo was equal. Capacitances are proportional to the dielectric constant of the coatings (ϵ) and inversely proportional to their thickness. Dry conditions are present in both ancient paints, due to their persistence in indoor conditions for many years and due to the short measurement time in contact with mineral water. These conditions induce low coating ε values and justify the low C₂ value measured on 1_Enna sample, as this ancient and the modern coatings have comparable thickness. In the case of 2_Bergamo, C_c is comparable to those measured on the modern paint and this could be connected to the lower coating thickness. The estimated R_n values of the ancient samples were more than one order of magnitude lower than that on modern gray cast iron at the end of salt spray test exposure, evidencing the higher corrosion rates of the underlying metal due to the scarce residual protectiveness of the ancient coatings.
