## Article

# Seismic Vulnerability Assessment of Historical Masonry Buildings in Croatian Coastal Area

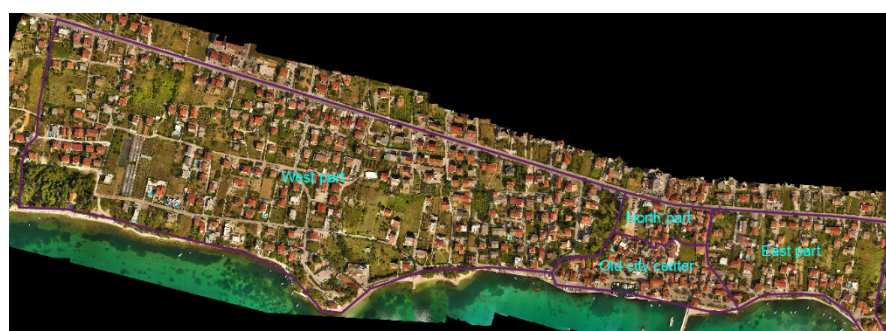
**Figure 3.** Kaštela Kambelovac test site with four characteristic parts.

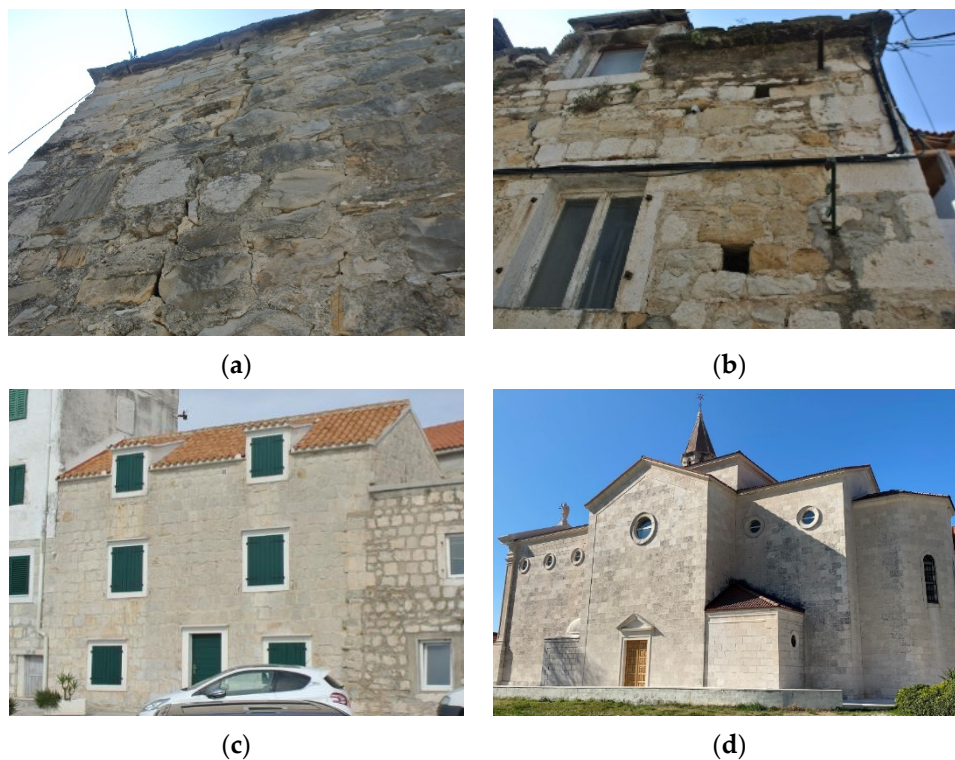
**Figure 4.** Examples of wall textures of stone masonry buildings: (a) non-squared roughly shaped stone masonry of various sizes arranged in chaotic manner; (b) wall composed of disorganized roughly shaped stones; (c) walls made of natural well-worked homogenous squared stones accurately executed; (d) walls of St. Mihovil church, composed of well-organized cut blocks.

The buildings in the historic center were constructed with stone blocks with mortar joints, the walls' thickness being between 45 and 75 cm. The structural frame is characterized by wooden floors consisting of beams and a wooden floor covering. The quality of the walls depends on the processing of the stone, their way of stacking, and on the quality of the mortar in the joints. The walls' textures vary from rough non-squared stone masonry of variable size arranged in a chaotic manner, to well-organized masonry made of well-shaped or cut blocks of almost uniform size (Figure 4). The mortar is mainly of a low

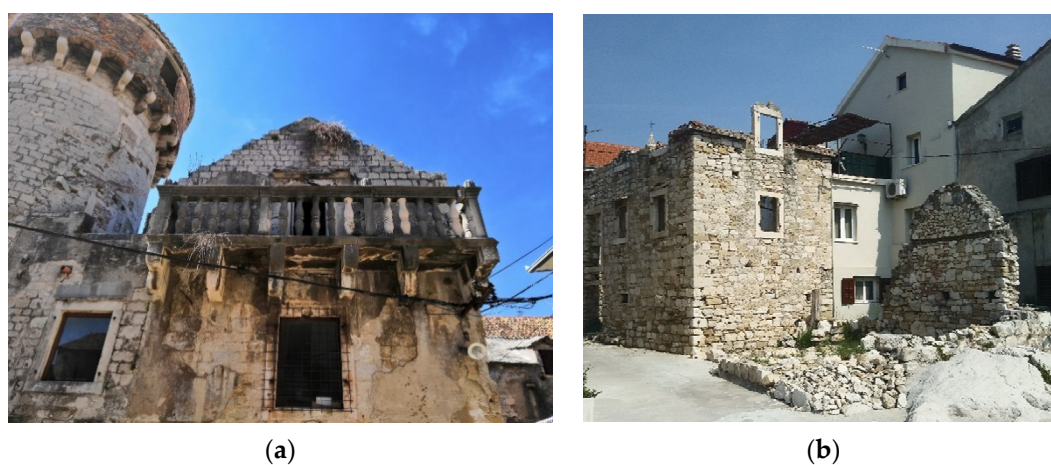
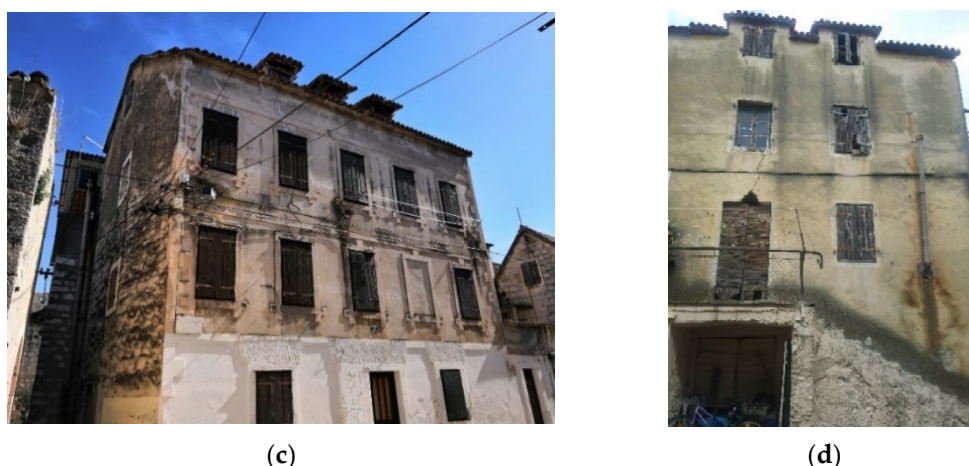
**Figure 5.** Current state of buildings in the historic centre: (a) damage to Cambi tower; (b) completely demolished building; (c,d) significant cracks in the load-bearing walls of residential buildings.

Some buildings are in very poor condition, without mortar in the joints between the stone blocks, significant cracks in the load-bearing walls and, in some cases, with collapsed roofs (Figure 5). Several buildings are completely demolished.

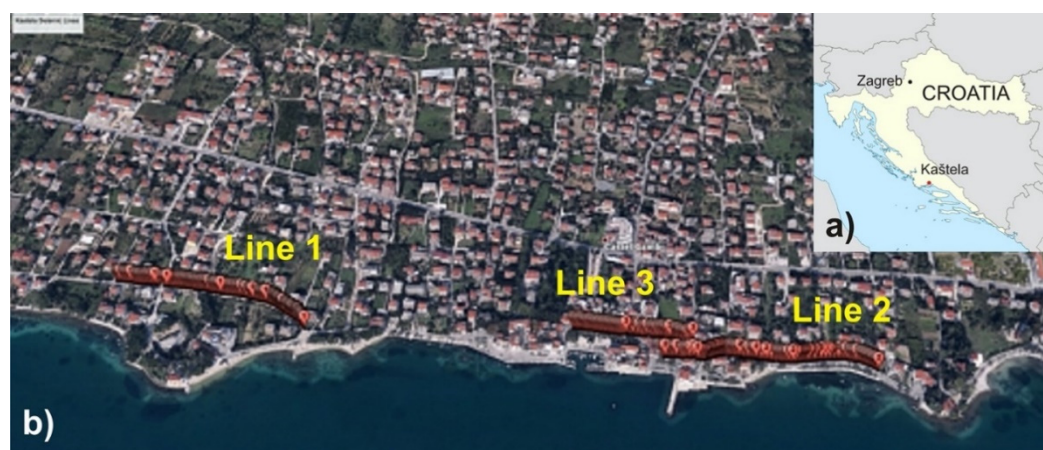
**Figure 6.** (a) Location of the Kaštela City on the Dalmatian coast. (b) Position of the seismic lines in the historic center of Kaštela [47].

The test site was investigated to classify soils according to [46]. Three seismic lines were acquired in May 2019 in the test site [47] (Figure 6). A velocity analysis based on travel time tomography of P, SV, and SH arrivals, acquired on three seismic lines on the shore of the Kaštela Bay, was performed. The  $V_{s,30}$  map along each line was also computed by averaging the vertical  $V_{sH}$  tomographic values from the surface to a depth of 30 m. Relatively high obtained values, between 1.2 and 1.7 km/s, indicate the presence of shallow hard rock [14], which can be classified as soil type A according EN 1998-1:2011 [46]. Considering the results obtained along the three investigated lines and given the size of the test area, the seismic hazard was assumed to be constant for all buildings in the area.

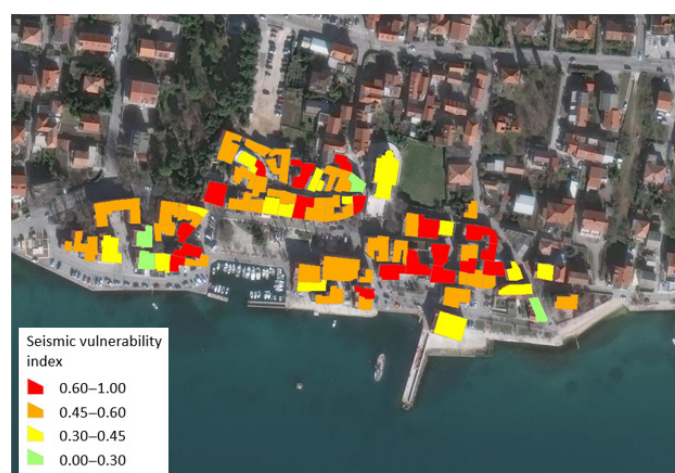
**Figure 7.** Vulnerability map of the historical core.

The buildings were divided into 4 vulnerability classes: low vulnerability for  $I_v < 30$ , medium-low vulnerability for  $30 < I_v < 45$ , medium-high vulnerability for  $45 < I_v < 60$ , and high vulnerability for  $I_v > 60$ . Figure 7 shows the vulnerability map of the area, whereas the distribution of the vulnerability is shown in Figure 8. Most buildings in the historical core belonged to the high vulnerability class (25%) and to the medium-high vulnerability class (47%). A small number of buildings were classified as medium-low vulnerability (21%). Only a few buildings were of low vulnerability (7%), and these were old stone buildings that were reconstructed. Buildings with vulnerability index of 45 and larger were considered highly vulnerable, as expected, given the age of the town center. The indexes ranged from 11.1, corresponding to one of the newer houses that was completely renovated at the boundary of the core, to 76.9, the vulnerability index of the Cambi tower. Houses made of poorly connected walls, with flexible floor structures, irregular in layout and height, were revealed to be more endangered. In addition to these basic aspects, the degree of general preservation of the building and the presence of subsequent reconstructions significantly affected the vulnerability indexes.

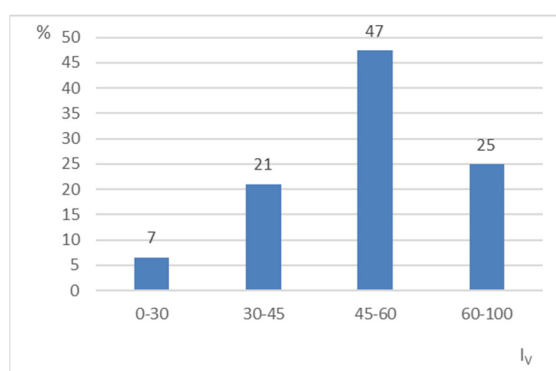
**Figure 8.** Vulnerability index distribution in the historical core.

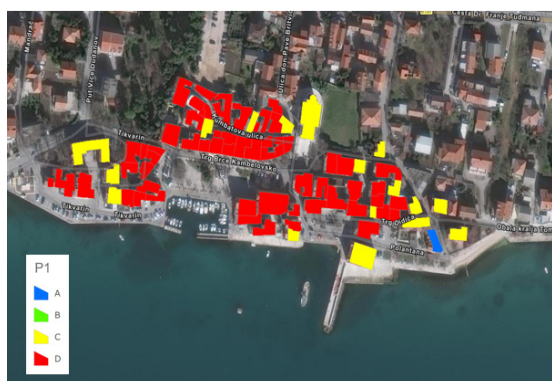
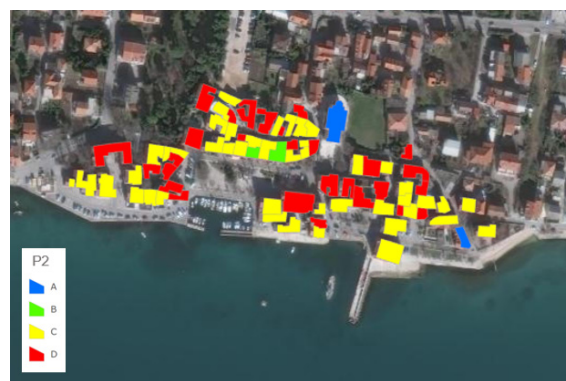
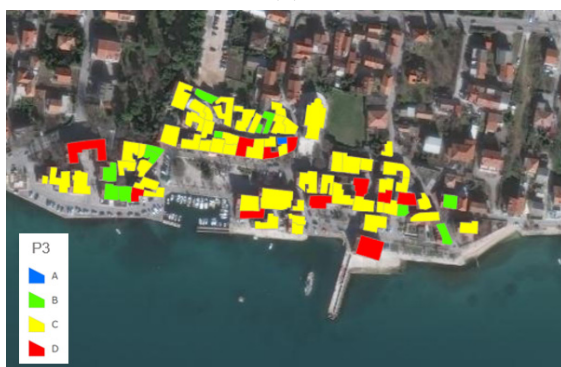
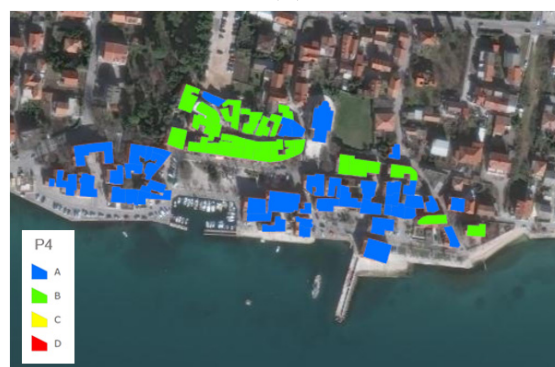
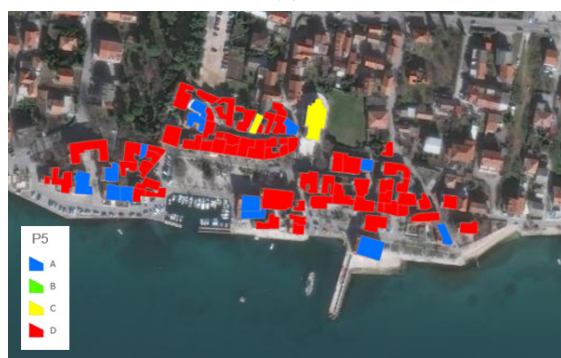
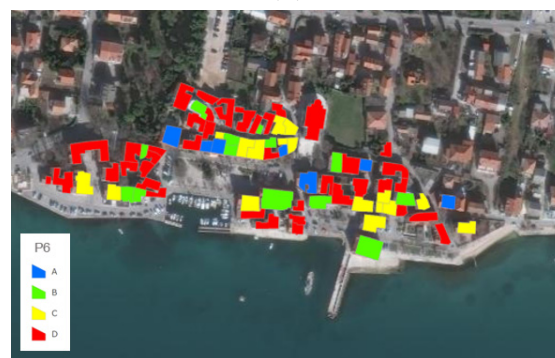
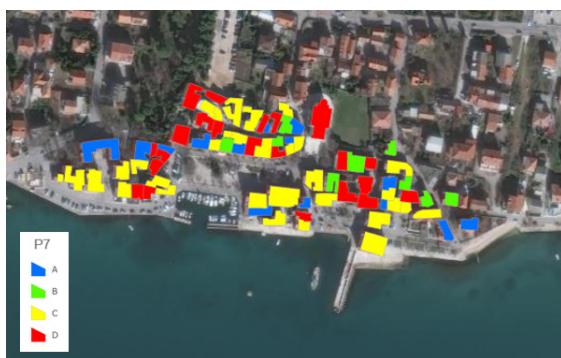
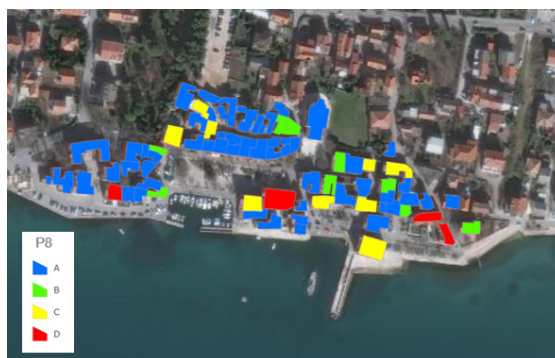
**Figure 9.** Spatial distribution of the 11 parameters that comprise the seismic vulnerability index: (a) type and organization of the resistant system; (b) quality of the resistant system; (c) conventional resistance; (d) position of the building and foundation; (e) typology of floors; (f) planimetric configuration; (g) elevation configuration; (h) maximum distance among walls; (i) roof; (j) non-structural elements; (k) state of conservation.

The investigation of the parameters necessary for evaluating the seismic vulnerability index allows us to characterize and draw some indicators that can help to better understand the overall vulnerability results. The spatial distribution of these parameters was analyzed and the results are shown in Figure 9.

The “position of the building and foundation” parameter considers the influence of the local morphology of the site and the natural slope of the ground. Its distribution in Figure 9d showed a low level of vulnerability. Specifically, 57% of buildings were in class

The presence of “nonstructural elements”, which can cause damages due to falling, highlighted an area of high vulnerability because most buildings had weakly connected nonstructural elements and belonged to classes C and D. The distribution shown in Figure 9j was 12%, 0%, 53%, and 35% for classes A to D, respectively.

The “state of conservation” parameter analyzes the condition of the building and the presence of cracks in structural walls. The relevant distribution, shown in Figure 9k, was as follows: 27% were in class A, 0% in B, 45% in C, and 28% were in class D. Most old stone masonry buildings, which have not yet been reconstructed, are in a bad condition and belong to classes C and D, whereas reconstructed buildings are in class A.

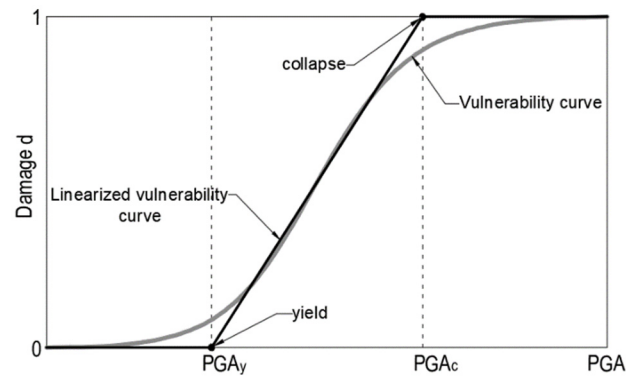
**Figure 10.** Vulnerability curve and its idealization.

as the level of the ground acceleration, were accounted for. Corresponding acceleration/damage laws can be represented with smooth vulnerability curves, such as the one shown in Figure 10.

For simplicity, Guagenti and Petrini substituted the vulnerability curve with a tri-linear law defined by the values of the peak ground acceleration corresponding to early damage,  $PGA_i$ , and to the collapse,  $PGA_c$ , as follows:

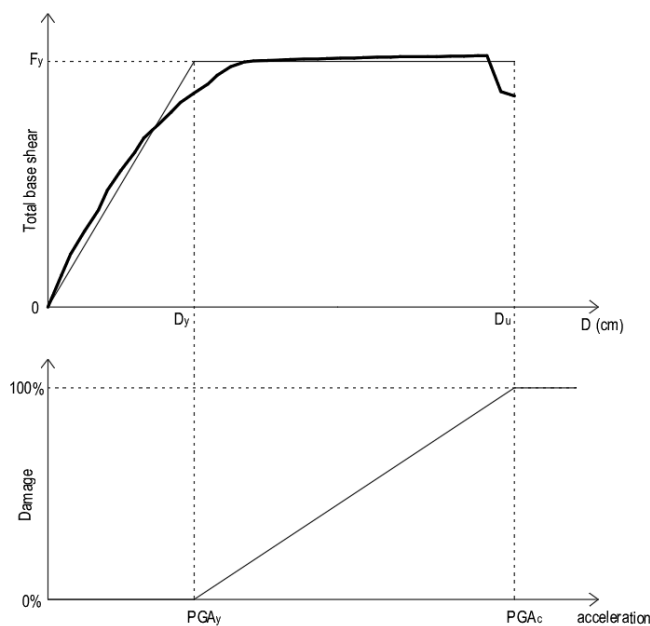
**Figure 11.** Pushover curve and tri-linear acceleration/damage law.

In this work, instead of a field observation of the damage caused by past earthquakes, a static non-linear pushover analysis was performed for the buildings at the test site; thus, the yield and collapse acceleration were determined. Then, using the previously computed vulnerability indexes and yield and collapse accelerations, new damage–vulnerability–peak ground acceleration relationships were derived. The damage index is expressed in the [0–1] space via a tri-linear law, shown in Figure 11, defined by two points: yield acceleration  $PGA_y$ , which represents the beginning of the damage ( $d = 0$ ), and acceleration for the collapse of the building  $PGA_c$  ( $d = 1$ ).

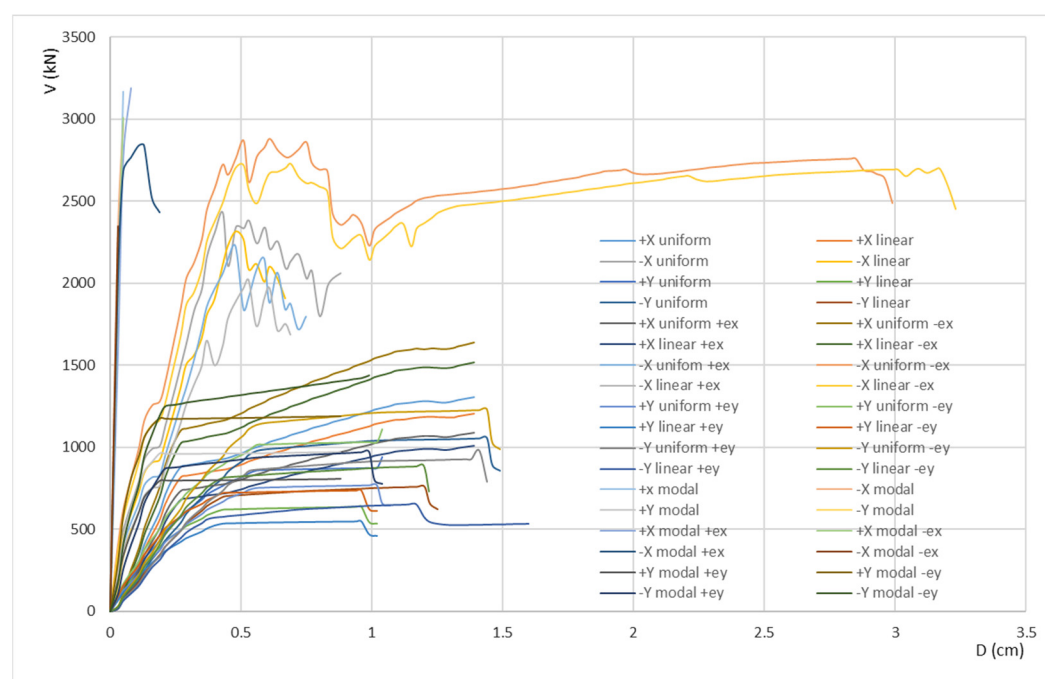
**Figure 13.** Pushover curves for the Public Library building.

The seismic demand was defined by the elastic acceleration response spectrum. A type 1 response spectrum [46] and soil class A [46] were used for the test site. The input parameters taken in the seismic analysis were the importance factor  $\gamma_1 = 1.2$ , the design ground acceleration  $a_g = 0.22$  g, and the soil factor  $S = 1.0$ . Figure 13 shows the results of a total of 36 pushover analyses. The behavior was different along the two main directions and depended on the direction of the lateral loads.

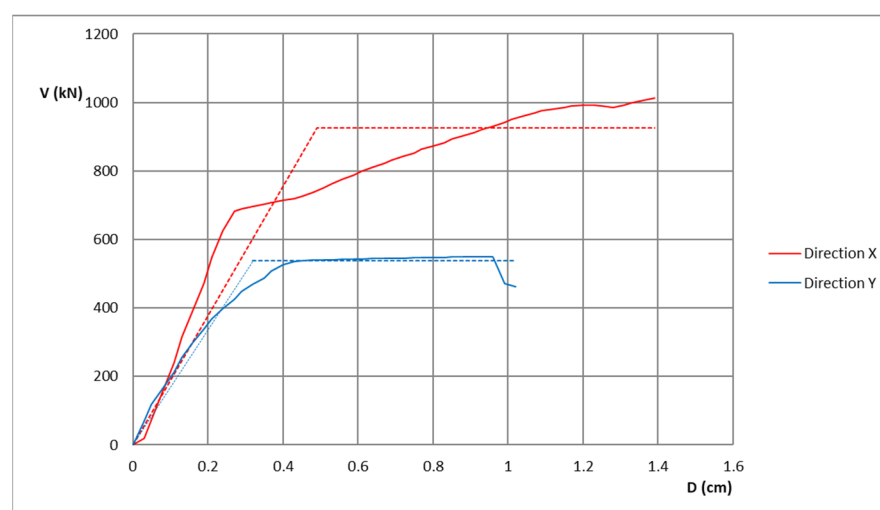
**Figure 14.** The worst cases of pushover curves.

The pushover curves which give the lowest capacity accelerations  $PGA_c$  in the x and y directions are shown in Figure 14, together with their bilinear idealizations, which are essential for capacity identification. The lowest capacity in both directions was obtained for the linear distribution.

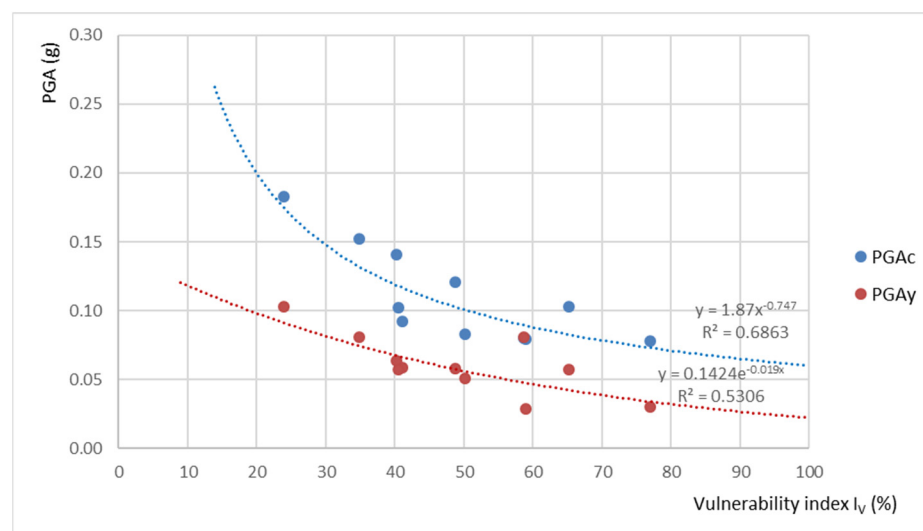
**Figure 16.** Trend lines  $I_v$ – $PGA_y$  and  $I_v$ – $PGA_c$ .

Figure 16 shows the relationship between the vulnerability index and collapse/yield accelerations for 11 buildings at the test site. The cloud of points represents the sample of buildings analyzed with the pushover analysis. The trend lines  $I_v$ – $PGA_y$  and  $I_v$ – $PGA_c$  for the yield and collapse states were obtained. The most representative functions were chosen. They can be used to approximately evaluate the yield and collapse peak ground accelerations for the historic center of Kaštel Kambelovac.

The vulnerability indexes for the buildings at the test site and the trend lines shown in Figure 16 were used to obtain the peak ground accelerations for early damage and collapse state. Figure 17 shows the collapse accelerations for the buildings in the test site.

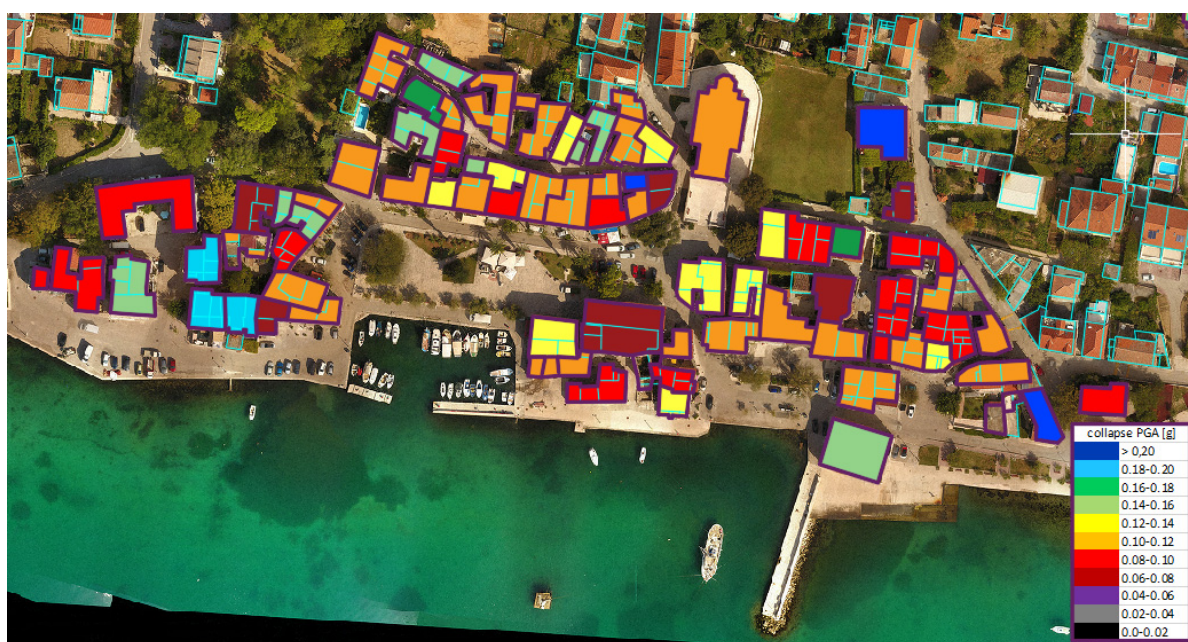
**Figure 17.** Map of collapse accelerations.

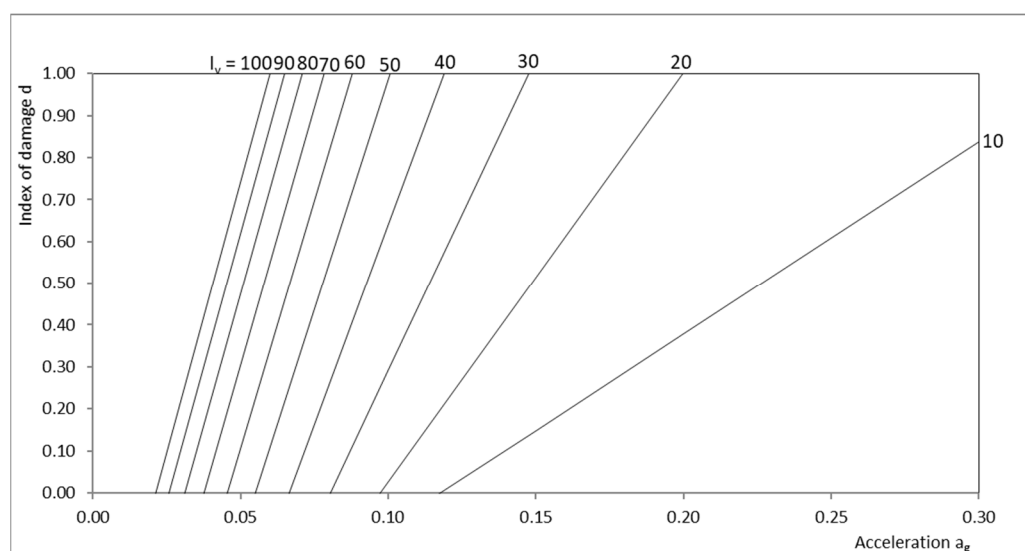
**Figure 18.** Vulnerability curves for the historic center of Kaštel Kambelovac.

The next step is the definition of the vulnerability curves for the historical center. Tri-linear vulnerability curves (Figure 3) were determined using yield and collapse peak ground accelerations,  $PGA_y$  and  $PGA_c$ , obtained through Equation (2) and using the relation shown in Figure 16. As  $PGA_y$  and  $PGA_c$  are functions of the vulnerability index  $I_v$ , the values of  $PGA_y$ , corresponding to damage  $d = 0$ , and  $PGA_c$ , corresponding to damage  $d = 1$ , can be computed for each value of  $I_v$ . These vulnerability curves are shown in Figure 18.

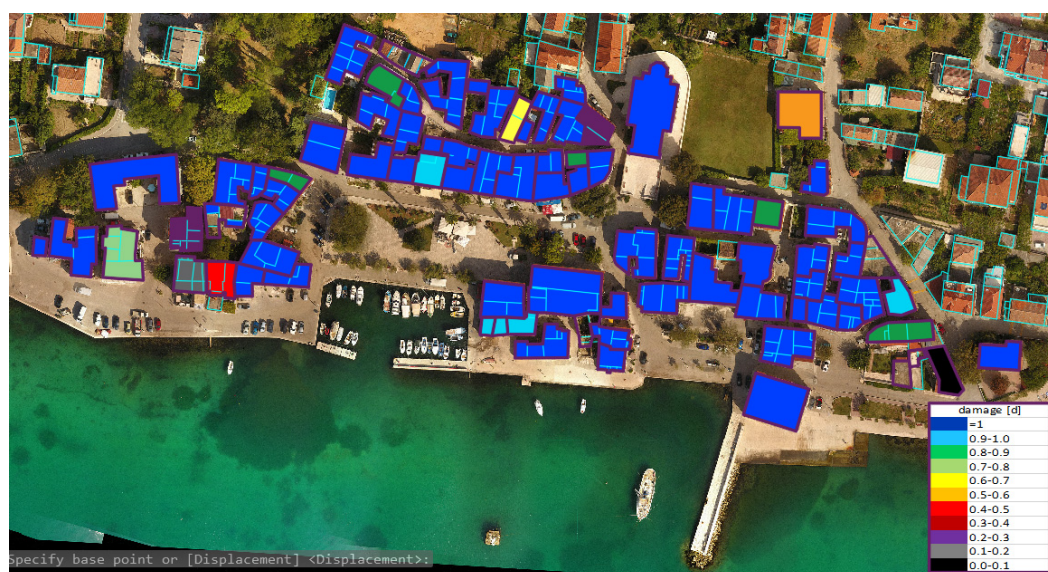
Figure 19. Map of the damage index for  $PGA = 0.11$  g and a return period  $T = 95$  years.

The damage indexes of the buildings were determined for the corresponding peak horizontal ground accelerations of 0.22 g and 0.11 g, and are presented in the maps in Figures 19 and 20.

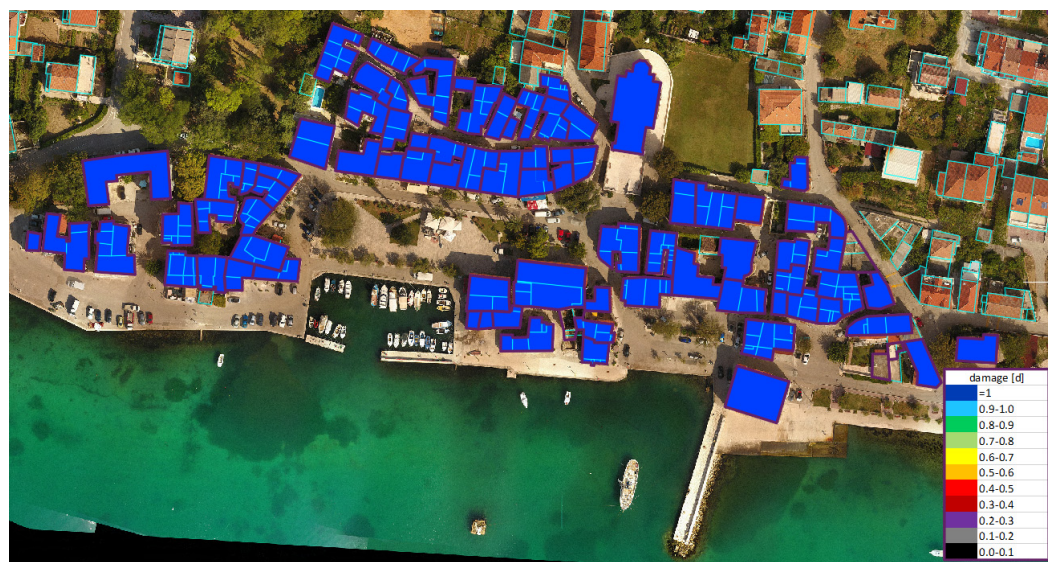
Figure 20. Map of the damage index for  $PGA = 0.22$  g and a return period  $T = 475$  years.
