# Hazard Analysis and Vulnerability Assessment of Cultural Landscapes Exposed to Climate Change-Related Extreme Events: A Case Study of Wachau (Austria)

**Abstract:** The present paper aims to study the Wachau Valley in Austria as a representative Cultural Landscape under threat from extreme hydrometeorological hazards linked to climate change. The primary objective is to investigate the impacts and assess the vulnerability associated with the events of heavy rain and flooding. The methodology employed consists of an investigation of recorded past events impacting the Wachau; a vulnerability ranking system; a climate time series analysis based on earth observation products; and future hazard maps at territorial level, developed with outputs from regional and global climate models. The investigation we carried out provides a vulnerability assessment of two terraced areas with a surface of about 10,000 m<sup>2</sup> in total, characterized by the presence of dry stone walls, with different state of conservation in the Municipality of Krems (Wachau). In addition, climate projections at territorial level for the extreme climate indices R20mm, R95pTOT, and R×5day—selected for investiga

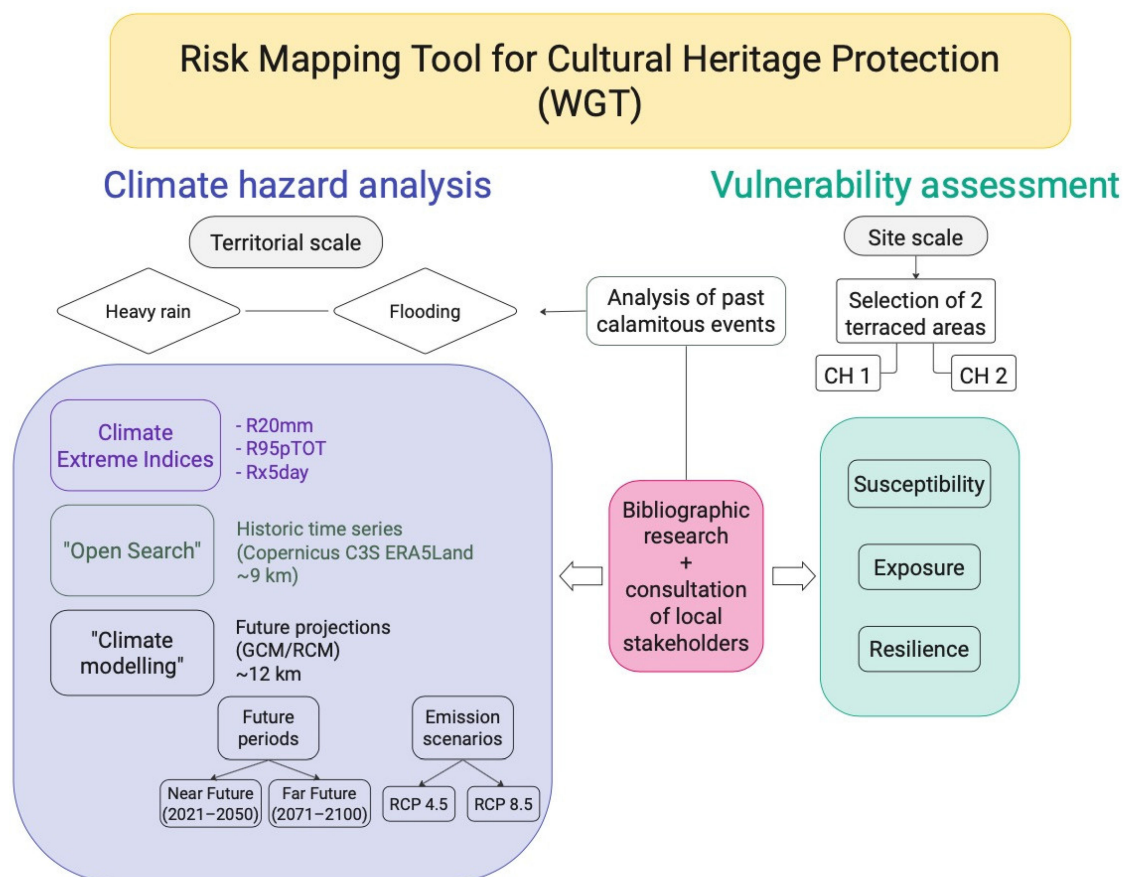
**Figure 2.** Overview of the methodological approach.

developed within the Interreg Central Europe projects ProteCHt2save and STRENCH, was created with the aim of providing a support tool to private and public authorities for the protection and management of cultural heritage sites in Europe at risk from extreme climate events, and it is accessible at <https://www.protecht2save-wgt.eu> (accessed on 20 December 2023) [31]. The methodological approach we followed is illustrated in Figure 2.

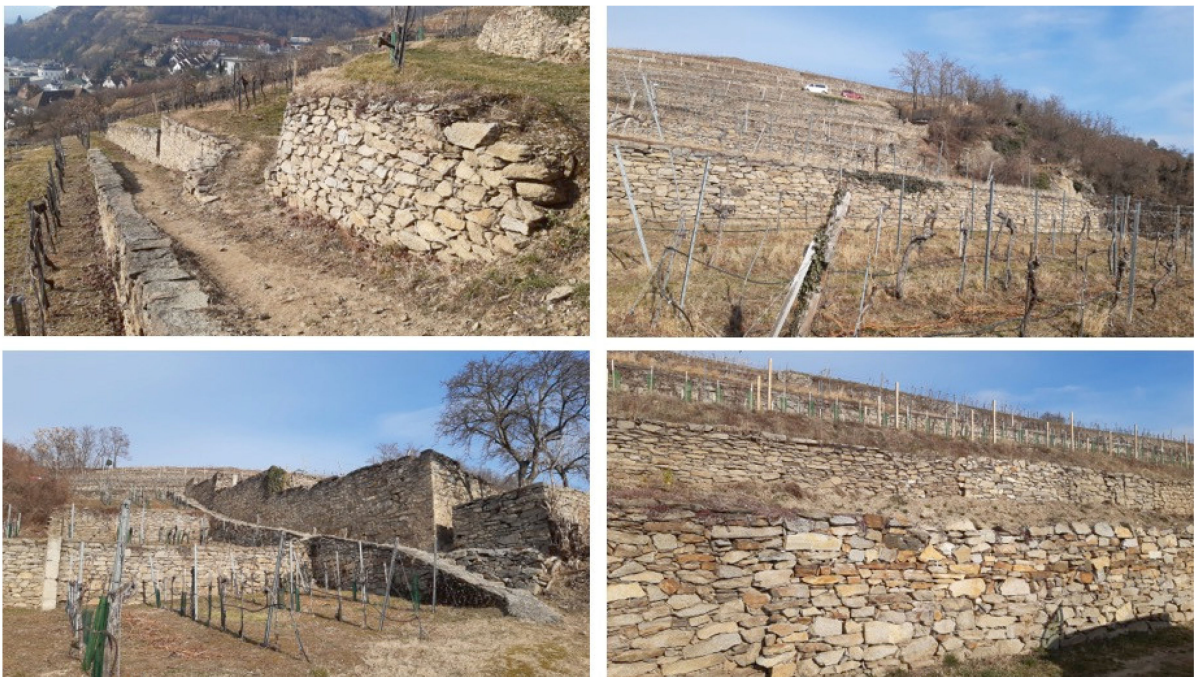
**Figure 4.** Details of the dry stone wall terraced area CH1 (credits to Rainer Vogler).

Concerning CH1, the fact that the constructions are made of resistant material (granite), in continuous use, in a good state of conservation, and have not been subjected to previous harming interventions (besides some minor acts of vandalism), as well as the presence of stable bedrock, coarse-grained soil (sand, gravel), and stable geological formation, were identified as the primary factors contributing to a notably low level of susceptibility. Regarding CH2, the materials used (gneiss) in constructing the vineyard walls are susceptible to deterioration or damage from impacts, and the overall conservation state is considered fair, thus contributing to a higher value of susceptibility. For both areas the presence of water features and the fact that the walls are close to water courses contribute to increasing their susceptibility values.

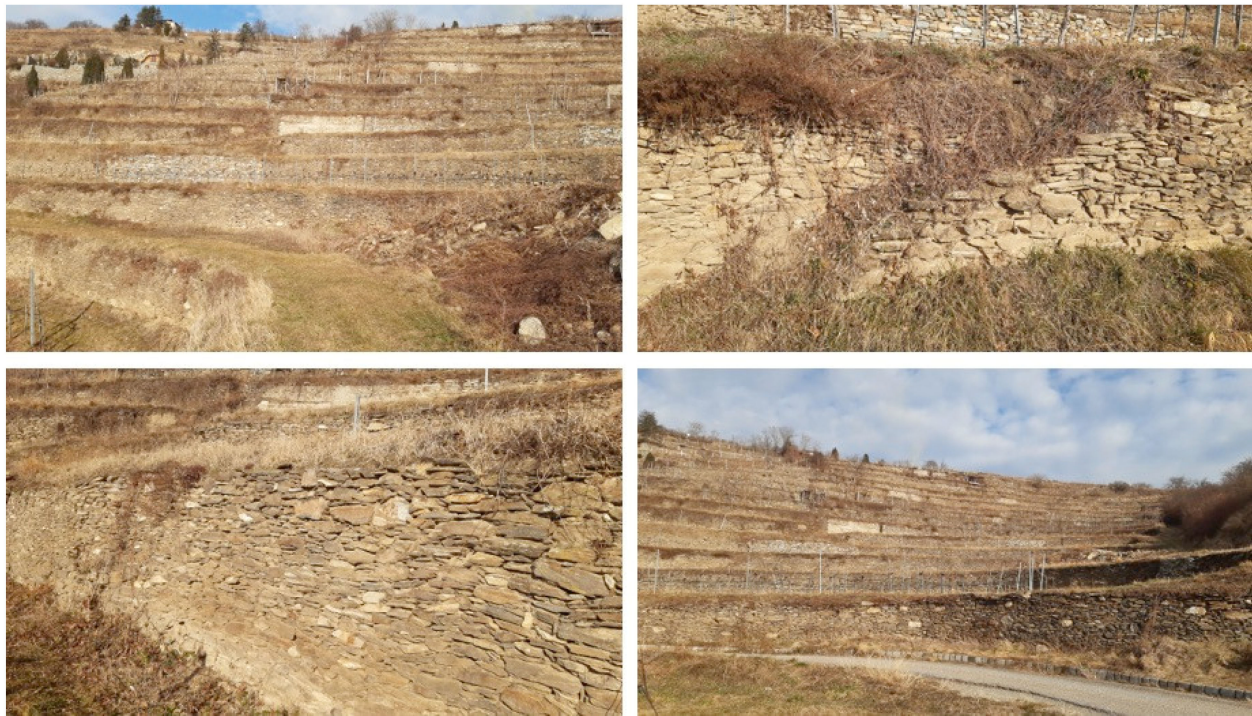
**Figure 5.** Details of the dry stone wall terraced area CH2 (credits to Rainer Vogler).

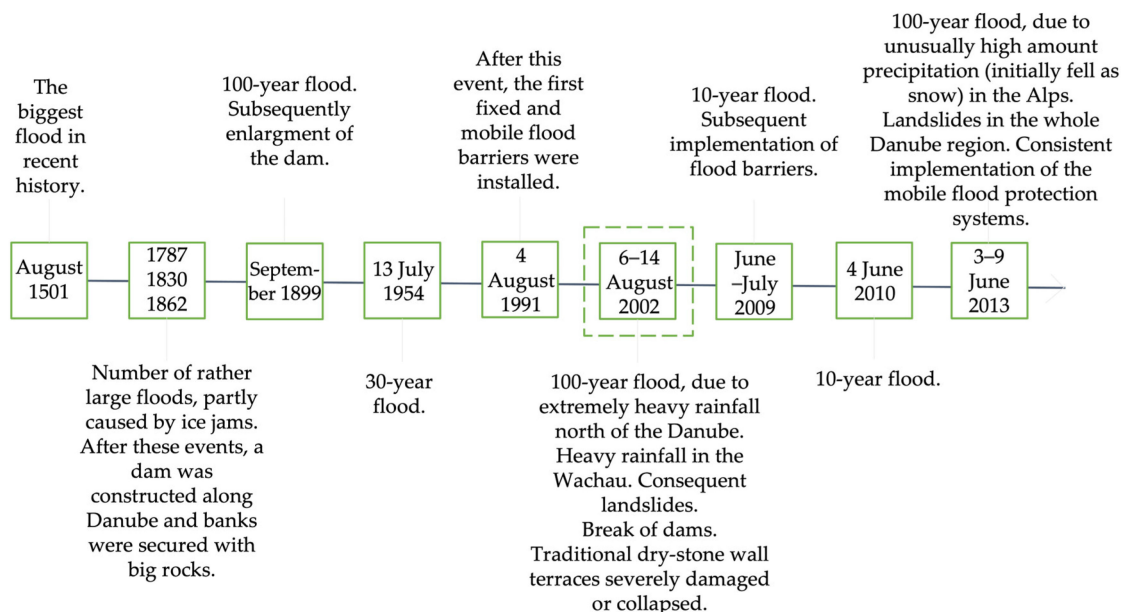
**Figure 6.** Main flood events recorded in Wachau Valley since 1500. The documented event causing severe damage to dry stone wall terraces is highlighted with a dashed line.

What emerged from the bibliographic research and consultation with local stakeholders about past calamitous events is that the main risks posed to the Wachau Cultural Landscape over time occur through flooding from the Danube River and its tributaries, principally due to episodes of extremely heavy rainfall and snowmelt [9,29,30,49]. Figure 6 shows the principal events of flooding in the Wachau Valley from 1500 up to now. A detailed list of all flooding events, with information on damage in the covered area, response actions, and main measures adopted, can be found in Blöschl et al., 2013; Schimek et al., 2020; and Bonazza et al., 2021 [9,29,30]. From the information collected, all the floods reported occurred due to episodes of extremely heavy rainfall and snowmelt in the upper Danube Basin. Following Schimek et al., 2020 [29], during the 100-year flood (a flood that has a 1% chance of occurring in any given year) of 2002, heavy rain was also

registered over the Wachau, causing severe damage to 150,000 m<sup>2</sup> of traditional dry stone wall wine terraces. In Figure 6 this event is highlighted with a dashed line.

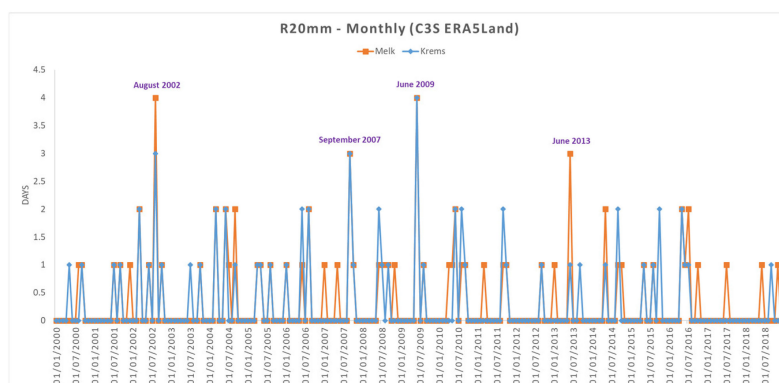
**Figure 7.** Time series (2000–2018) relating to R20mm (number of days in a month with precipitation greater than or equal to 20 mm/day) values extracted from C3S ERA5 Land monthly scale for Krems and Melk.

Concerning the examination of historic extremes of precipitation occurring in the area under investigation, the trend over time of the climate extreme indices R20mm and R×5day has been analyzed from 2000 to 2018. Figures 7 and 8, respectively, illustrate the monthly time series of the two indices elaborated for the cities of Krems and Melk (which delimit the Wachau Valley along the Danube) by using historic precipitation data derived from C3S ERA5 Land reanalysis. The graphs clearly show that most of the maximum values of both indices correlate with the most important past events of flooding and heavy rain registered in the area under study. In particular, peaks of R20mm and R×5day related to August 2002 and June 2009 in Figures 7 and 8 are certainly representative of the recorded catastrophic heavy rainfall and floods of the years 2002 and 2009, as listed in Figure 6, showing a higher value in the city of Melk in August 2002. As shown in Figure 7, the record of the flood event that occurred in the area of Wachau in 2013 is better represented by the index R20mm (number of days in a month with precipitation greater than or equal to 20 mm/day) which shows the higher value at the city of Melk compared to Krems in the same year (2013). Analyzing the overall trends, it is evident that not all the peaks present in the graphs of Figures 7 and 8 correspond to the recorded events listed in Figure 6. For a more exhaustive evaluation, an investigation of the indices' trends at a larger spatial scale including the river basin area would be recommended. Nevertheless, this finding supports the choice of extreme precipitation indexes selected, particularly R20mm and R×5day, for investigating the past and future trends of the considered hydrometeorological hazards.

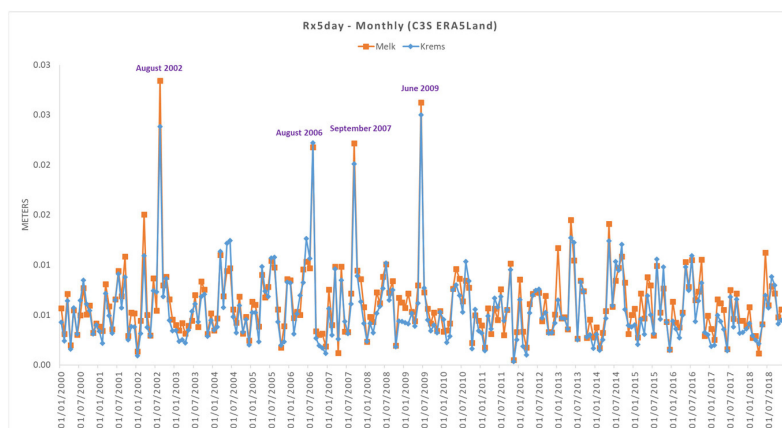
**Figure 8.** Time series (2000–2018) relating to  $R \times 5$  day (monthly maximum of cumulated precipitation over consecutive 5-day periods) values extracted from C3S ERA5 Land for Krems and Melk.
