Back analysis of the 2014 San Leo Landslide using combined terrestrial laser scanning and 3D distinct element modelling

Rock Mechanics and Rock Engineering

BACK ANALYSIS OF THE 2014 SAN LEO LANDSLIDE USING COMBINED TERRESTRIAL LASER SCANNING AND 3D DISTINCT ELEMENT MODELLING

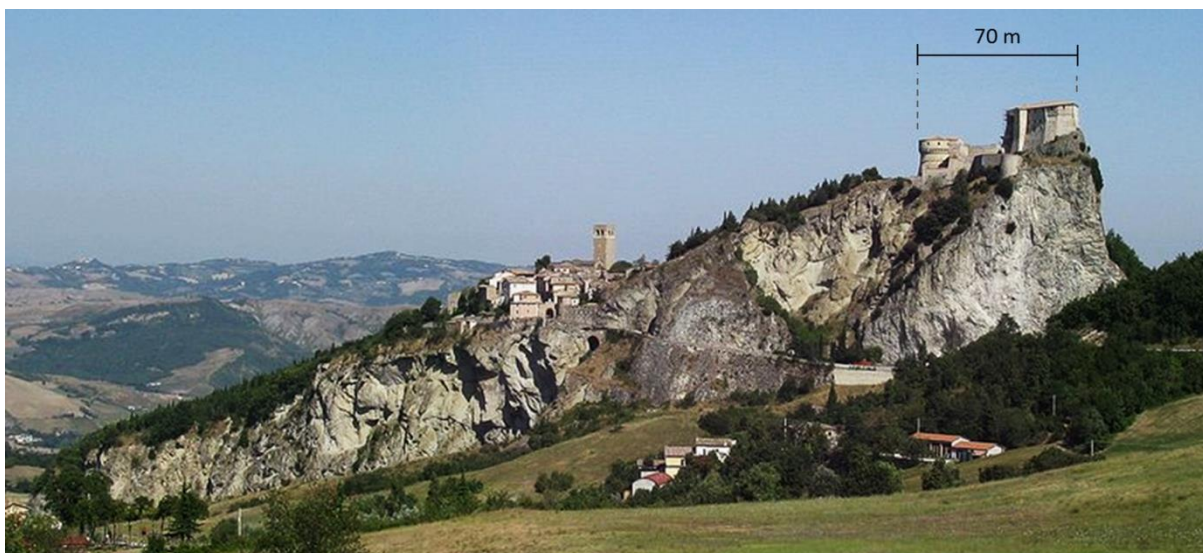
Fig.2 San Leo rock slab, view of the south cliff. Scale is indicative

The Ligurian units are unconformably overlain by sedimentary deposits, known as the Epiligurian units, which were deposited during the Middle-Late Eocene and the Late Messinian in the minor piggy-back basins developed on the Ligurian units during their translation, and were transported to their current position. Usually, they comprise limestones and sandstones. Differential weathering and erosion processes have resulted in these rock slabs being clearly recognizable within the gentle clayey slopes (Fig. 2).

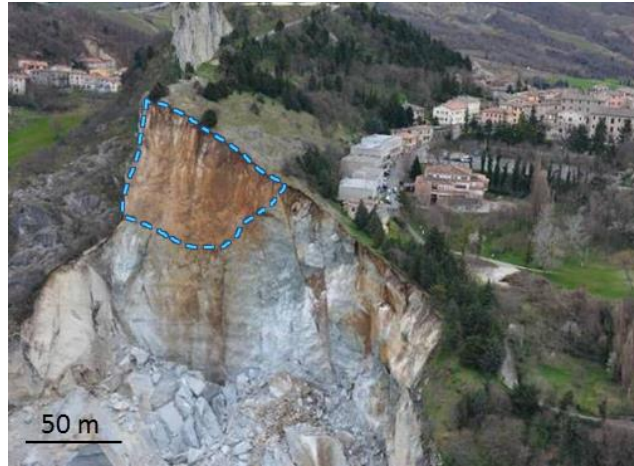
Fig. 4 View of the landslide area from the top, the dashed blue line highlights the discontinuities named SL2.1. Scale is indicative (Photo courtesy STB Romagna)

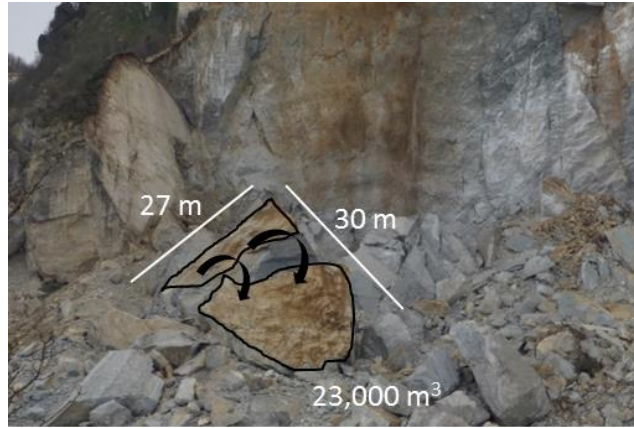
Fig. 9 Blocks in the deposit area, which appear to have been broken on impact with the ground

The digitization of the blocks in the landslide deposit area allowed an evaluation of the block size distribution. More than 300 blocks were mapped, corresponding to almost the 37% of the estimated deposit volume. The majority of larger blocks broke only on impact with the ground (Fig. 9).
