The Church of the Nativity in Bethlehem: Analysis of a Local Structural Consolidation

Claudio Alessandri & Jessica Turrioni

**International Journal of Civil
Engineering**

Int J Civ Eng
DOI 10.1007/s40999-017-0148-0

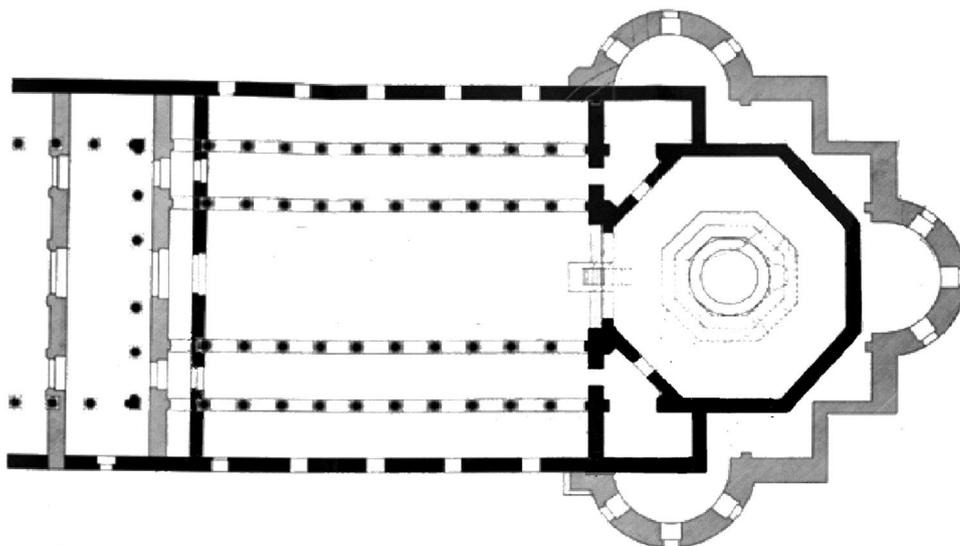
Fig. 1 The Basilica according to Bagatti's re-construction. Black Constantine's Church. Grey Justinian's Church

Like many basilicas of the early Christian period, the Church of the Nativity rests on four colonnades placed at both sides of the nave (Fig. 1). The vulnerability of classical columns to dynamic excitations has been investigated by Papalau [11] using Finite Element numerical models. Lagomarsino and Podestà [12], on the other hand (following the 1997 earthquake that struck some regions of central Italy), described a methodology for assessing seismic damage to ancient churches by means of 18 geometric and technological indicators. However, the latter approach is more useful from an urban-planning perspective, as the indicators defined are strictly related to the specific areas taken into account.

century AD by Emperor Justinian. Its longitudinal body, which is slightly longer than the previous footprint (Fig. 1), consists of a nave with four flanking aisles and four colonnades, two on each side. A transept and an apse took the place of the original octagonal structure built above the main Grotto, which was visible from a hole placed in the centre of the octagon. Detailed archaeological reports can be found in the books of Hamilton [16] and Harvey [17], as well as in the comprehensive research carried out over many years by Bagatti [18].

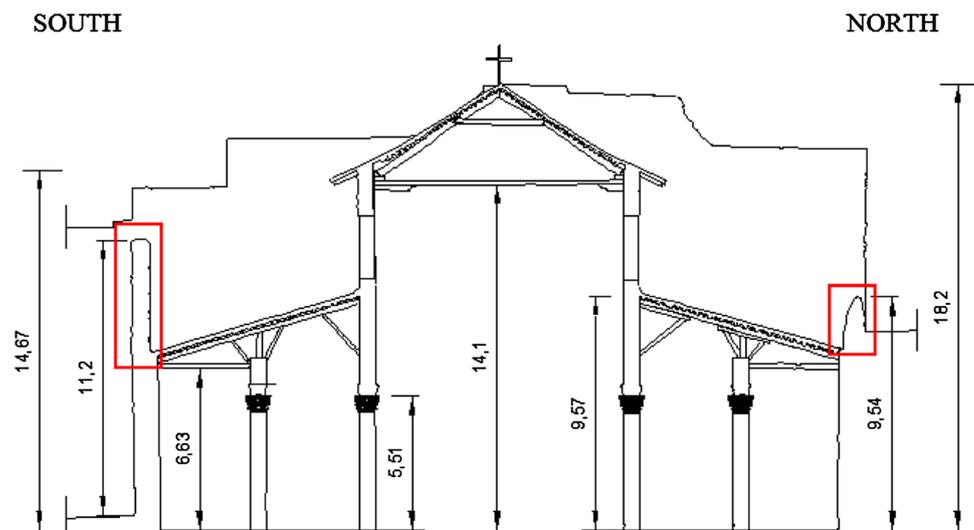
Fig. 2 Additional walls built during the Crusades—view from the apse

During the Crusades (twelfth century AD), the Church underwent several transformations, mainly involving the roof structure of the narthex. Some additional perimeter walls were also raised over the existing ones, probably for defensive purposes. In particular, two additional walls were built above the external walls of the longitudinal body for a length of about 28 m—one to the north, which was 1.50 m high, and the other to the south, 4.50 m high. (Fig. 2).

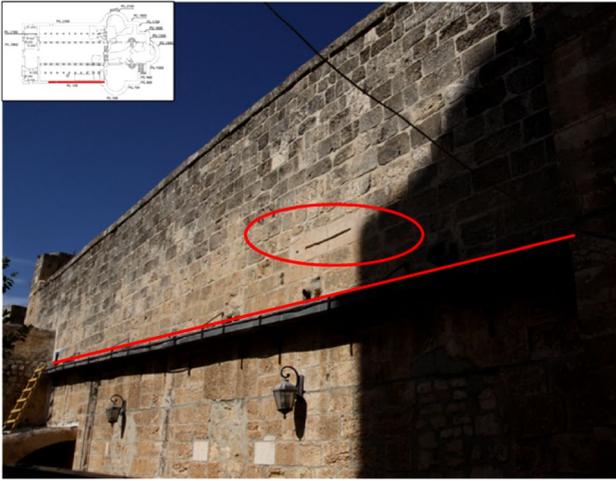
Fig. 3 View of the additional south wall

Careful stratigraphic analysis of the addition above the south wall (Fig. 3) has evidenced that the wall in this section was thinner, the stones used were smaller, and there was a change in the way that these stones were worked and finished. It also shows that some stones were taken from other parts of the Church, like, for instance, a long block of pink limestone, which bears several marks and inscriptions (circled in Fig. 3).

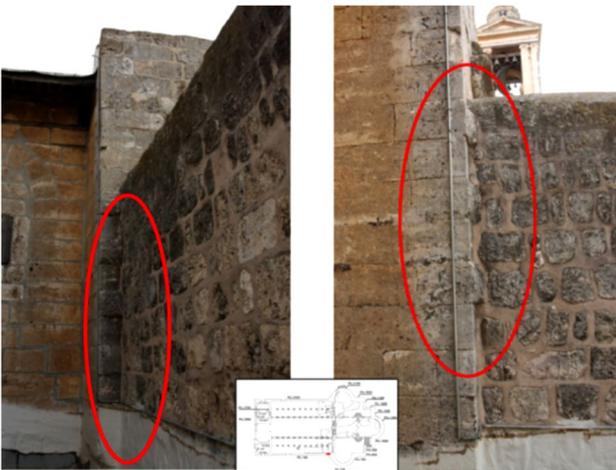
Fig. 4 Connections between the additional wall and the pre-existing orthogonal ones

It is worth noting that this wall was simply built butting up against the pre-existing orthogonal ones, although there are some decorative stones, visibly protruding from the transept wall on both sides of the basilica (Fig. 4), which were probably placed to improve the connection. However, these stones did not serve to greatly strengthen the joint.

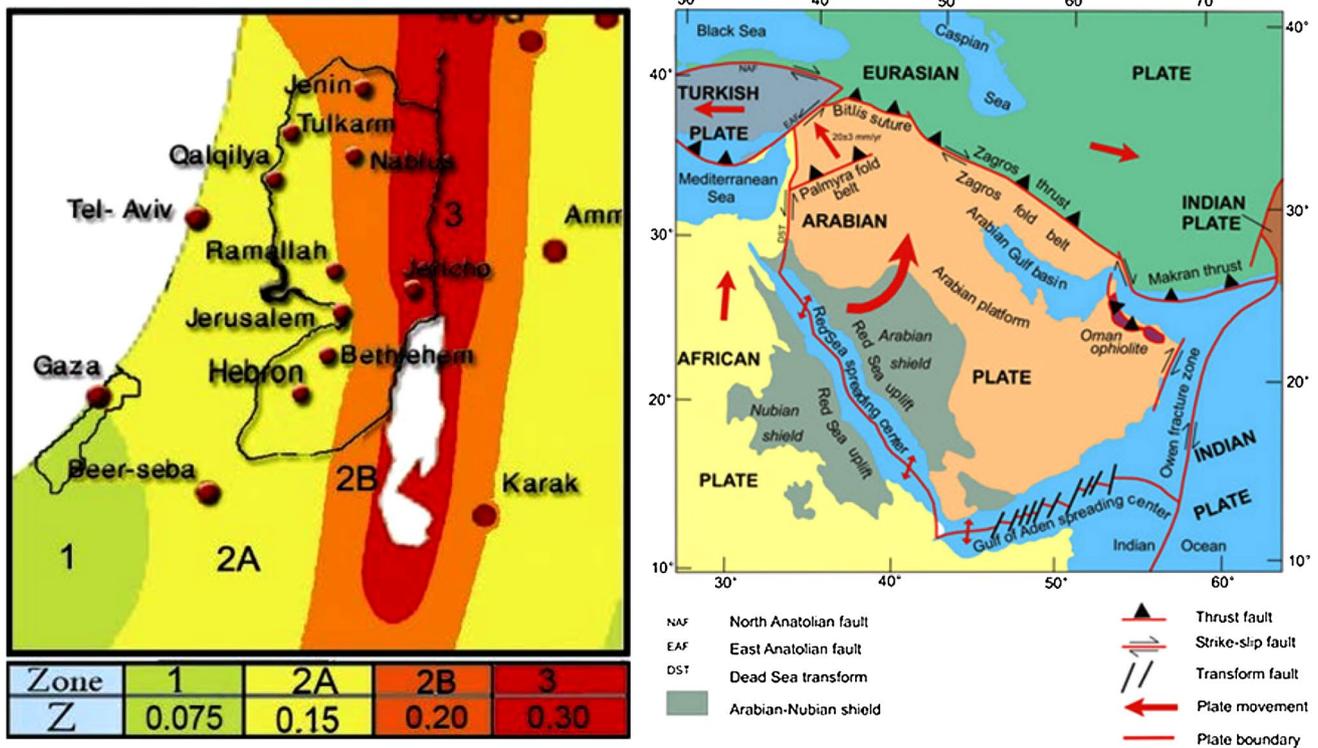
Fig. 5 Seismic map of the area and fault line between the African and Arabian plates

Bethlehem is located between two areas of medium–low seismicity, one to the west and one to the east side. It is situated close to the fault line separating the African and

Arabian tectonic plates (Fig. 5), and has, in the past, been affected by several minor and major earthquakes with epicentres in the surrounding areas.

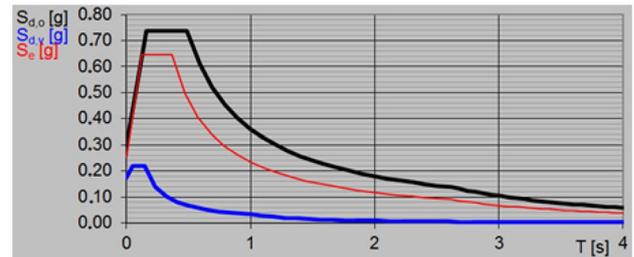
Fig. 6 Elastic and design spectra obtained by means of the computer code SPETTRI NTC

All these data and the geographical coordinates of the Italian equivalent site were entered into the computer code SPETTRI NTC, ver. 1.0.3, published on the Italian website of the Higher Council of Public Works [20]. The reference elastic spectrum (S_e), the design spectrum in the vertical component ($S_{d,v}$) and horizontal component ($S_{d,o}$) were obtained according to the procedure described in [19], as shown in Fig. 6, which yielded the following values:

- $a_g = 0.253 g$
- $F_0 = 2.550$
- $T_c^* = 0.363$

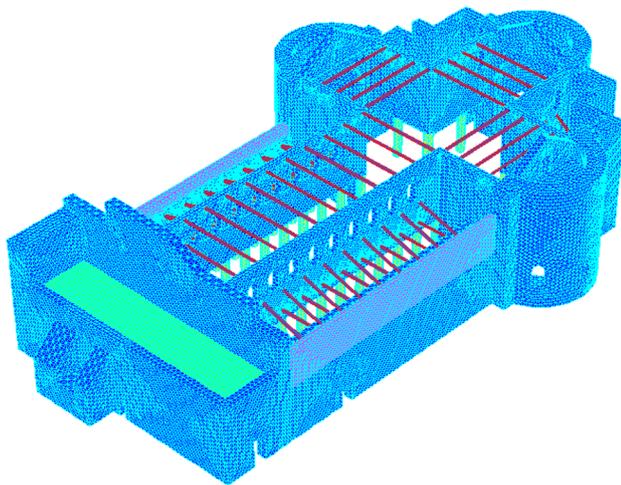
Fig. 7 3D discretized linear elastic FE model developed by Straus7–103 beams elements, 375,431 tetrahedral brick elements, 92,256 nodes

The model was discretized by means of 103 beams elements, 375,431 tetrahedral brick elements and 92,256 nodes, with mesh size 50 cm everywhere except in the areas where higher stress concentrations were expected (Fig. 7).

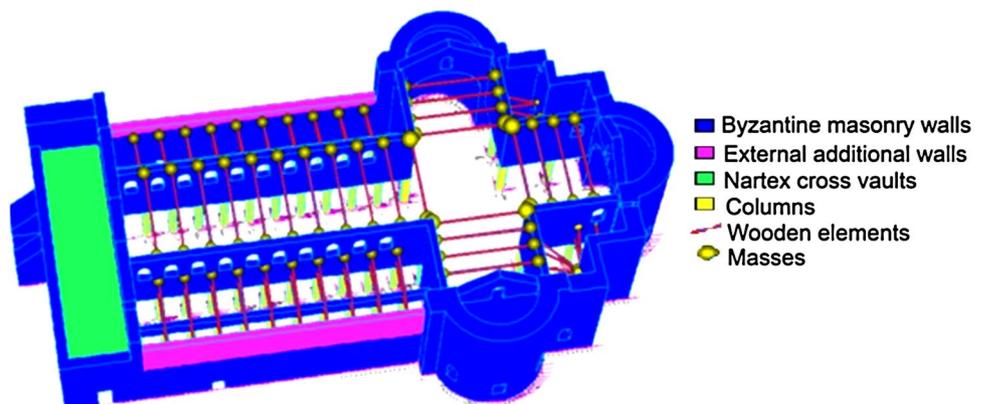
Fig. 8 Materials, masses and constraints of the 3D FE model

Figure 8 shows the variety of the component materials, i.e. Byzantine masonry walls (Table 1), narthex cross vaults (Table 3), external additional walls (Table 2), columns (Table 4), and wooden elements (Table 5).

It also shows the masses concentrated at both ends of each truss and the boundary constraints.

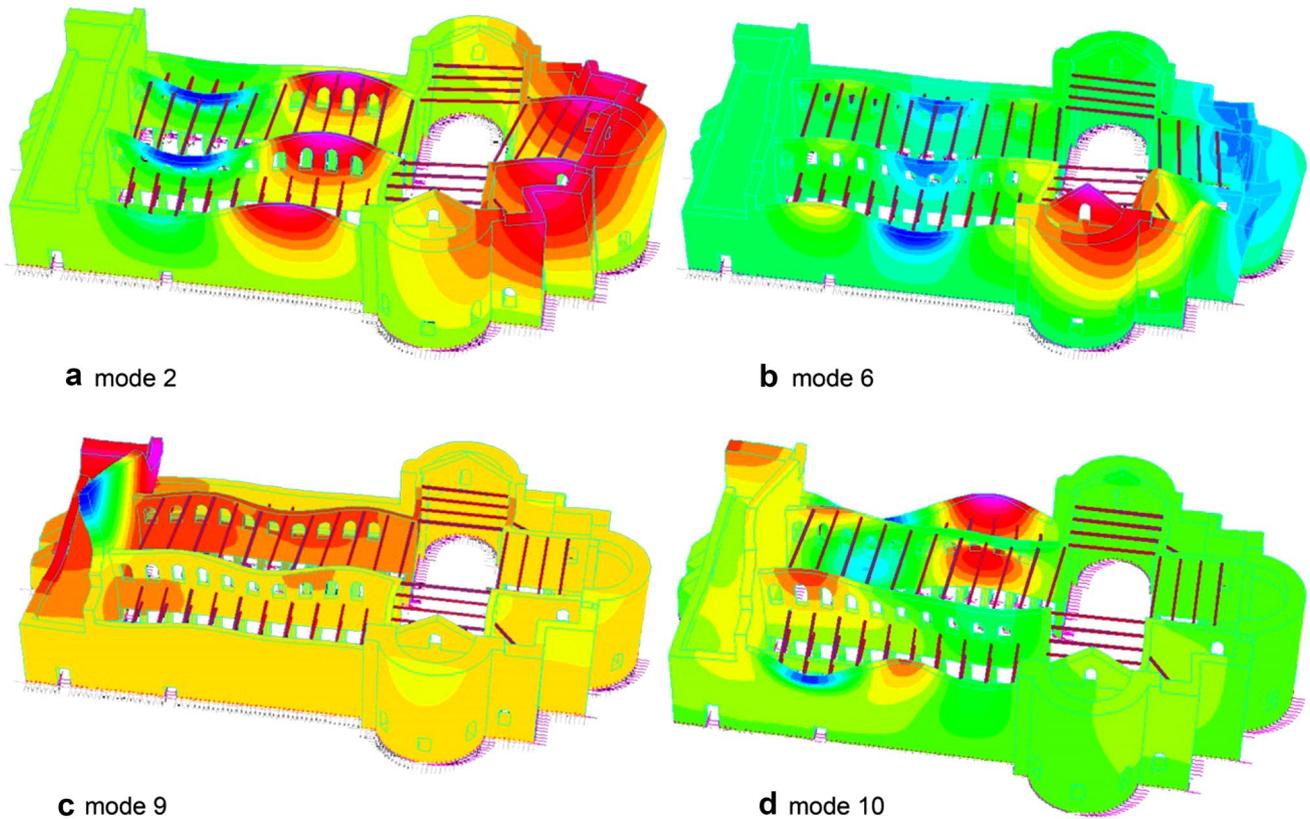
Fig. 9 Modes activating the highest mass percentages

For the sake of brevity, only the vibration modes activating the highest mass percentages are shown in Fig. 9.

This global analysis shows that the structure is mainly characterized by local modes, particularly in the longitudinal walls of the nave and aisles (Fig. 9a, b, d), and in the tympanum of the façade (Fig. 9c). Other local but less significant modes are clearly visible in the apse and adjacent corners. As expected in this type of building, the compactness of the whole structure results in rather low values for activated mass percentage and high values for frequency.

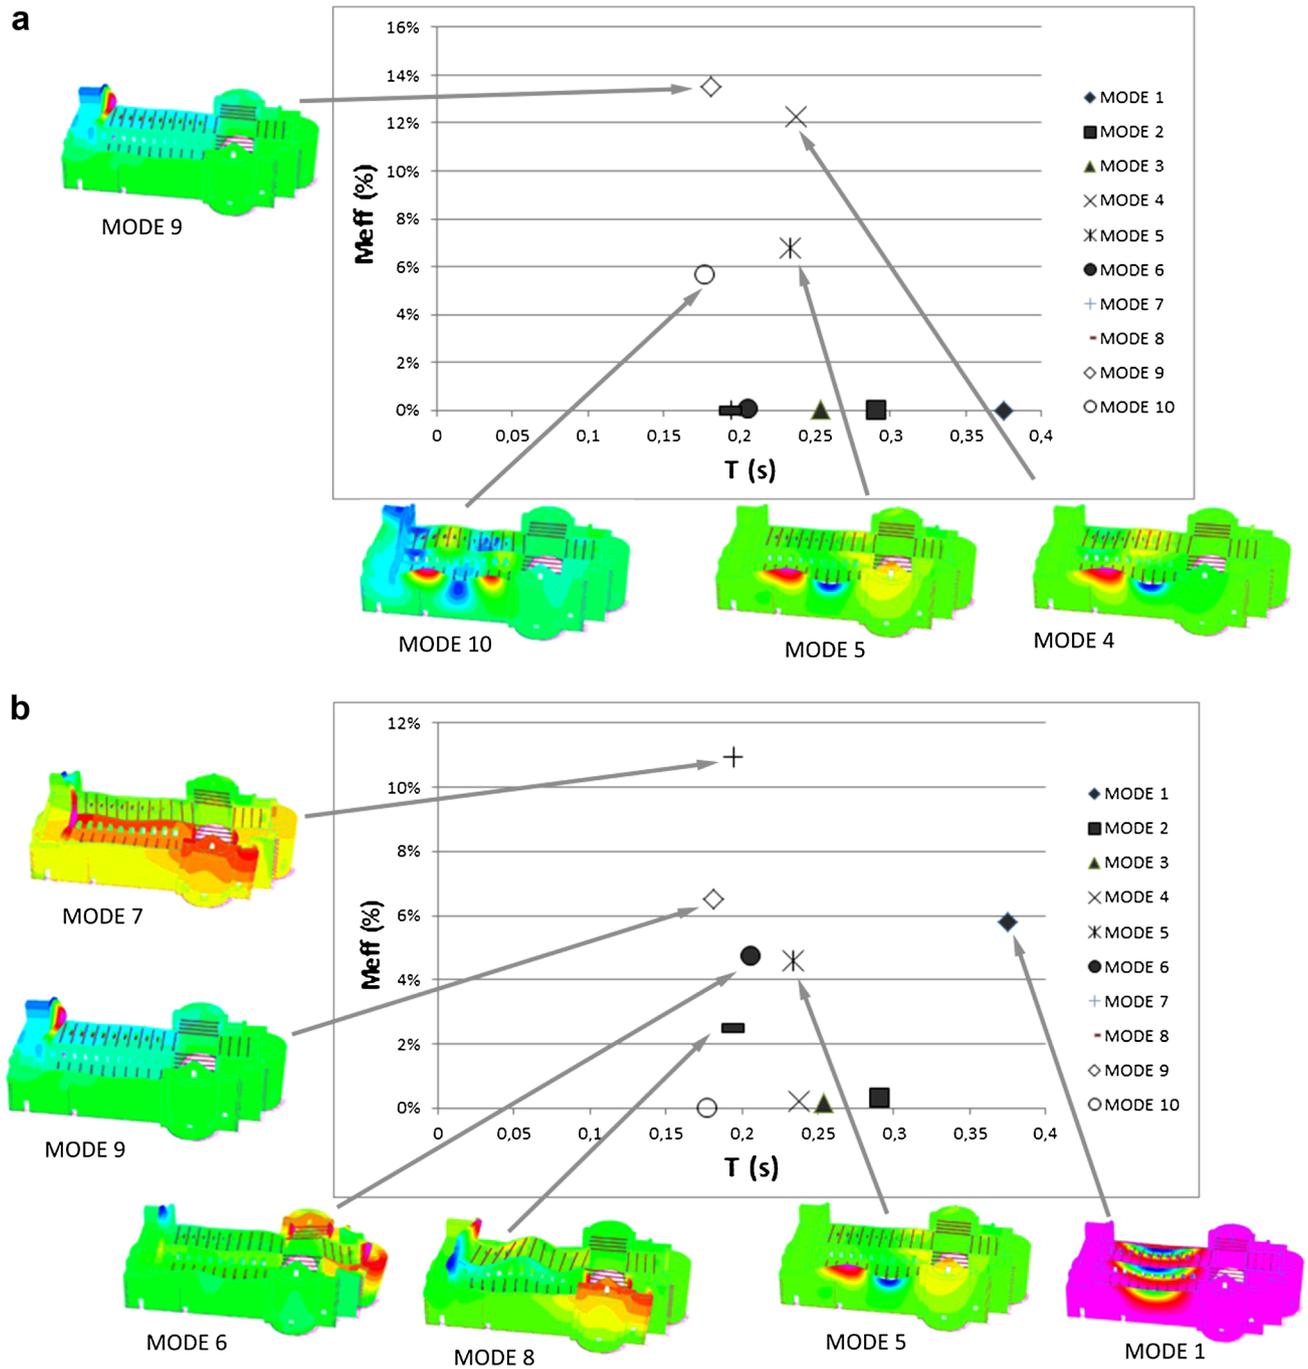
Fig. 10 Distribution of the first ten modal shapes for the earthquake acting in longitudinal (a) and transverse directions (b)

The dynamic behaviour of the Church is summarized, as previously performed by Brandonisio et al. [23] and Milani et al. [24–26], in Fig. 10a, b, where the modal participating mass ratios (M_{eff}) of the first ten modes analysed in both transverse and longitudinal directions are plotted as a function of the vibration period (T). It is very clear that almost all vibration modes, except modes 4 and 9 in the

By comparing Fig. 10a, b with Fig. 6, it can also be observed that the vibration modes with the higher participating mass ratios correspond to very low spectral

in Fig. 10b it is possible to deduce that the first mode associated with a non-negligible participating mass is mode 1, namely the first out-of-plane mode of the longitudinal walls and internal colonnades, whereas the higher modes in the

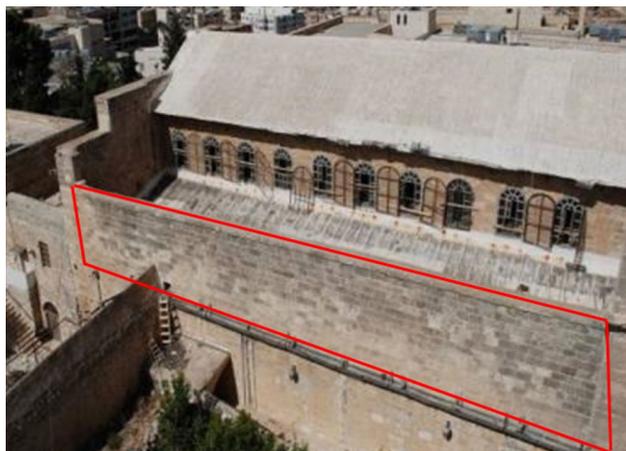
Fig. 11 View of the south wall addition

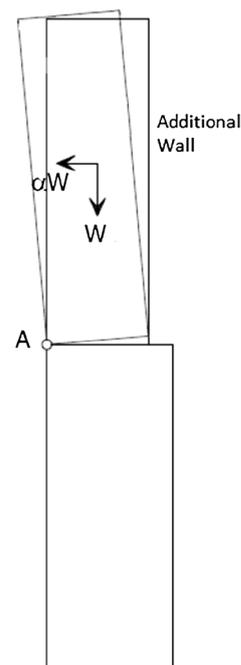
Fig. 12 Simple overturning collapse mechanism of the additional wall around a side of its base

unconstrained at both vertical sides and, therefore, likely to overturn around one side of its base in the presence of specific horizontal loads (Fig. 12). The hinge A is at 7.4 m from the ground, at the base of the additional wall. The macro-element considered in the standard linear kinematic analysis is 1 m long.

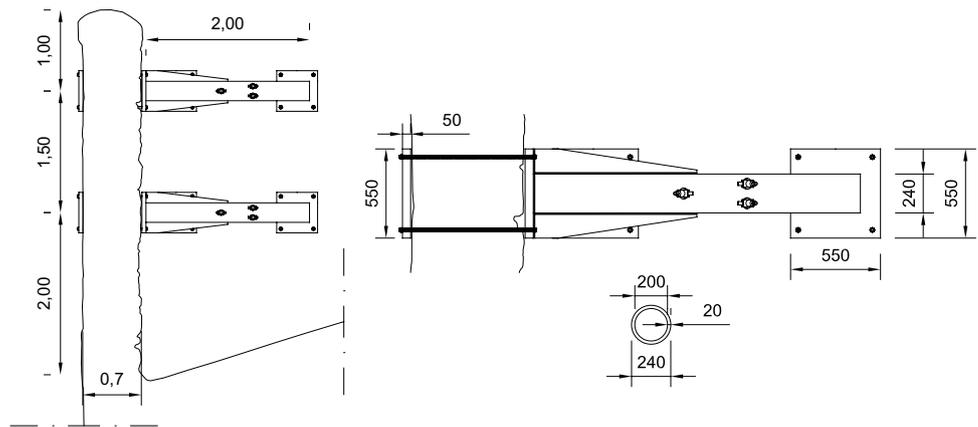
Fig. 13 The two horizontal tension-structure systems and dimensions of the anchorage tube

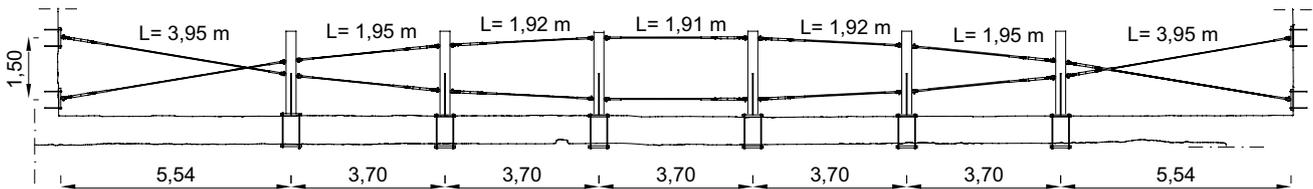
Fig. 14 Horizontal view of each tension-structure system

with respect to the mid-plane of the whole system, with the convex part facing inwards (Figs. 14, 15).

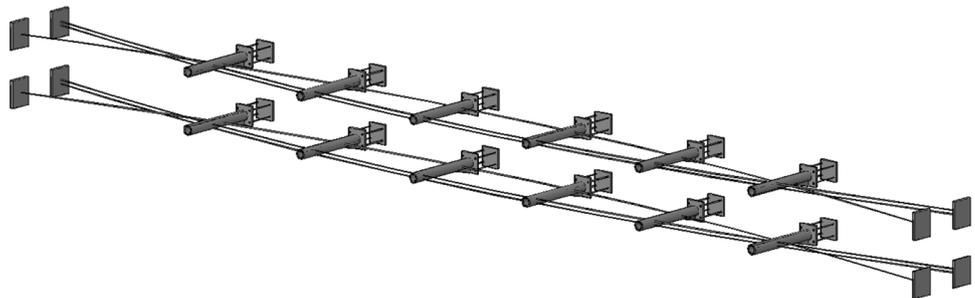
Fig. 15 Axonometric view of both tension-structure systems

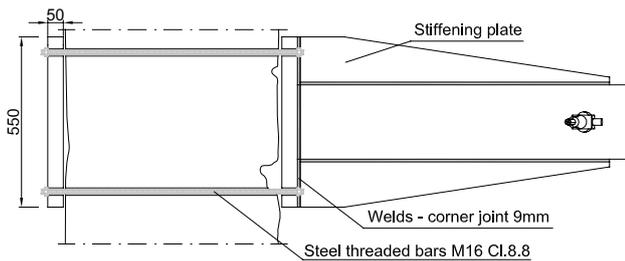
Fig. 16 How the plates are anchored to the wall

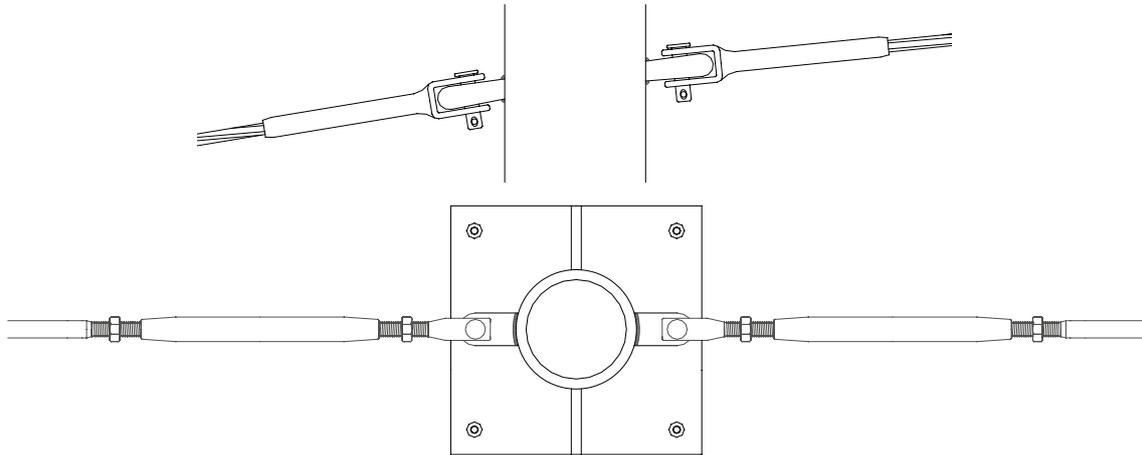
Fig. 19 Outward-convexity cable and its connection via tubes and anchorage plate

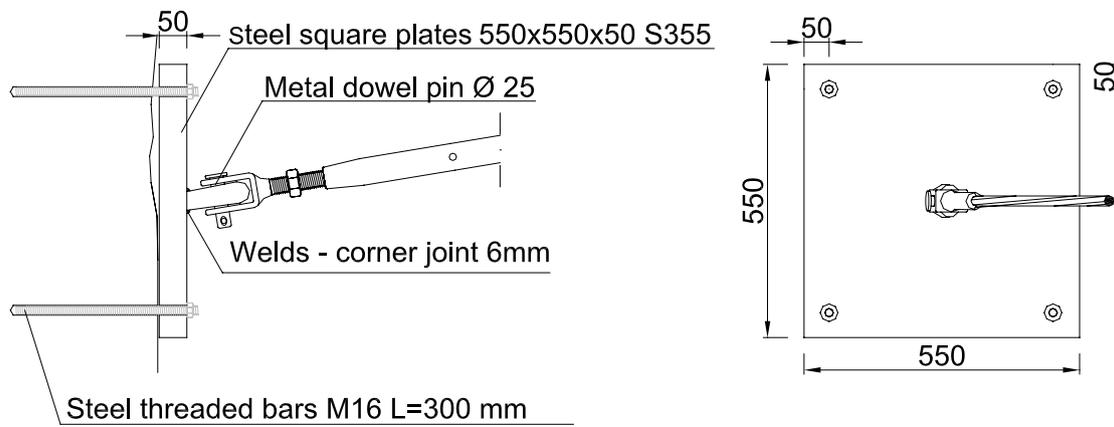
Fig. 20 Anchorage of a cable to an orthogonal wall

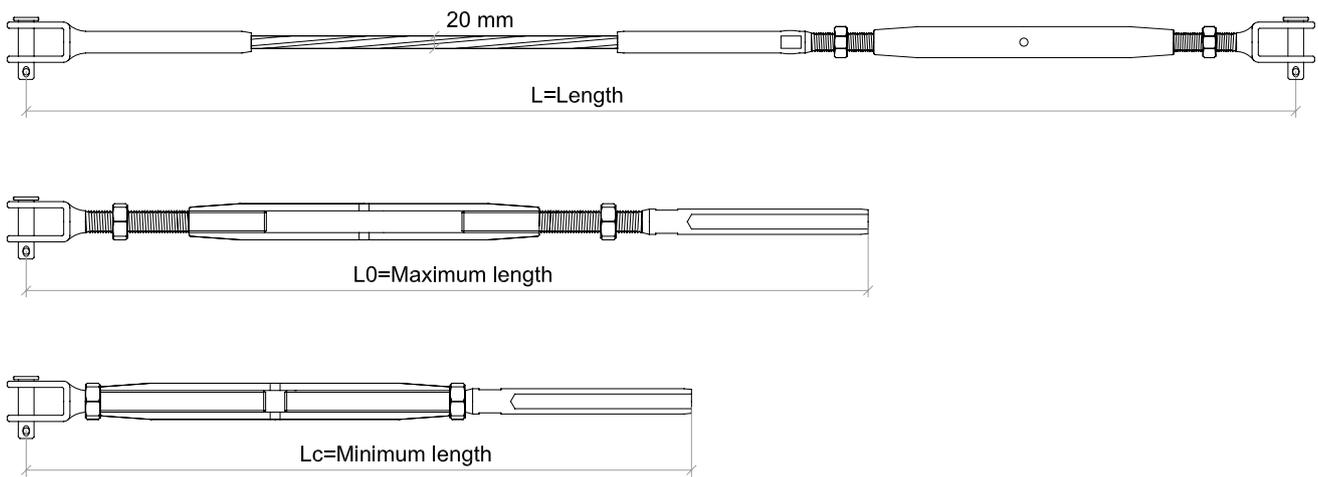
Fig. 21 Tensioner limit configurations

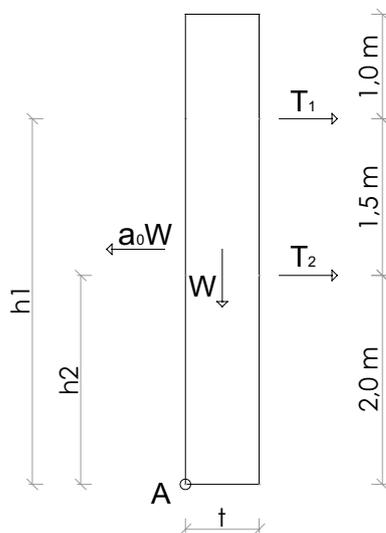
Fig. 22 Loads acting on the walls in the case of an earthquake

$$T_1 = 15.00 \text{ KN and } T_2 = 8.75 \text{ KN.}$$

For the sake of simplicity, a single value for such concentrated loads, $T = 15.00 \text{ KN}$, was assumed for the tension structures at both levels. However, the authors believe that the ground acceleration defined for Bethlehem, as described in Sect. 2, is unreliable, as Bethlehem

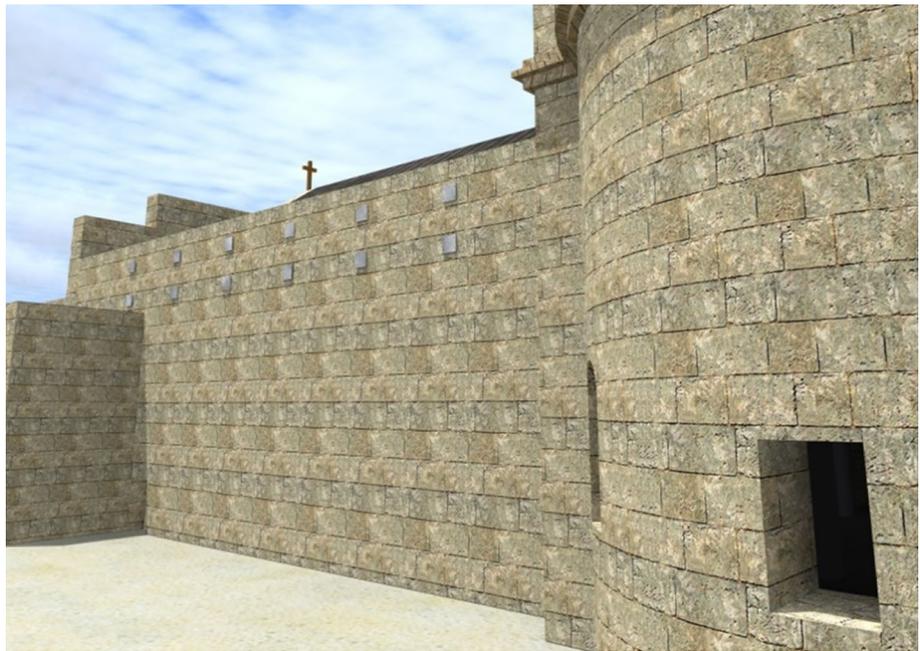
Fig. 25 FE model with outward-oriented seismic loads

explained in Sect. 7. The simple overturning collapse mechanism was found to be that most likely to occur, and the wall was constrained at the base in such a way as to rotate either around the external edge, when the seismic loads are directed outwards (Fig. 25), or around the internal edge, when they are directed inwards toward the Church (Fig. 26). All nodes in the two vertical sides had their longitudinal displacements impeded to take into account the presence of the orthogonal walls.

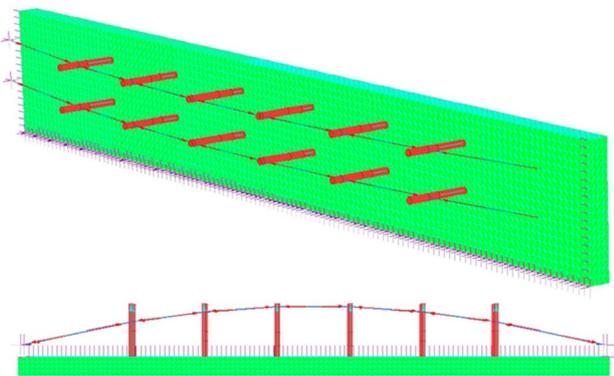
Fig. 26 FE model with inward-oriented seismic loads

Table 10 refers to inward-oriented seismic actions, and shows the percentage reduction of the maximum horizontal displacement corresponding to successive increments of the tension in the cables, starting from the maximum displacement (264.30 mm) corresponding to the design earthquake with no tension in the cables. The maximum tension corresponding to a horizontal displacement lower than that

admissible (11.1 cm) is 70 kN. This corresponds to a 61% reduction of the initial maximum displacement.
