Combined In-Situ and Laboratory Minor Destructive Testing of Historical Mortars

Article in *International Journal of Architectural Heritage* · May 2017

Keywords: Masonry, Lime Mortar, Minor Destructive Testing (MDT), Double Punch Test (DPT), Helix Pull-out Test (HPT), Pin Penetration Test (PPT), On-site Testing, Compressive Strength, Modernist Architecture, Puig i Cadafalch.

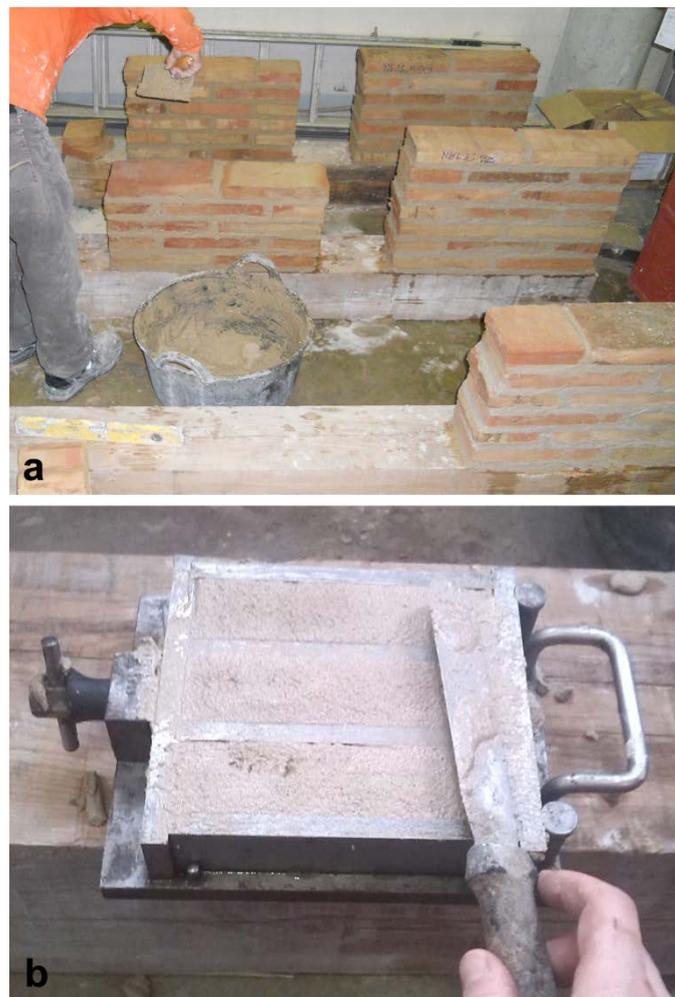
Figure 1 – Construction of walls for the experimental program in the laboratory (a) and preparation of standard prismatic specimens of mortar in steel moulds (b).

Two series of small walls were built in stretcher bond with dimensions (width \times height \times depth) $0.69 \times 0.42 \times 0.145 \text{ m}^3$ (Figure 1a). Each wall was composed of seven courses and

The strength properties of the two mortars were characterised in a first stage by using the standards for new construction. Prismatic mortar specimens were prepared with metal moulds during the construction of the two series of walls (Figure 1b). Standard flexure and compression tests were carried out on this kind of specimens according to EN 1015-11:2007 (CEN 2007). Three prisms with dimensions $40 \times 40 \times 160 \text{ mm}^3$ were tested at different hardening ages to obtain the flexural strength f_f of mortar CT and KK (Figure 2a). The compressive strength f_c of each type of mortar was determined by loading the six fragments produced by the flexure tests, measuring roughly $40 \times 40 \times 80 \text{ mm}^3$, with steel loading platens of $40 \times 40 \text{ mm}^2$ (Figure 2b). Both the flexure and compression tests were conducted under load control with a compression machine with a loading cell of 10 kN.

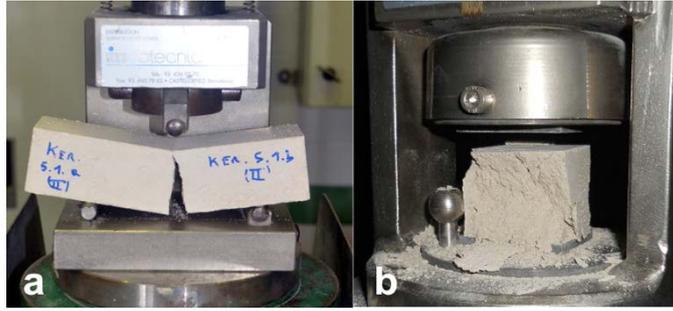
Figure 2 – Flexure (a) and compression (b) tests on standard prismatic specimens of mortar.

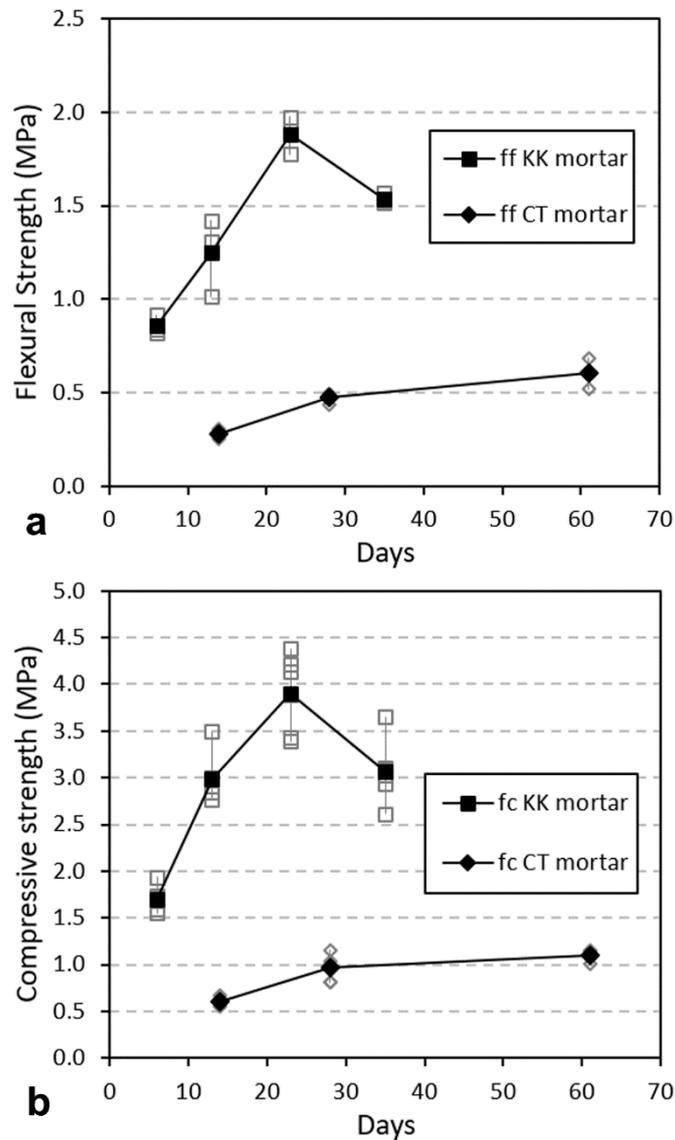
Figure 3 – Time evolution of average flexural strengths (a) and compressive strengths (b) of standard prismatic specimens of mortar.

The experimental results on prismatic specimens of KK and CT mortars are summarized in Table 1 in terms of average values and coefficients of variation (CV). Figure 3 shows

the graphs with the time evolutions of the average values of flexural and compressive strengths. Both strength evolutions look consistent throughout the time, i.e. an increase/decrease of the compressive strength corresponds to an equivalent trend for the flexural strength. Mortar KK presents a faster increase of strength than mortar CT, since the former is a premixed mortar for restoration with fast hardening and the second is a standard lime mortar obtained from raw materials and thus requiring longer time for curing (Pelà et al. 2017, 2016b; Baronio et al. 1999, 1995). At the age of 23 days, the specimens of mortar KK exhibited local peak values of compressive and flexural strengths that then decreased at 35 days. On the other hand, mortar CT showed a slow and monotonic increase of the compressive and flexural strengths for the different investigated ages.

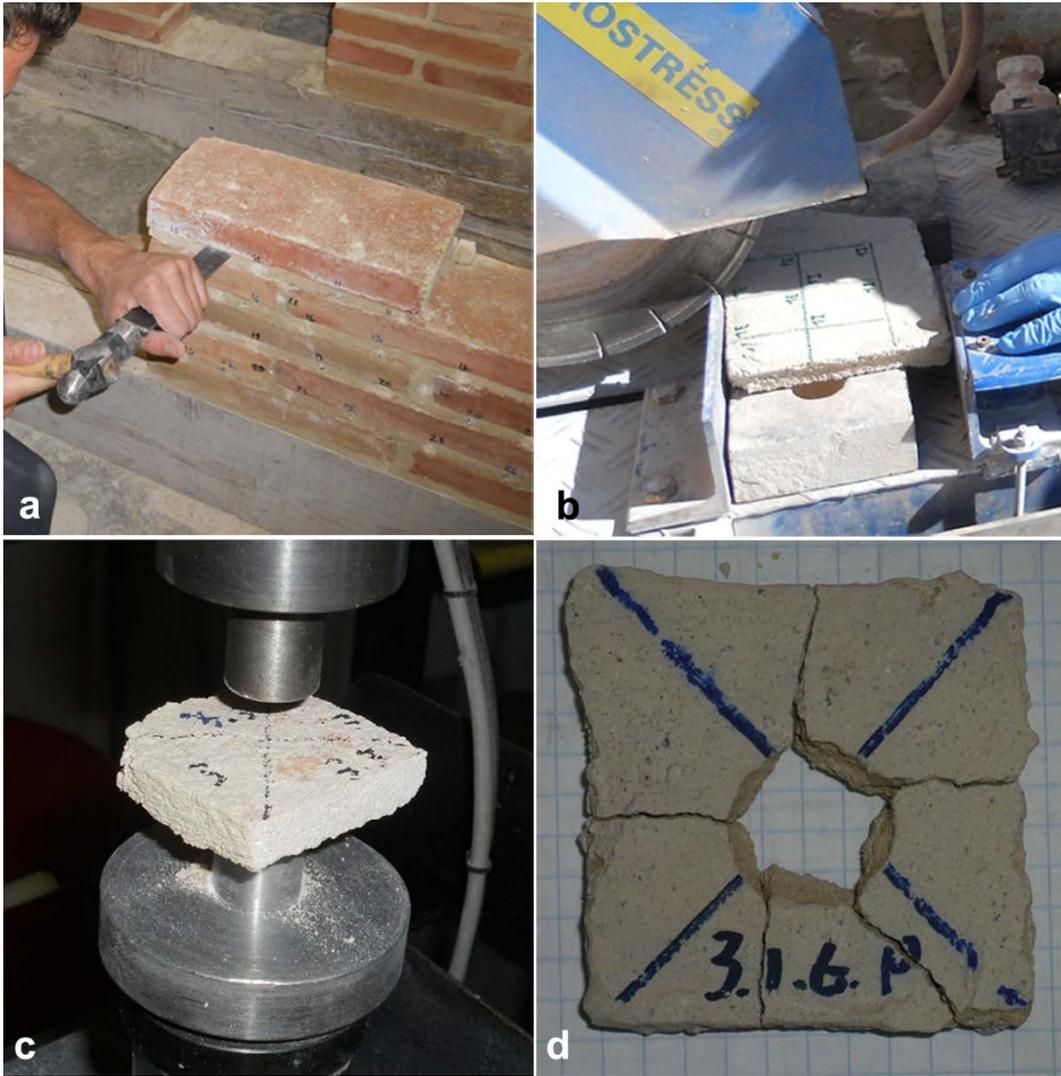
Figure 4 – Extraction of mortar layers from the walls (a), cutting of joint specimens for double punch test (b), experimental setup (c) and typical failure after the test (d).

Some courses of the walls were disassembled with the help of a chisel to extract mortar joints for the execution of the DPT at different ages of hardening (Figure 4a). The mortar layers between the units were cut into $50 \times 50 \text{ mm}^2$ joint specimens (Figure 4b) having variable thickness around 15 mm. The tests were performed under load control using a compression machine with a loading cell of 10 kN and with loading punches of 20 mm diameter (Figure 4c).

Older references about the DPT (Henzel and Karl 1987; International Union of Railways 2011; DIN 18555-9:1999) suggest to level the surfaces of the mortar sample with 1 mm thick gypsum plaster in contact with the loading punches. This approach was not followed in this research since previous works by the authors showed that this regularisation technique could produce a considerable increase of the strength measured for low-strength mortar samples (Pelà et al. 2016c). In any case, the mortar joints were tested in this research making sure that their loaded surfaces were plane and parallel with intact edges (Marastoni et al. 2016a). After the DPT, the samples showed a crushed central part in-between the loading punches as well as radial cracks towards the exterior perimeter (Figure 4d).

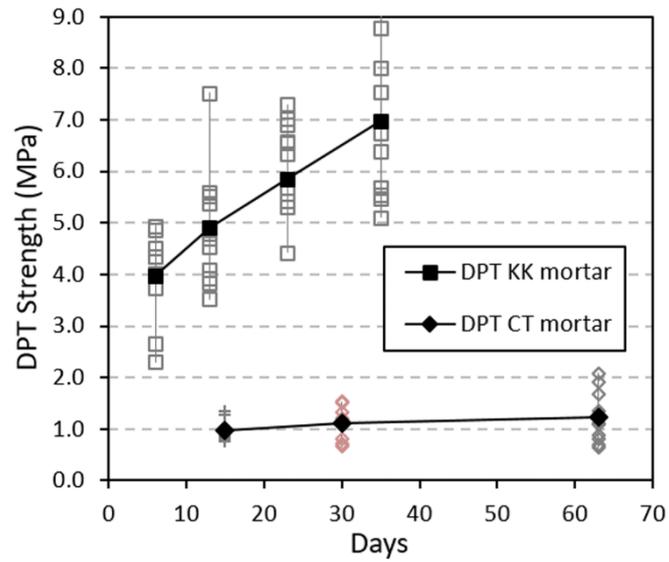
Figure 5 – Time evolution of double punch test strengths of mortar joint samples extracted from the walls.

Figure 5 shows the graphs with the time evolutions of the average values of the DPT strengths. Both mortar KK and CT show a monotonic increase of the strengths for the different investigated ages, even though the former presents a higher rate and the latter a much slower one. DPT strengths of mortar KK did not show any anomalous peak, as opposite to what was observed for the compressive and flexural strengths in standard prismatic specimens (Figure 3).

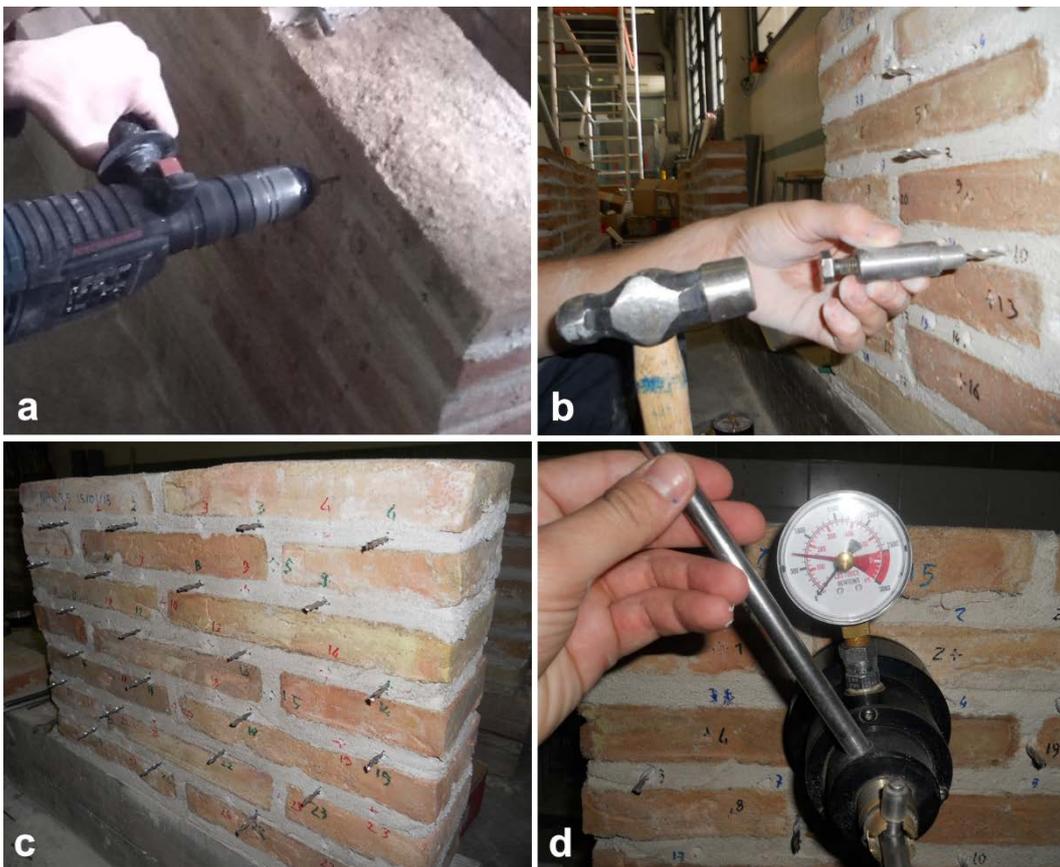
Figure 6 – Operation of the screw (helix) pull-out test: drilling the pilot hole (a), insertion of the helix into the bed joint using the sleeved driving tool (b), helical ties ready for extraction (c) and pull-out with the loading device (d).

The test procedure utilized in this research is as follows. A high-strength steel helical tie with a diameter of 6 mm is mounted into a driving tool. Holding the sleeve of the tool horizontal, the exposed end of the tie is pushed into the pilot hole to a depth of 30 mm. Using the sleeved driving tool, the helical tie is hammered carefully into the pilot hole so

that the specified length of its thread is embedded in the mortar. This procedure allows the tie to rotate and cut a thread in the mortar during insertion. After installation, a gripper is then screwed onto the end of the tie. This holds the tie fixed during the test, restraining it from rotating, ensuring a shear failure in the tested material. The loading device is then attached to the gripper and the assembly was rotated to screw down the tie and take up any slack. The reaction frame, constituted by a steel ring, provides the contact with the material's surface. The load applied to the tie is increased steadily until failure. The peak load reached during each test is recorded as the pull-out force. [Figure 6](#) shows the test arrangement as well as the sequence of the operations followed during the HPT.

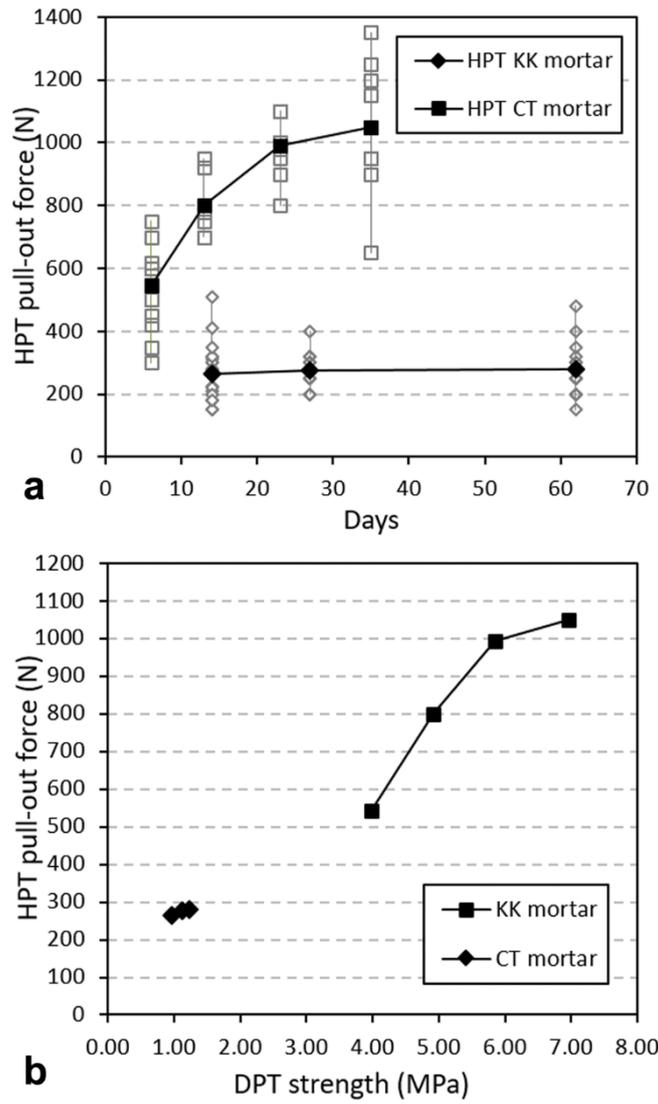
Figure 7 – Time evolution of helix pull-out forces (a) and empirical relationships between double punch test strengths and helix pull-out forces (b).

[Table 3](#) reports the average values of pull-out forces measured on CT and KK mortar bed joints at the different investigated ages. [Figure 7a](#) shows graphically the time evolution of the HPT pull-out forces. KK mortar shows an increasing trend of HPT results in agreement with that of DPT strength observed in [Figure 5](#). CT mortar presents lightly increasing values of HPT pull-out forces for the investigated ages, similarly to the very slow rate of increase of DPT strengths. [Figure 7b](#) shows the empirical relationships between DPT and HPT measurements for the two types of mortar. These curves show the capability of the HPT to represent the monotonically increase of the DPT strength of the mortars in the bed joints.

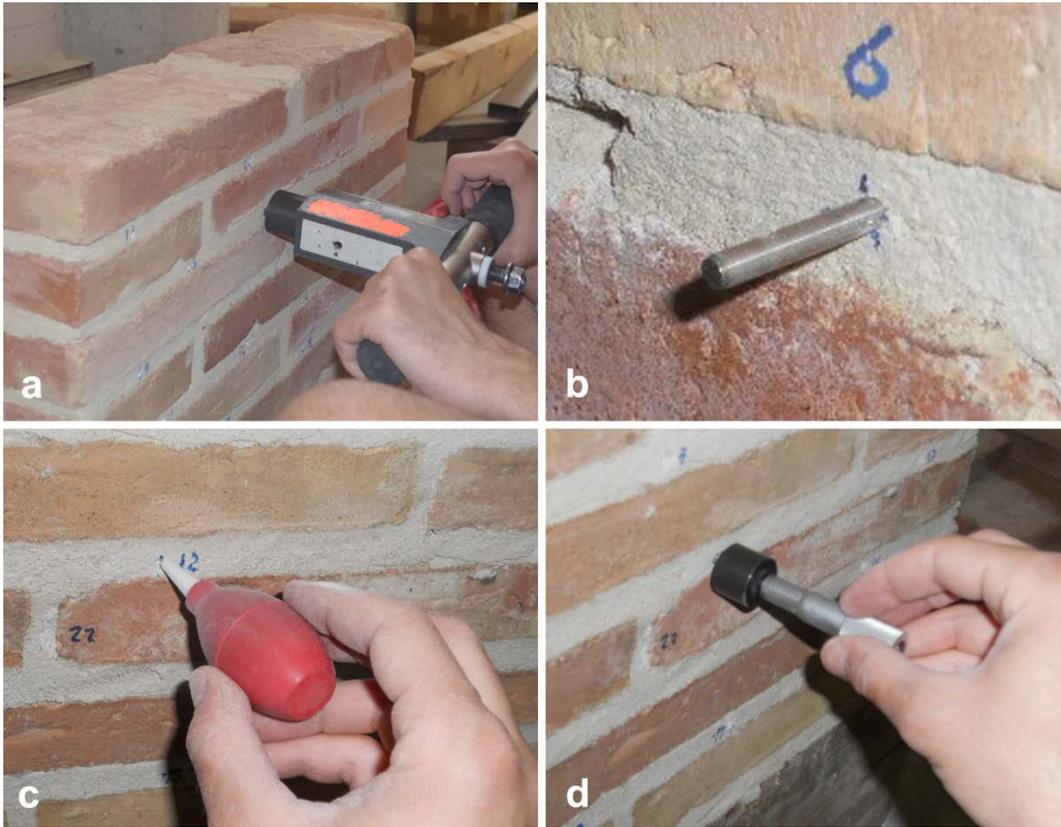
Figure 8 – Operation of the Windsor pin penetration test: instrument for pin insertion (a), pin penetrated into the mortar joint (b), cleaning of the indentation produced by the pin (c) and micrometer for depth measurement (d).

The PPT was executed only on the series of walls built with KK mortar. [Figure 8](#) shows the sequence of operations followed during the development of the experimental tests. In the PPT test utilized, a 3 mm diameter and 30.5 mm long pin is inserted into the chuck. The loading nut is tightened, until the trigger mechanism latch closes to hold the spring in place, and then it is completely slackened to the top of the load screw before pulling the trigger. The instrument is placed perpendicularly to a smooth flat surface of the bed joint to be tested ([Figure 8a](#)). The trigger is pulled, holding the instrument firmly against the mortar surface ([Figure 8b](#)). Once the instrument is removed, a rubber bulb-type blower is used to clean out the small hole made by the pin on the material surface ([Figure 8c](#)). A micrometer is then inserted into the indentation left by the pin, making sure that the reference surface of the micrometer for the measurement is flat on the surrounding material ([Figure 8d](#)). The micrometer reading is noted. The penetration is obtained by subtracting the reading from one inch (25.4 mm).

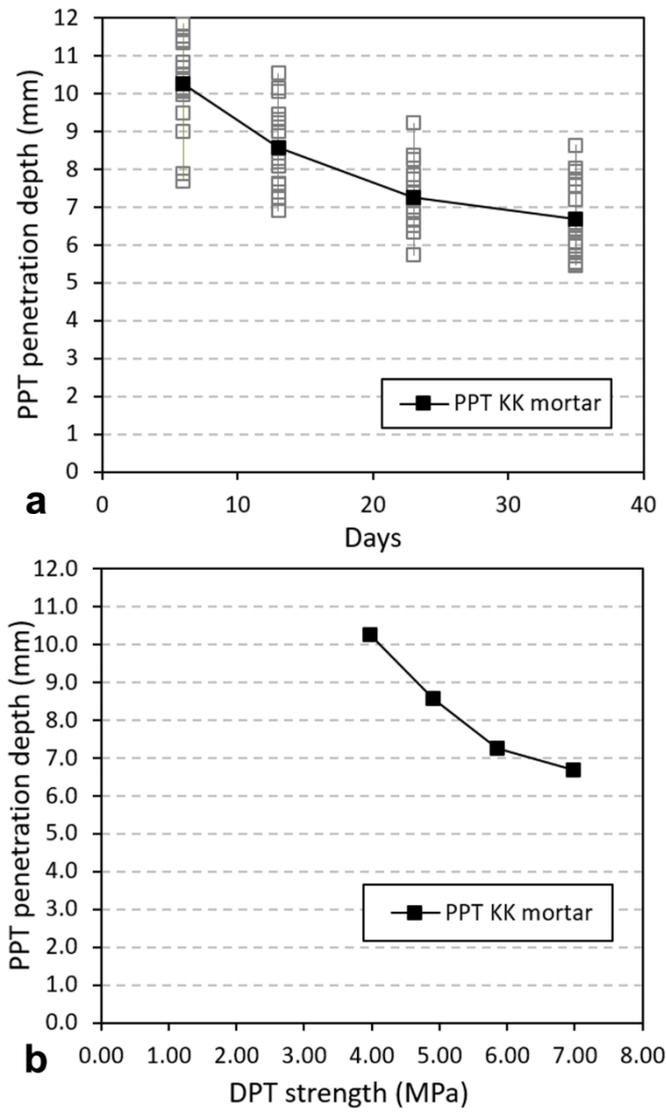
Figure 9 – Time evolution of the penetration depths obtained from the Windsor pin penetrometer (a) and empirical relationships between double punch test strengths and pin penetration depths (b).

Table 4 reports a summary of the experimental results from PPT in terms of average values of pin penetration depths and coefficients of variation obtained at the different ages. The depth of penetration decreases as the mortar hardens and its strength increases (Figure 9a). Figure 9b shows the empirical relationship between PPT readings and DPT strengths at the investigated ages of mortar KK. The MDT technique provides clear and distinct measurements corresponding to the different investigated DPT strengths.

Without the permission of extracting mortar samples from the interior walls, only in-situ HPT and PPT were executed on bed joints. Four small “windows” were opened in few interior walls by removing just the superficial plaster, in order to induce negligible damage to the existing structural members (Figures 11c-d). Being the Casa Puig i Cadafalch the result of the transformation of three pre-existing buildings, the testing points were selected in order to investigate the different parts of the complex and to understand the corresponding properties of the different mortar materials. The mortar exhibited a brownish colour at the ground floor and at the first floor (Figure 11d), whereas in another position at the first floor and at the second floor the mortar was light grey. Table 6 presents a summary of the HPT and PPT results at the different locations. The HPT provided average measures between 275 N and 654 N, whereas the PPT provided average measures between 13.6 mm and 10.7 mm. A tentative extrapolation of the equivalent DPT strength of mortars in the interior walls could be done by comparing these ranges of values with the DPT vs. HPT and DPT vs. PPT relationships of Figure 7b and Figure 9b. As for the HPT values, the empirical correlations of Figure 7b would suggest DPT strengths ranging between 1.1 MPa and around 4 MPa. As for the PPT values, the obtained measurements fall outside the correlation shown in Figure 9b. However, this

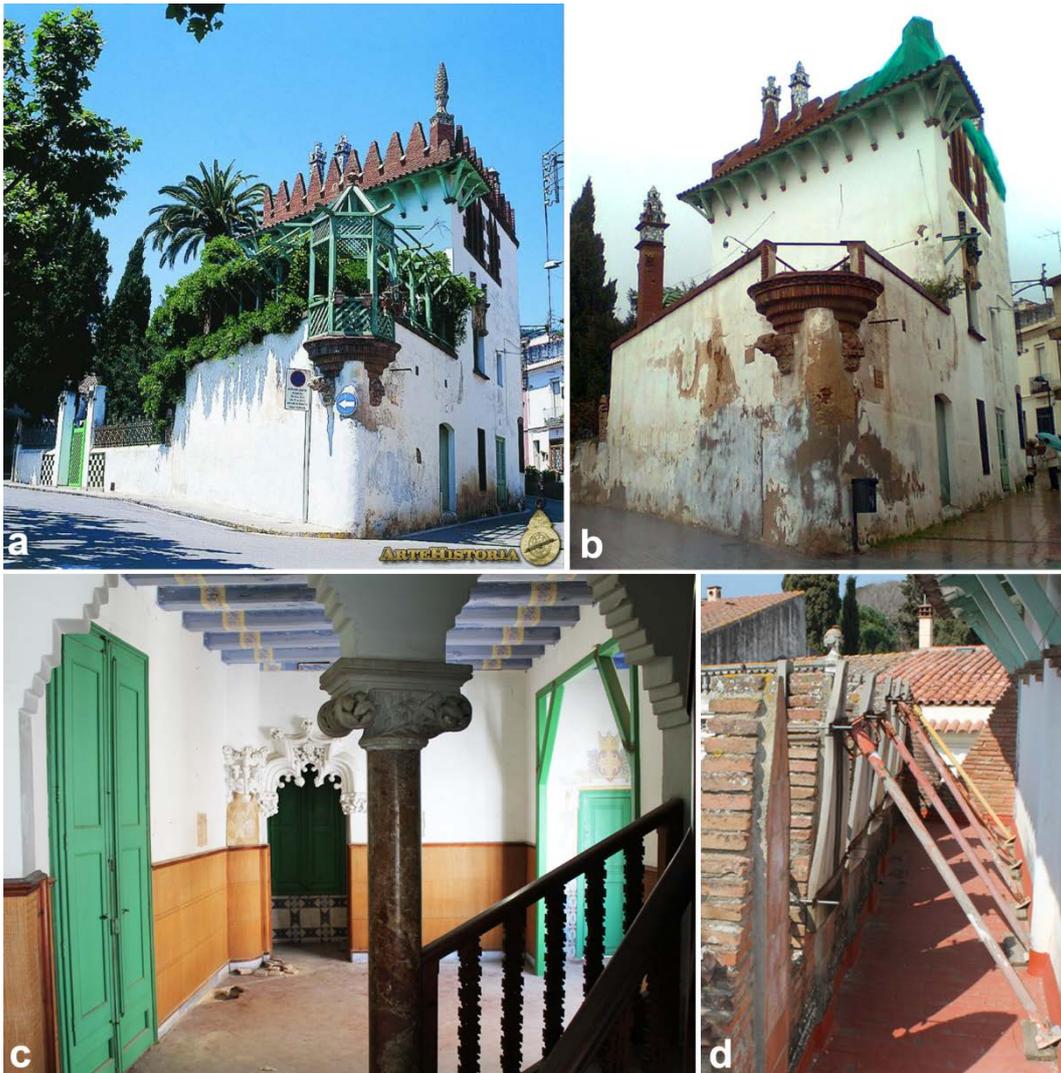
Figure 10 – Casa Puig i Cadafalch in Argentera, Barcelona: exterior view before (a, copyright ArteHistoria) and after the collapse of the pavilion and the merlons (b), view of the interior (c) and emergency propping of deformed merlons (d).

The building is currently under restoration due to the deterioration problems experienced during the last years. Different concerning problems had occurred, such as the collapse of the pavilion of the perimeter walls and of several merlons of the roof parapet (Figure 10b). The planning of the necessary restoration and retrofit interventions required a previous experimental activity with field tests in order to assess the mechanical properties of the existing materials. A particular attention was devoted to the assessment of the strength of the existing mortar. This assessment was of special importance in order to understand the residual capacity to wind actions of the merlons and other decorative elements. The assessment of the mortar strength was also important in order to evaluate the load bearing capacity of the masonry walls. Due to the heritage value of the building, different MDT techniques were applied in order to limit as much as possible the damage on the existing structural members.

Several merlons had fallen down due to the considerable wind actions and the heavy deterioration of the lime mortar in the joints. Some others were disassembled to avoid possible collapse, whereas those showing excessive deformation required urgent

propping (Figure 10d). MDT was applied on some merlons that were disassembled, stored and intended to be reconstructed during the restoration works of the house.

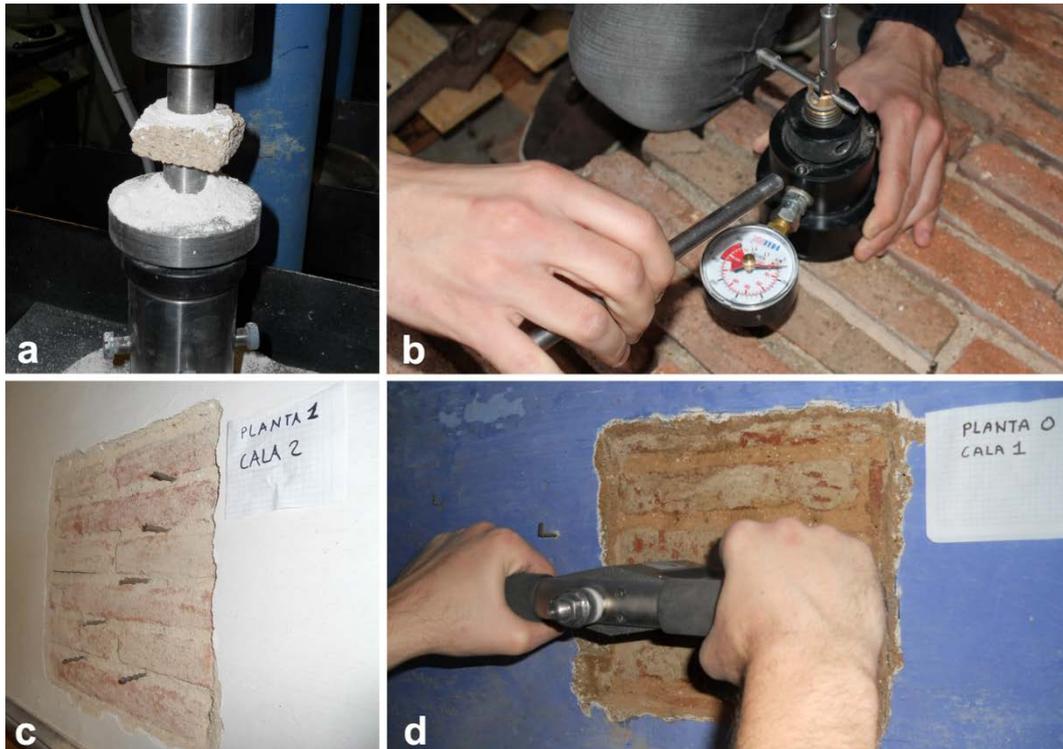
Figure 11 – Minor destructive testing of historical mortars in Casa Puig i Cadafalch: double punch test on mortar joints extracted from the merlons (a), helix pull-out test on the joints of the disassembled merlons (b), helix pull-out test (c) and pin penetration test on joints of the interior walls (d).

DPT was executed on bed joint samples brought to the laboratory (Figure 11a). Due to the irregular faces on the extracted mortar joints, gypsum powder was used for surface regularization. This novel approach was adopted as an alternative to gypsum plaster which had showed to be inappropriate for lower strength mortars, as already commented in Section 2.3. HPT was carried out directly on the mortar joints of the merlons (Figure 11b). Table 5 shows a summary of the DPT and HPT results. Two different types of mortar were detected in the merlons, differing in colour, i.e light grey and dark grey. This basic distinction of the two types of mortar, based on different visual appearances and colours, was later confirmed by the subsequent experimental tests. The light grey mortar provided a DPT average strength of 1.70 MPa, whereas the dark grey mortar gave higher values of 5.45 MPa, see Table 5. The HPT provided average pull-out forces of 248 N for light grey mortar and of 858 N for dark grey mortar. The comparison of these values with the DPT vs. HPT relationships of Figure 7b, referring to the laboratory experimental program presented in Section 2, shows very good agreement.

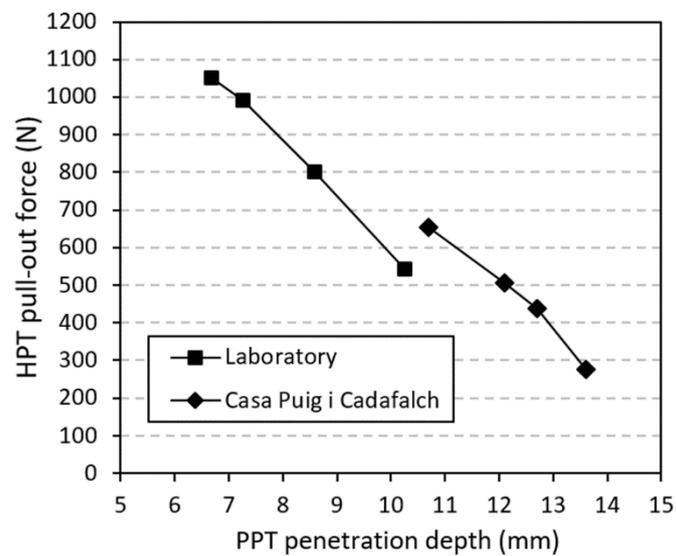
Figure 12 – Helifix pull-out force vs. Windsor Pin penetration depth: correlation obtained from the experimental programs in the laboratory and in Casa Puig i Cadafalch.

[Figure 12](#) shows a summary of all the HPT and PPT measurements obtained from this combined laboratory and in-situ experimental research. The graph of pull-out force vs. penetration depth shows that there exists an intrinsic relationship between the two

different testing systems. This result shows that their combined use in the evaluation of existing mortars allows a mutual control of the quality of the experimental results.
