Title: End-repair of timber beams with laterally-loaded glued-in rods:
experimental trials and failure prediction through modelling

Article Type: Research Paper

Corresponding Author: Dr. Benedetto Pizzo, Ph.D.

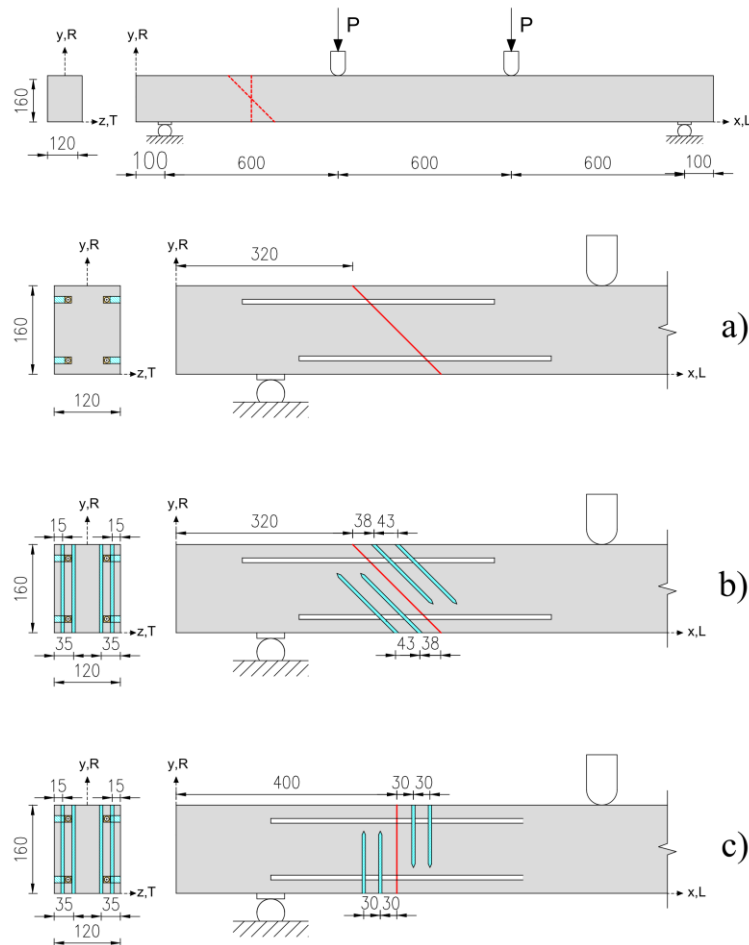
175 **Fig 1** - Specimen configurations and test arrangements: (a) the reference one (cut inclined 45°, no
176 reinforcing screws); (b) same as (a) but with the use of reinforcing screws inclined 45° compared to wood
177 grain; (c) configurations with vertical cut and perpendicular-to-grain reinforcing screws.

143 A total of 15 glulam, simply supported beams (cross section 120 x 160 mm²; span length 1800 mm), graded
144 as GL28h and made of Norway spruce (*Picea abies* Karst.) were analysed in 4-points bending tests (**Fig 1a**,
145 **1b** and **1c**). The various specimens were cut close to one end and then the two parts were re-sewed using 4
146 steel bars (S275, nominal diameter 10 mm, length 400 mm) glued into specifically prepared slots by means
147 of epoxy adhesive (Mapewood Paste 140). In this way, the variability related to wood characteristics
148 (density, slope of grain, moisture content, ageing effects etc.) on joint performances was kept to a minimum.
149 The transversal geometry of specimens is shown in **Fig 2**. Rods were placed parallel to wood grain, and slots
150 had a square section, as usual in interventions carried out onsite [37,38]. Bars were centred along each slot
151 using stoppers, thus ensuring an equal anchorage length between the two parts of the beam. Additionally, to

367 Moreover, considering that our experimental test arrangement was configured so as to make appreciable the
368 shear stress close to the repaired end-parts (**Fig 1**), it is worth evidencing that the average values of shear
369 stress at collapse, also calculated considering a continuous wood section, that is using the expression

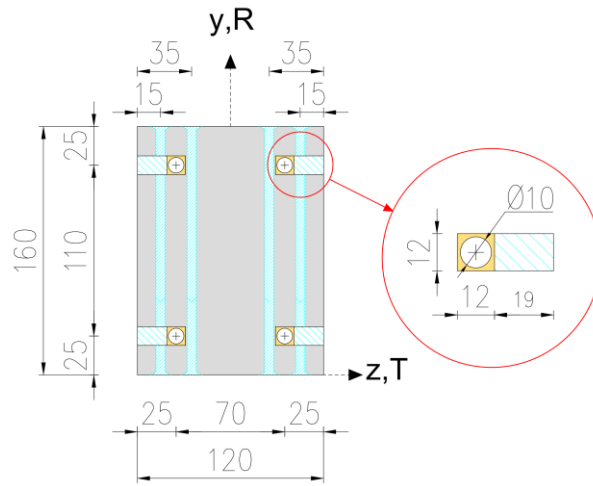
180 **Fig 2** - Scheme of the transversal section of all repaired beams. The position of screws is also visible in the
 181 cross-section.

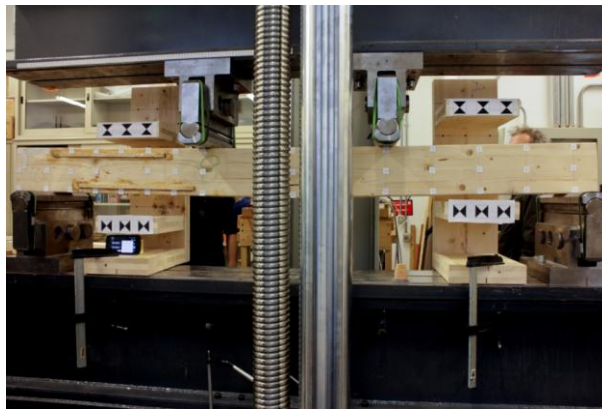
214 **Fig 3** - Location of targets and sample beam prepared for photogrammetric detection.

209 In order to do this, 12 targets (**Fig 3**) connected to the bending machine's frame, were located on the same
210 plane of the photographed face of the beam and surveyed with a precise Leica TS06 total station. The targets
211 were assumed to be stable during the whole duration of the test.

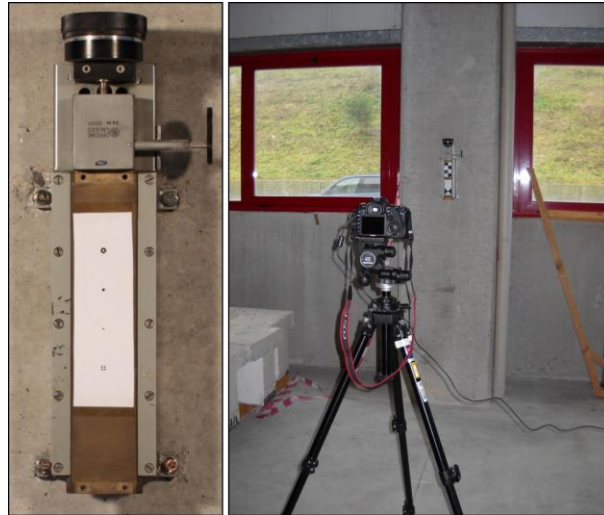
224 **Fig 4** - On the left: device for micrometric displacement imposition. On the right: image acquisition during
225 preliminary tests for automatic displacement detection.

219 The photogrammetric measurement system was previously developed by simulating displacements in
220 laboratory and by detecting them through a MATLAB script. During these preliminary tests, the
221 displacements were imposed and known with an accuracy of few micrometers (**Fig 4**).

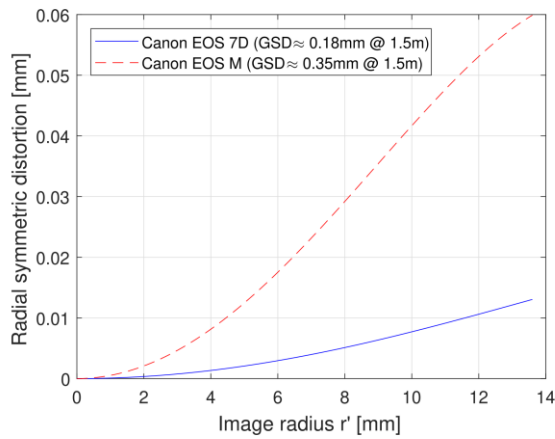
242 **Fig 5** - Radial distortion for EOS 7D and EOS M cameras: the first one (blue) is equipped with very low
 243 distortion lens, while the second one (red) has a wide-angle lens.

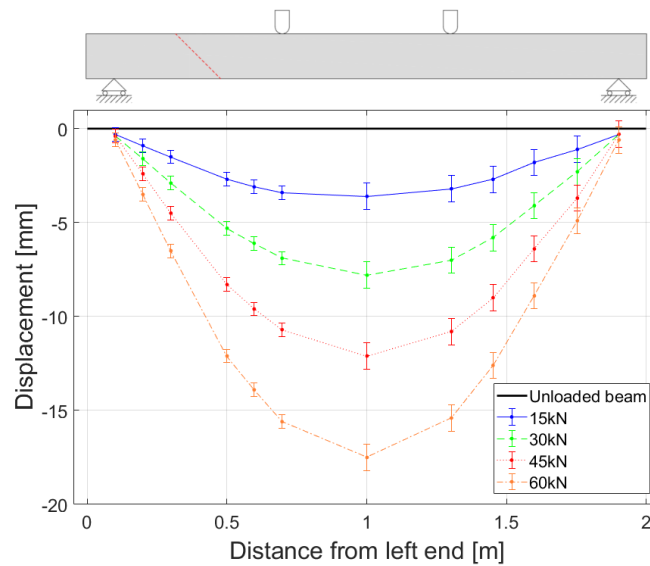
397 **Fig 8** - Photogrammetrically detected deflections of one representative beam of series 45/refer (error bars
 398 have been magnified by a factor of two). The left end measurements are more precise due to the smaller
 399 pixel size on Canon EOS 7D pictures.

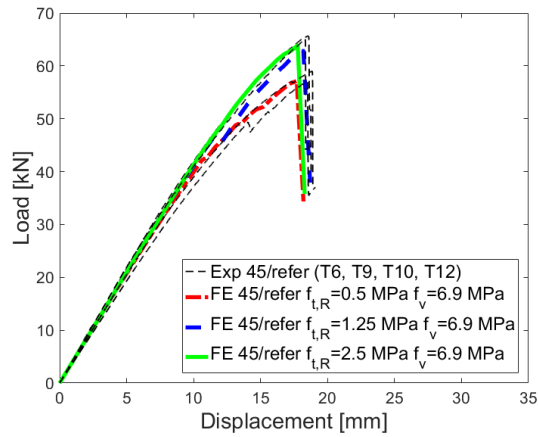
555 **Fig 17** - Sensitivity analysis: Influence of the radial tensile strength. $f_{t,R}$ obtained with $f_{t,L} = 35$ MPa,

$$f_{c,L} = 65 \text{ MPa.}$$
