RURBAN SEQUENCES Inquiries on Dropull's states of Liminality

Structural Assessment and Seismic Performance of Traditional Stone houses in Dropulli region

Nikolla Vesho

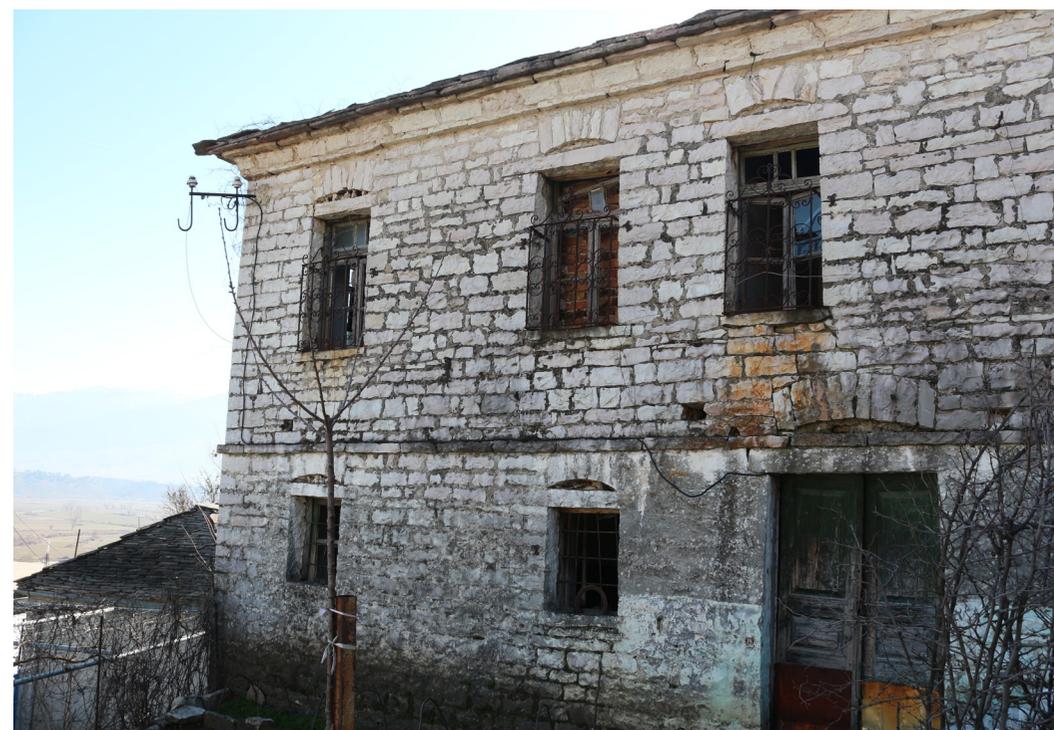
Fig. 1 / Traditional stone house on Dervician, the selected building (February 09, 2019)
Source / the author

Below is two-storey house with stone walls and timber construction under the stone roof. The building has timber-joisted floor and rubble stone masonry foundation.
