INTACT ROCK BRIDGE BREAKAGE AND ROCK MASS FRAGMENTATION UPON FAILURE: QUANTIFICATION USING REMOTE SENSING TECHNIQUES

Abstract

CASE STUDY

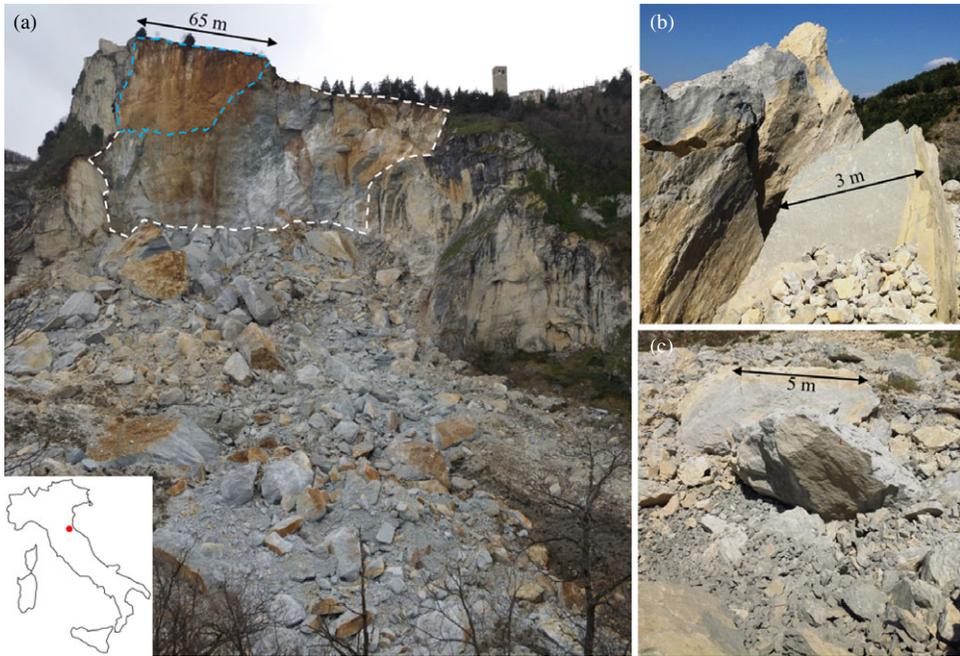
FIG. 1. Photographs of the 2014 San Leo landslide in Italy, acquired a few days after the landslide. (a) The difference in colour between fresh (grey) and weathered (white-orange) fractures can be appreciated in the landslide scarp and in the deposit. The dashed line indicates the boundary of the landslide scarp. The light-blue dashed line highlights the distinct pre-existing surface, identified at the top of the eastern side of the cliff and named SL3.1 in Spreafico et al. (2016). (b), (c) Examples of boulders in the deposit area.

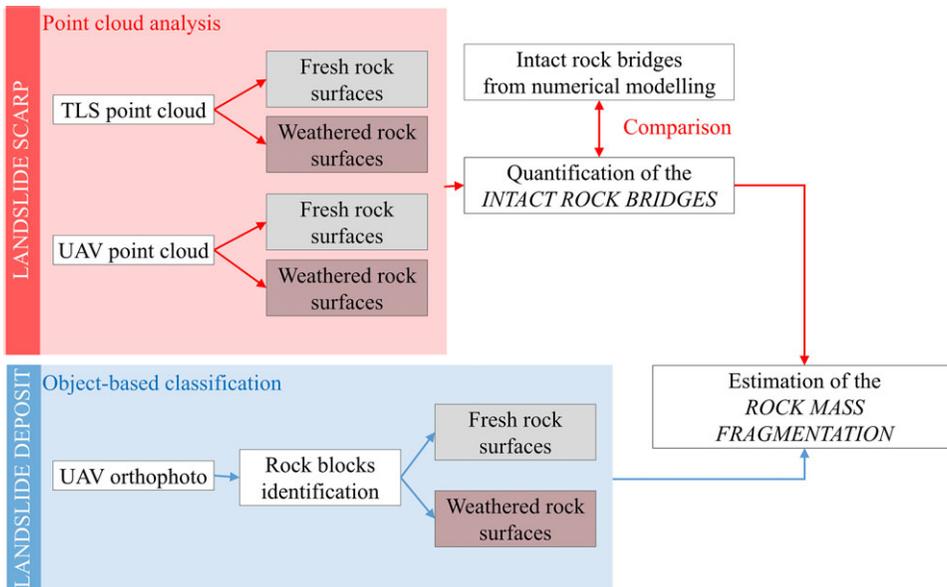
FIG. 2. Flowchart showing the methodology used for the quantification of the intact rock bridges' percentage in the landslide scarp and for the estimation of the rock mass fragmentation amount that occurred after failure.

An object-based classification was then applied to identify and quantify the percentage of new fractures in the landslide deposit. The difference between the proportion of fresh fractures recognised on the cliff and in the deposit can provide an evaluation about the degree of fragmentation that has occurred during the rebound phase and upon impact. A landslide deposit orthophoto (ground sample distance (GSD) of 5 cm), obtained from the UAV survey, was made available by the Emilia-Romagna Region (Agenzia per la sicurezza territoriale e la protezione civile, Servizio Area Romagna). The adopted methodology is presented in Fig. 2.

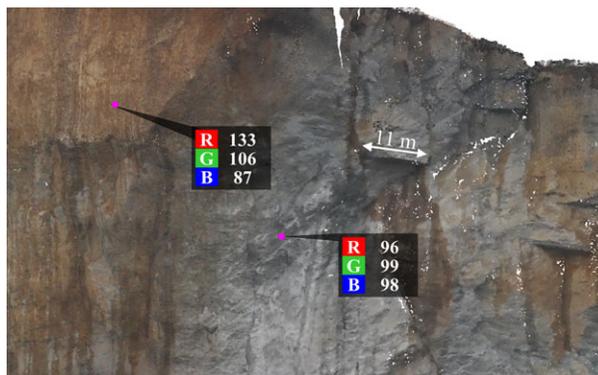
FIG. 3. Example of point cloud inspection: the point on the left is located on a weathered surface, while the one on the right belongs to a fresh fracture. The differences in RGB intensity values can be appreciated.

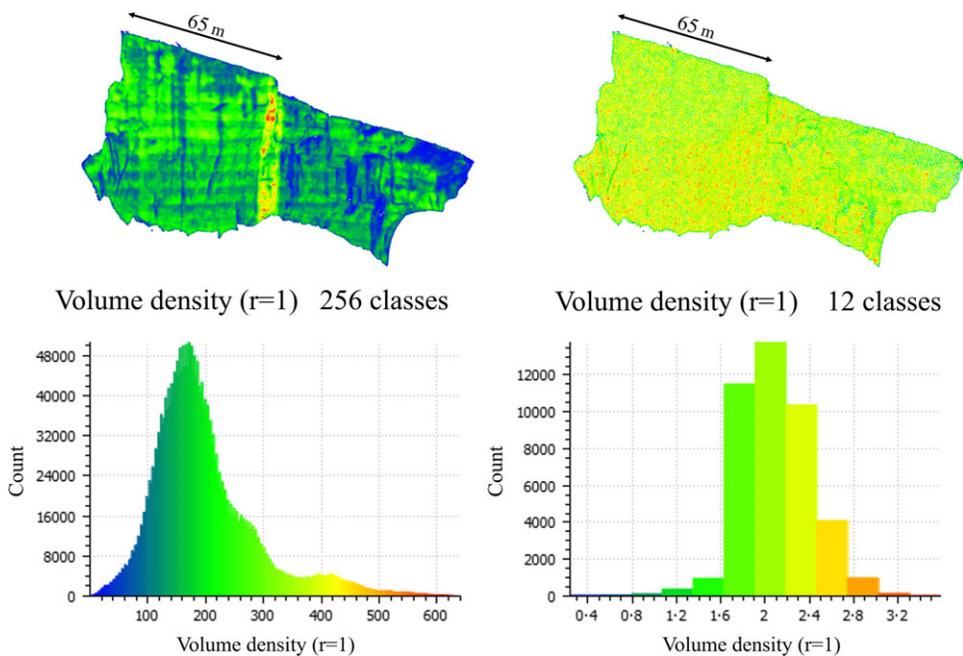
FIG. 4. Point density estimated in CloudCompare for the TLS point cloud before (left) and after (right) the resampling procedure; r refers to the sphere radius used for the calculation.

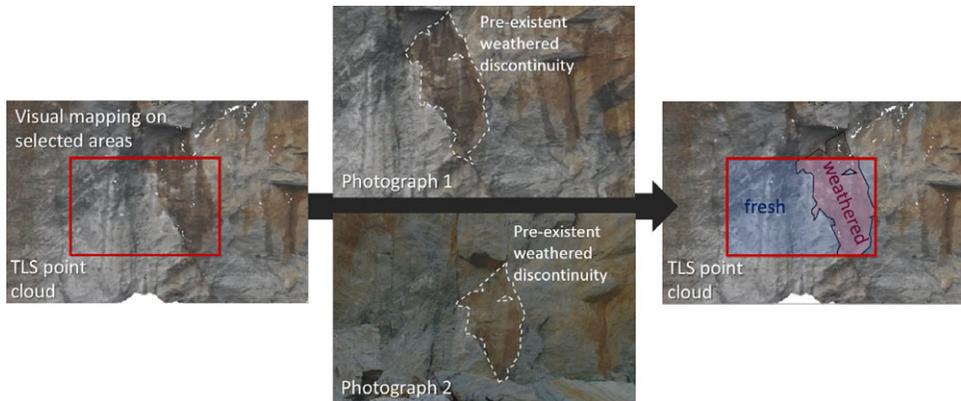
FIG. 5. Example of the visual recognition of weathered discontinuities, used in the result validation phase. The visual mapping was performed in selected areas. The operator was aided by photographs of the failure surface, taken from different viewpoints.

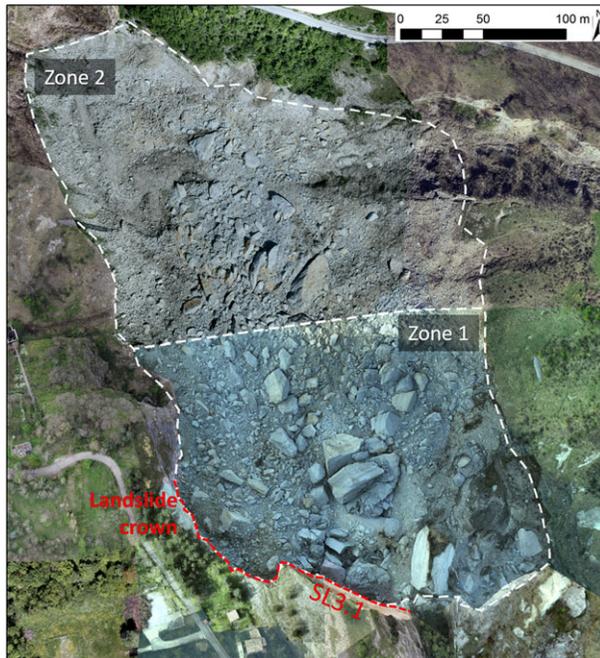
FIG. 6. The orthophoto subdivision. Zone 1 covers 32 707 m² and Zone 2 covers 35 465 m². The landslide crown is highlighted in red, and it also comprises the SL3.1 discontinuity trace (along which part of the failure took place – see Spreafico et al., 2016).

In the present work, a multi-level object-based approach was developed using the eCognition Developer software, version 9 (Trimble, 2014). The orthophoto of the landslide deposit (68 172 m²) was subdivided into two different zones (Zone 1 and Zone 2) due to the different light acquisition conditions (Fig.6). The application of slightly different

(1)	Zone 1	$R - B < -40$ fresh $R - B \geq -40$ weathered
(2)	Zone 2	$R - B < -100$ fresh $R - B \geq -100$ weathered.

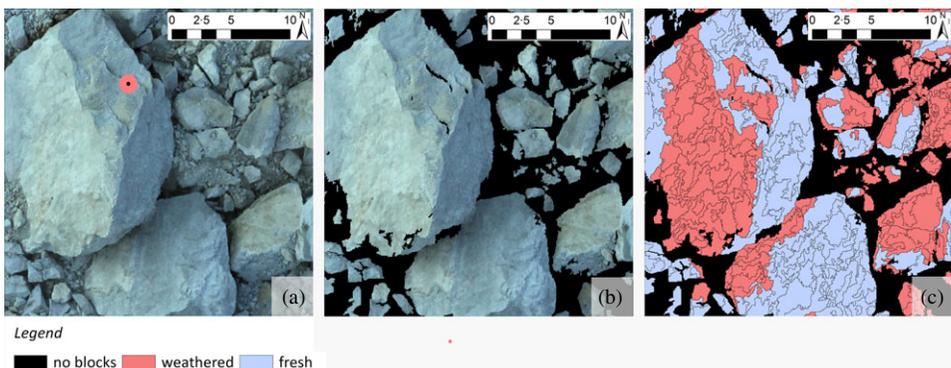
FIG. 7. A subset of the orthophoto. (a) The original data. The red dot represents the point used for the ground truth (weathered surface). The dot has been enlarged for visualisation purposes. (b) Rock blocks identification at the “Optimized” level. (c) Sub-objects representing weathered and fresh surfaces.

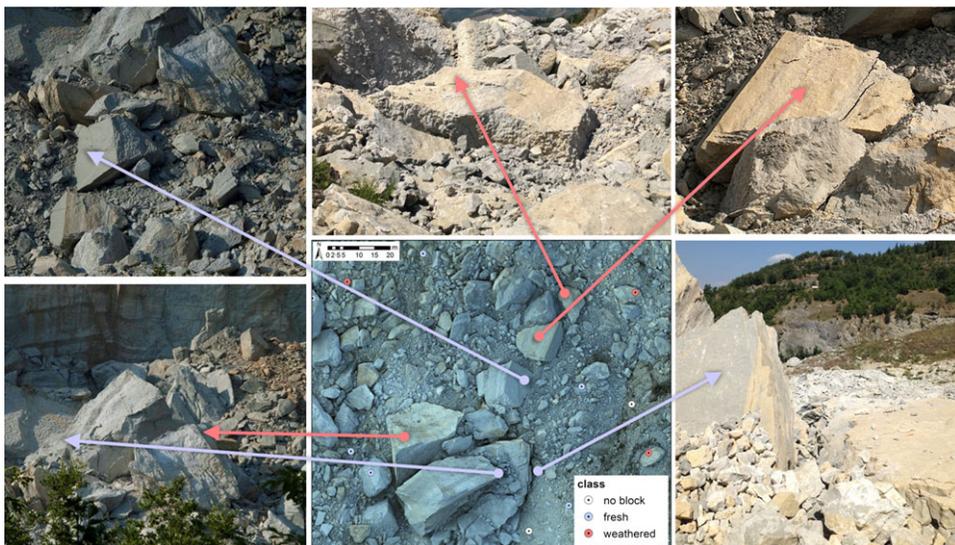
FIG. 8. Example of ground-truth points. The photographs show some of the blocks identified in the field and used as ground truth to validate the classification.

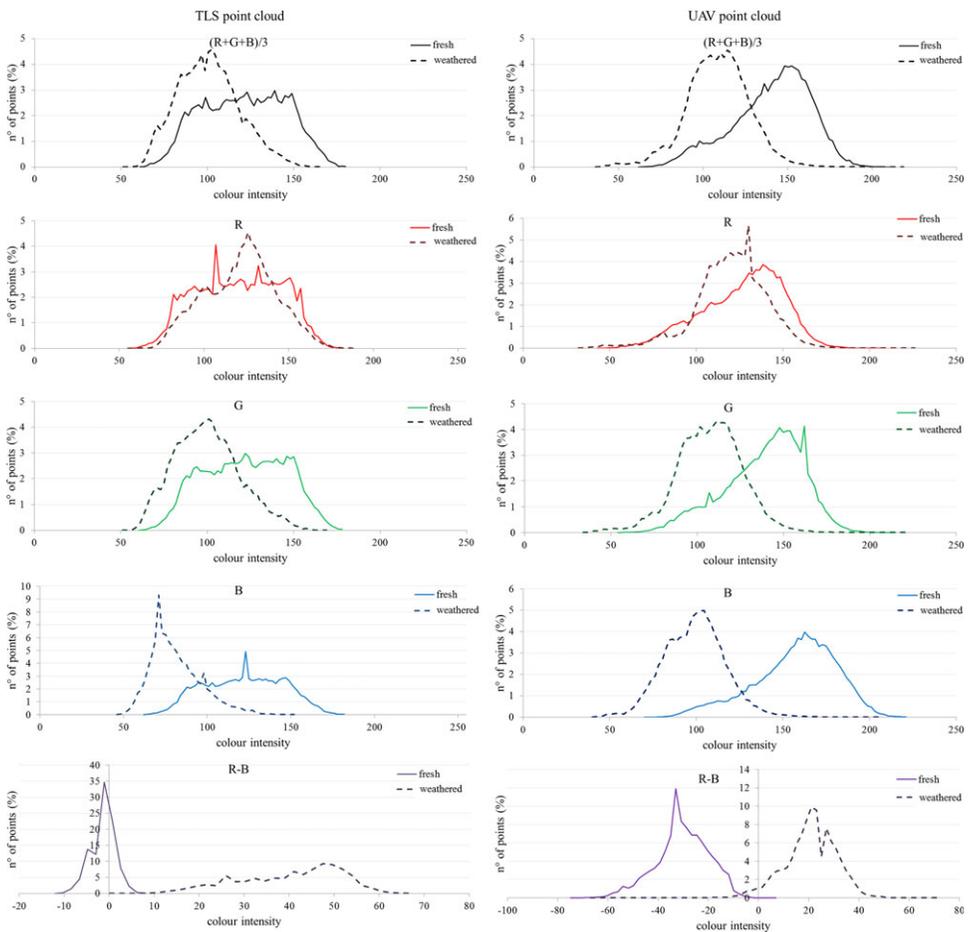
FIG. 9. Colour intensity versus the number of points for fresh and weathered test areas. Left: graphs related to the TLS point cloud. Right: graphs derived from the UAV photogrammetric point cloud. Colour combinations from top to bottom are: (R + G + B)/3; R; G; B; R – B.

rock results in the presence of a lower B intensity and a slightly higher R intensity. The results were similar in the UAV point clouds, where the proportion of B was greater than that of the other primary colours for the points identified as fresh rock. Based on this inspection, five colour combinations to be analysed were chosen: R, G, B, R – B and (R + G + B)/3. In Fig. 9, graphs describing the correlation between the colour intensity and the number of points for the fresh and weathered test areas are presented.

With the R and G components, fresh and weathered rock surfaces are hardly differentiable. Only the green component of the UAV point cloud can probably be used for this purpose. The blue component seems to be more suitable for this discrimination. As expected, its intensity is higher on the fresh surfaces. With the R – B combination for the TLS point cloud, freshly exposed rock is represented by a distribution with a mean close to zero, since the three primary colours have a similar intensity. Contrast this with the UAV

point cloud where, again as expected, the mean of the same distribution is negative due to the higher intensity of the blue colour. Observing these results, the B and R – B intensities can be chosen as the most discriminating between the two classes. In ROC curves (Fig. 10), the diagonal straight line from the bottom-left to the top-right corners, called the *line of no discrimination*, represents a random guess. Curves above this line represent good classifications; the greater the AUC, the higher the model’s accuracy. The ROC curves obtained can be used also to select the classification threshold. The different thresholds tested for each combination or colour intensity are, in fact, represented by points on the ROC curves. The best classification is the one closer to the upper left corner of the graph (coordinates (0, 1)), which represents a classification with no false negatives and no false positives. The suitability of the B and R – B intensities was confirmed by the correspondent ROC curves in Fig.10 and holds true, with different thresholds, for both point clouds. In fact, since a direct comparison between the results was not needed, the colour data was not calibrated.

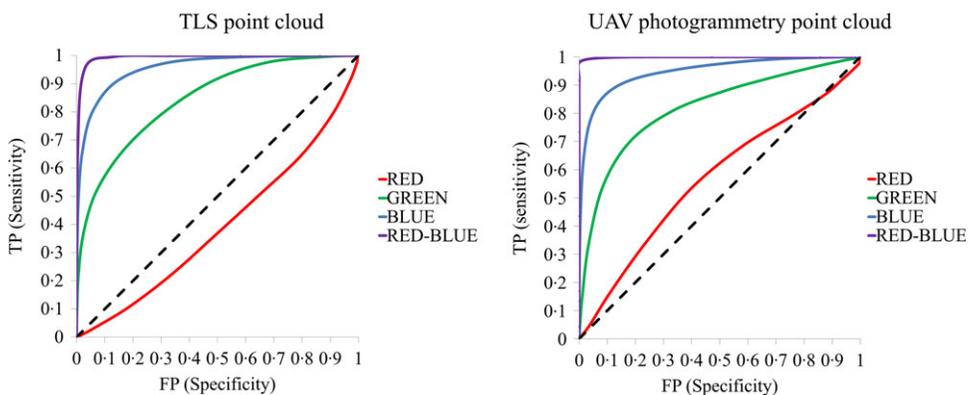
FIG. 10. Comparison of the ROC curves derived for each discrimination method, on the TLS and UAV photogrammetric point clouds. TP = true positives; FP = false negatives.

For both point clouds, the R – B combination proves to be the best prediction method, with an AUC of 0.989 and 0.998 for the TLS and UAV point clouds, respectively. Also, the B intensity can be used, with a slightly lower performance (AUC of 0.952 for the TLS point cloud and of 0.945 for the photogrammetric UAV point cloud). The G intensity has a global accuracy of 0.813 if tested on the TLS point cloud and of 0.839 on the UAV point cloud. Finally, the R intensity showed AUC values below 0.5 (0.394 for the TLS point cloud and 0.435 for the UAV point cloud), which basically indicates no improvements over a random classification. The AUC values provide an idea about the “goodness” of the classifications, but they have to be read with a critical eye. In fact, the ground truth used to calculate the ROC curves, based on visual recognition of weathered rock surfaces, can be slightly biased by certain factors. For example, small pre-existing fractures are difficult to recognise by manual inspection (scale bias). In addition, closed or unconnected pre-existing discontinuities will not be identified because they will not show signs of weathering. Thus, not all the biases present in the classifications were fully highlighted by the analysis of the ROC curves.

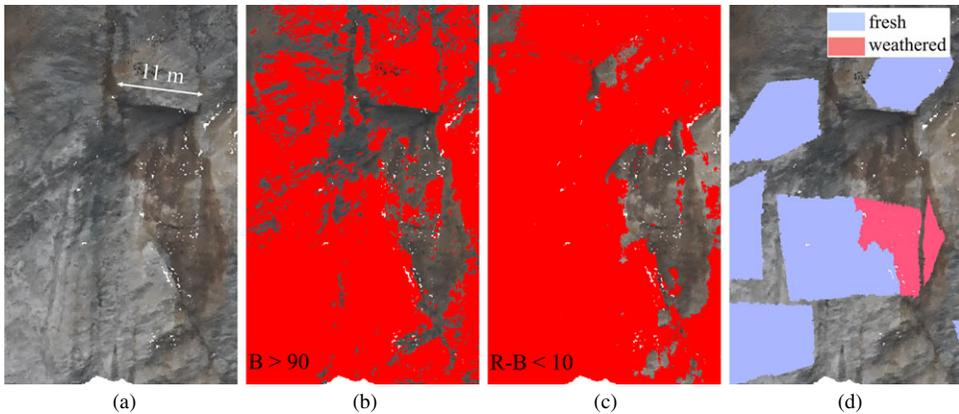
FIG. 11. Details of the TLS point cloud (a) and relative classifications (b) and (c). In red are the points classified as fresh surfaces. (d) Manually classified points, used as a reference to validate the results.

are more affected by light conditions and shadows on the cliff, and by the differences in the initial rock colour: shadow areas will result in a lower B intensity for fresh rock as well, and thus can be misinterpreted as weathered surfaces (Fig. 11(b)). By subtracting two colours with $R - B$, the effect of light conditions is reduced, since a shadowed area will have a lower B intensity but also a lower R intensity (Fig. 11(c)).

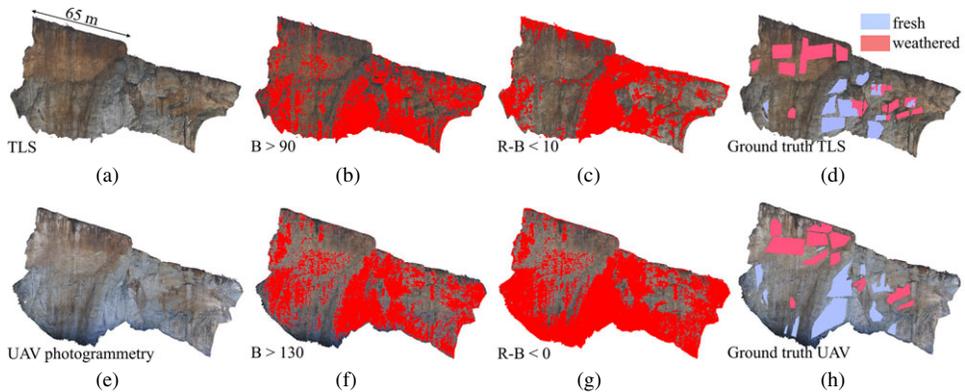
FIG. 12. Subsampled point clouds (a and e) and points extracted applying the thresholds summarised in Table I. The points identified as belonging to fresh rock surfaces are highlighted in red (b, c, f and g). Fresh and weathered surfaces identified through manual mapping were used to validate the results (d and h).

shown in Fig. 12, the average percentage of fresh fractures appears to be of the order of 54%.

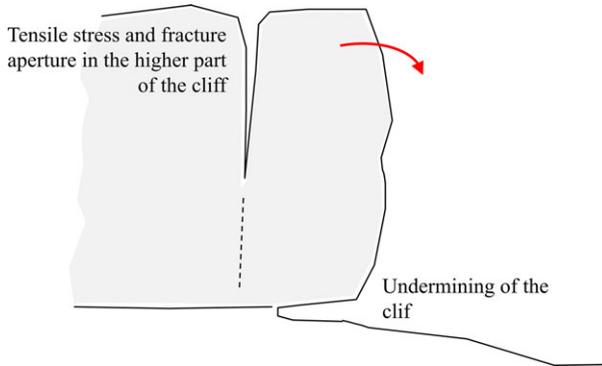
FIG. 13. Simplified sketch of the failure mechanism. Undermining of the cliff is causing tensile stress to develop in the upper portion of the plateau. For this reason, a greater number of open fractures at the top of the cliff are expected.

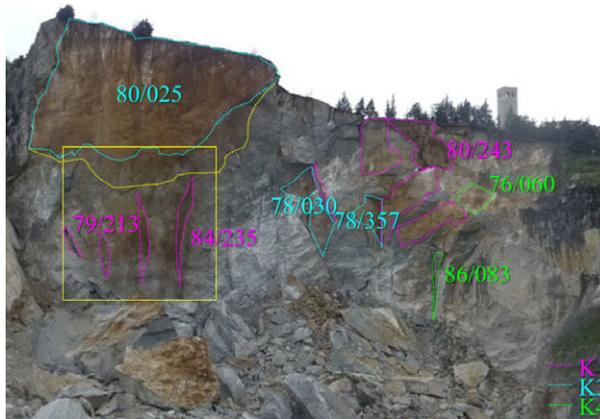
FIG. 14. Main identified pre-existing fractures: the colour is related to the joint set. The areas highlighted in yellow represent an area where weathered surfaces and discontinuity planes do not overlap (for example, only a portion of the joint plane is weathered).

Besides these sets, other non-planar discontinuities in the proximity of the joint SL3.1 showed signs of weathering. The areas, located below the SL3.1, are highlighted in yellow in Fig. 14. In particular, in the lower portion of this area, the staining has an irregular shape and does not cover the entire fracture plane. The most plausible hypothesis for this is that the failure plane was already developing in this area before the rockfall event that occurred on 27th February 2014. The degree of alteration, lower than that on the main SL3.1 surface, is probably an index younger fracture, developed after the joint SL3.1 exhibited a certain

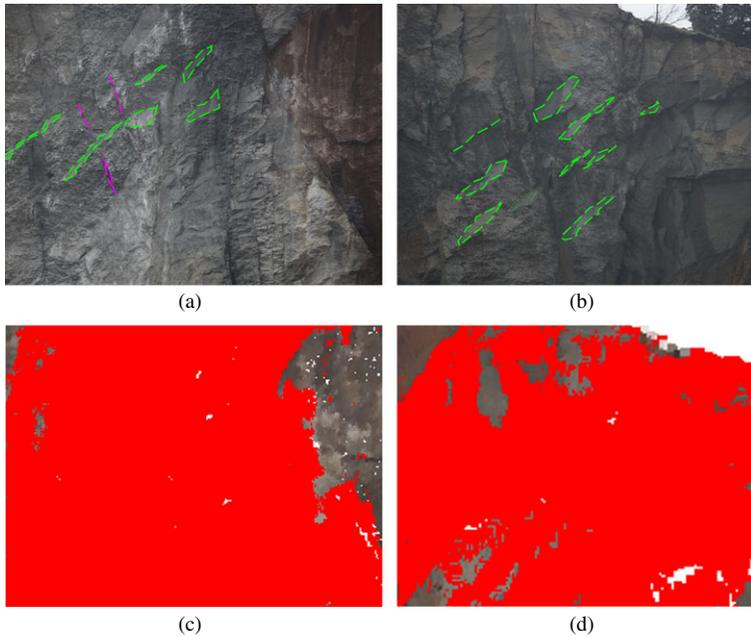
FIG. 15. Details of the cliff showing areas composed of low-persistence discontinuities connected by intact rock. (a, b) Some of the pre-existing fractures are highlighted (set K4 in green, set K1 in magenta). In (c) and (d), fresh surfaces are classified in red using the R – B combination on the TLS point cloud.

Sturzenegger and Stead (2012) showed that, for large failures, wide rock-surface intervals that resemble intact rock bridges at small scales, if observed in detail, are in fact composed of a low-persistence discontinuity connected by an intact rock fracture. Tuckey (2012) supported this conclusion. The same behaviour, dependent on the resolution of the investigated 3D model, can also be observed in the San Leo cliff (Fig. 15).

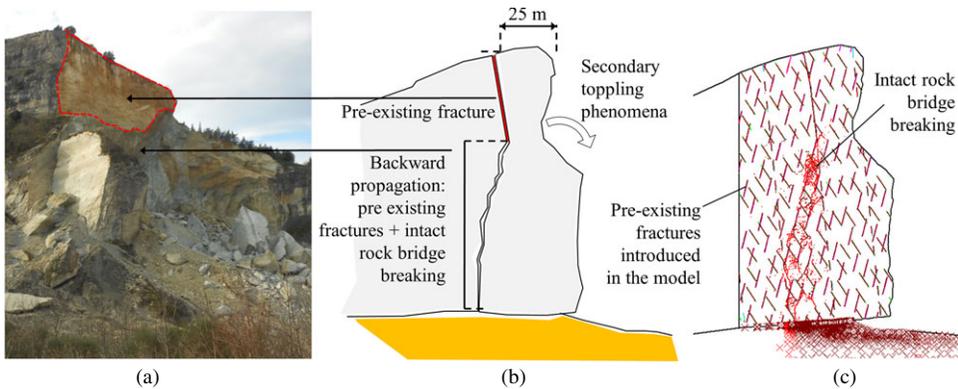
FIG. 16. Numerical modelling workflow. (a) Photograph of the landslide scarp, with the pre-existing discontinuity SL3.1 highlighted in red. (b) Sketch of the 2D section. (c) Modelling results, showing the pre-existing fractures introduced in the model (persistence equal to 50% of the fracture length) and, in red, the intact rock bridge breaking. Modified from Spreafico et al. (2017).

Spreafico et al. (2017) back analysed the same failure using the 2D numerical code Phase2 (version 8 – now called RS2 – see Rocscience Inc., 2014). They used a simplified discrete fracture network (DFN) model to simulate fracture propagation along pre-existing discontinuities together with a Voronoi tessellation for propagation through intact rock masses. Through the DFN definition, it is possible to choose an infinite fracture length, or to specify a persistence (the ratio of the joint length to total length along the joint plane). Different scenarios were simulated, varying the persistence of the pre-existent discontinuities between 25%, 50% and 75%. Despite the differences between the two methods used to estimate the rock bridge percentages, it can be still interesting to make a comparison between the results. This is notwithstanding the fact that with the 2D numerical modelling method only a section was analysed, whereas with the 3D point cloud classification the whole slope was taken into account. Furthermore, different assumptions were made for each of the techniques, both containing intrinsic uncertainties. The failure mechanism was correctly simulated in the numerical model only with a fracture persistence of 50% (Fig. 16). If the pre-existing fractures were assumed to be more persistent (75%), the rock mass behaves as a continuum, not correctly reproducing the shape of the failure surface. On the other hand, with a lower persistence (25%) and thus a higher proportion of intact rock bridges, the slope remained stable even with undermining 10 m deeper than the one measured in the field (about 20 m of undermining). Analysing the simulations' outcomes in more detail, 59% of the resulting failure profile belongs to pre-existing discontinuities, while

the remaining 41% is due to fracture propagation along intact rock bridges. Since in the numerical models the pre-existing discontinuity SL3.1 was introduced explicitly, to compare the Spreafico et al. (2017) results with the findings of this study the fresh-surface percentages were recalculated removing this discontinuity. Analysing the four classifications

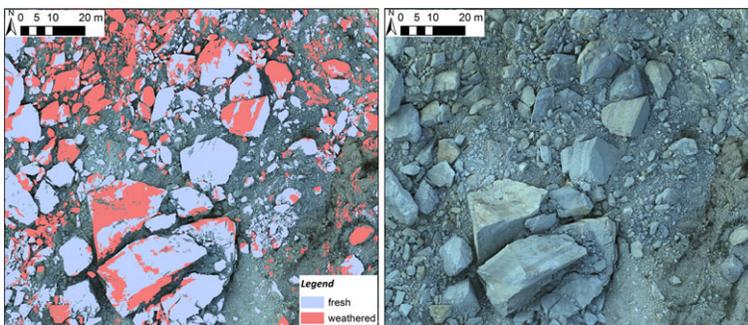
FIG. 17. Left: details of the classification results. Right: original orthophoto.

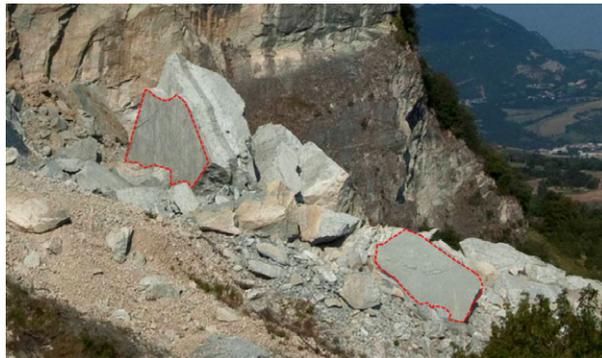
FIG. 18. Photograph depicting examples of blocks in the deposit. Bedding planes along which fragmentation has occurred are highlighted in red.

Examining the blocks in the deposit, this work recognised a high number of blocks in which fragmentation occurred along pre-existing weak rock planes and sedimentary features (for example, bedding planes); examples are shown in Fig. 18. A similar behaviour was
