Computers and Structures

The narthex of the Church of the Nativity in Bethlehem: A non-linear finite element approach to predict the structural damage

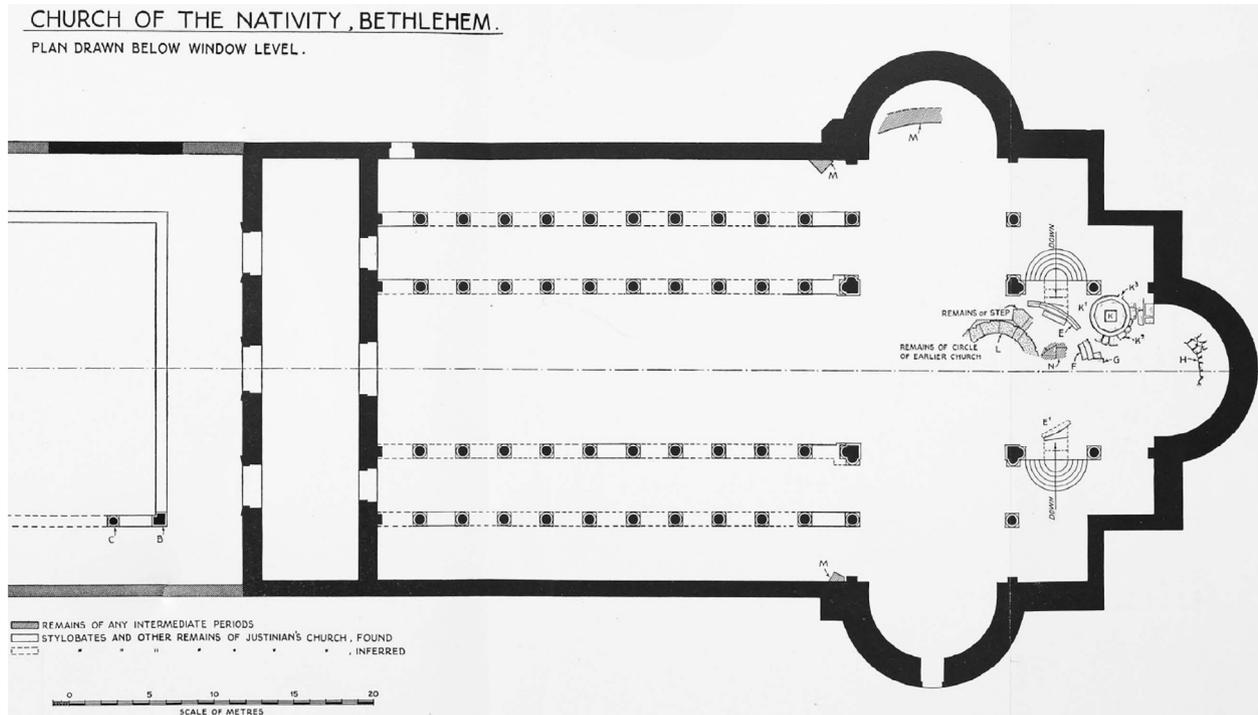
Fig. 1. Original narthex of the Church of the Nativity.

Very little is known about the history of the transformations of the narthex of the Nativity Church since its construction. The narthex that we see now (or at least the narthex that we can imagine on the basis of the current volumes or the traces of some ancient and still visible openings on the walls) replaced a larger cloister in the second half of the VI century; such a cloister belonged to the previous Church, ordered by Queen Helena, mother of Emperor Constantine, in the IV century. From the outcomes of some archaeological excavations made by Hamilton [1] in the thirties of the last century and from the results of some subsequent studies [2,4], it was possible to go back to the original form of the narthex; differently from now, it was composed of a single volume, had a bigger central door flanked by two smaller side doors in both the principal walls and two windows placed symmetrically with respect to the front door, Fig. 1.

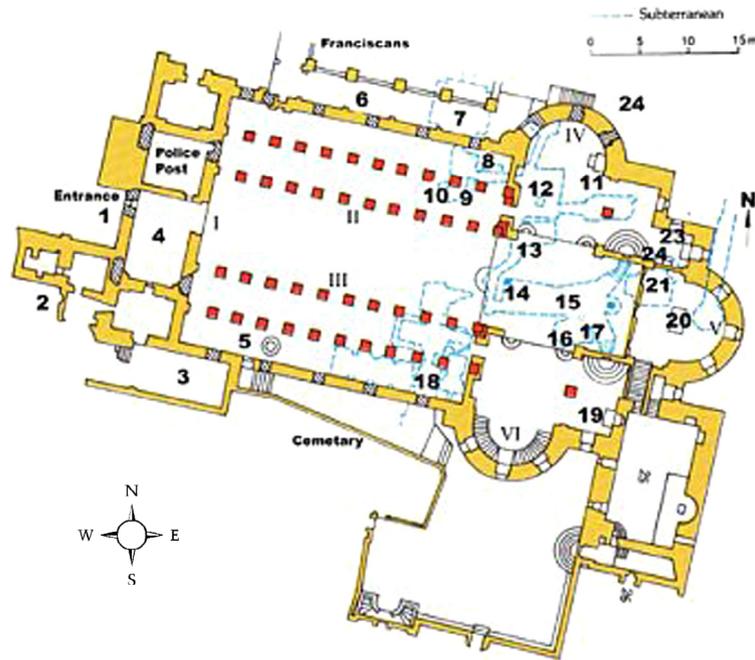
Fig. 2. Plan of the Church with the current narthex. 1. Courtyard; 2. Armenian monastery; 3. Armenian courtyard; 4. Narthex; 5. Font; 6. Cloister; 7. Chapel of St. Jerome; 8. Altar of St. Eusebius; 9. Sts Paula and Eustochium; 10. St. Jerome; 11. Altar of the Virgin; 12. Tombs of the Holy Innocents; 13. Altar of St. Joseph; 14. Cistern; 15. Grotto of the Nativity; 16. Manger; 17. Altar of the Magi; 18. Burial grottoes; 19. Altar of the Circumcision; 20. Main altar; 21. Cistern; 22. Star of the Nativity; 23. Altar of Kings; 24. Church of St. Catherine; 25. Sacristy and chapel of St. George; 26. Bell tower.

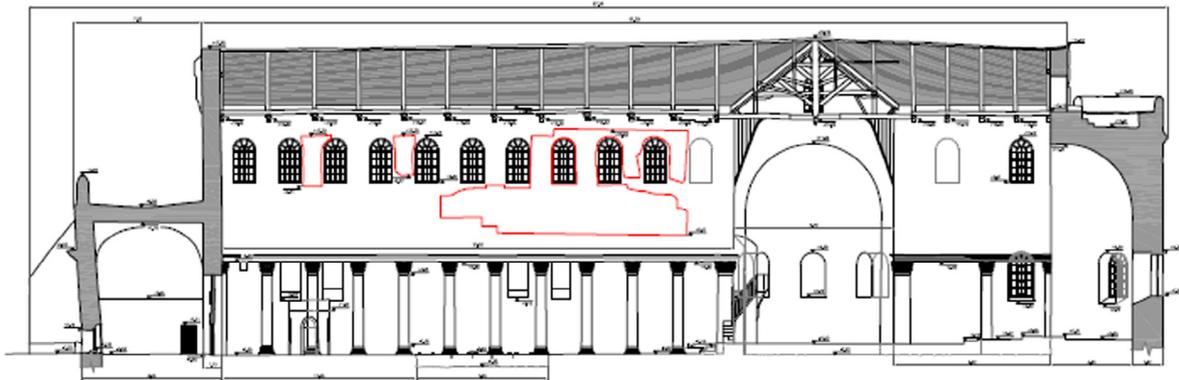
Fig. 3. Longitudinal section of the Church.

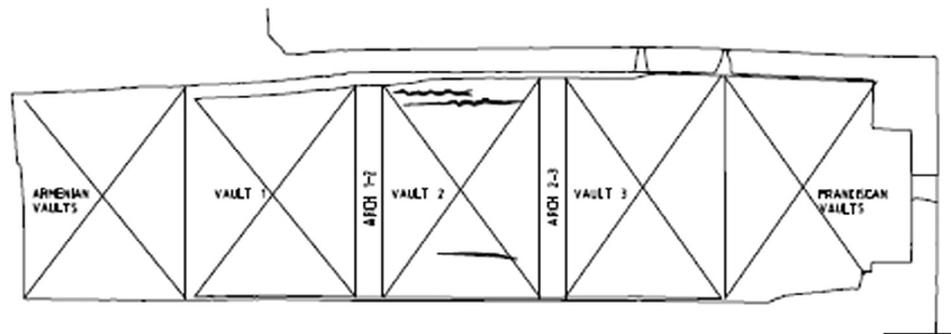
vertical displacements downwards in the central zones, detachments from the façade walls and both extrados and intrados cracks. Especially the central vault, propped since the thirties of the last century, exhibits detachments equal to 17–19 cm from the narthex façade and 10–11 cm from the Church façade, Fig. 5a. Moreover, large cracks, parallel to the façades, are visible at the extrados, Fig. 5b.

Fig. 5. (a) Detachments from the wall, (b) cracks at the extrados of the central vault.

It is worth noting that both the state of damage and the values of vertical displacements found on the cross vaults through the numerical analyses are in a very good agreement with what was observed in reality, see Fig. 5.

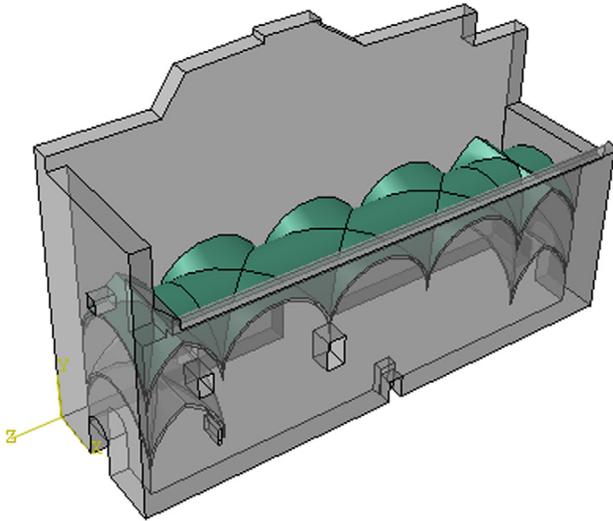
Fig. 6. The system of masonry cross vaults in the model of the narthex.

door (the Humility door) and two small windows. The original openings of Justinian's time are still not reproducible because of the lack of reliable survey data. The side walls of the narthex are supposed to be connected to the longitudinal external walls of the Church. The vaults are connected to the surroundings walls and have thicknesses and heights with constant values, averaged over the real ones that show some differences among them. They are also connected to each other in the East - West direction by means of arches similar to the real ones, Fig. 5b, and clamped to both the façades. Moreover, the façade of the Church is connected to the orthogonal walls of the nave and aisles. Fig. 6 offers a view of the masonry cross vault system in the model of the narthex.

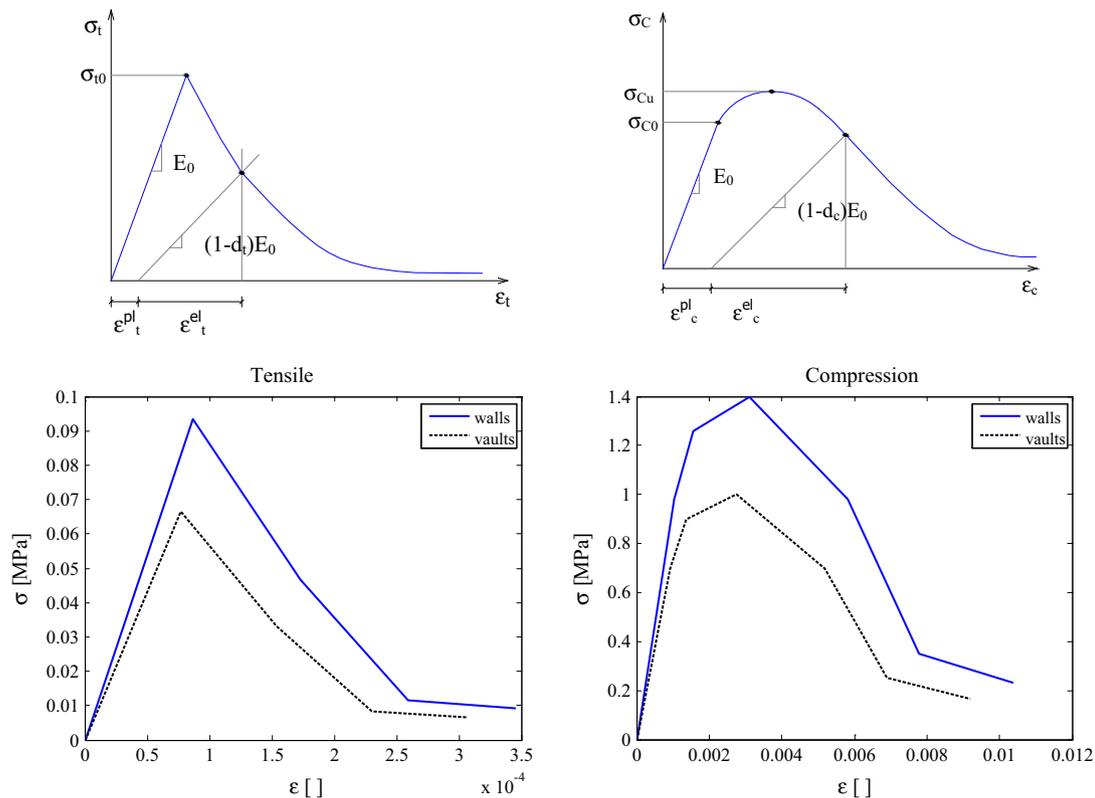
Fig. 7. Tensile and compression mono-axial inelastic curves for masonry adopted in the numerical simulations.

In this study the non-linear behavior of masonry is modelled through the Concrete Damage Plasticity (CDP) model presented by Lubliner [31] and then modified by Lee and Fenves [32], which is available within the ABAQUS software. Although originally conceived to describe the non-linear behavior of concrete, the model can be used for masonry through a proper adaptation of the main parameters [18,33]. The model is based on the assumption of a scalar isotropic damage with distinct damage parameters in tension and compression and it is particularly suitable for the analysis of structures subjected to cyclic and dynamics loads. A different elastic-plastic behavior in tension and compression can be taken into account, as illustrated in Fig. 7.

In tension the stress-strain response follows a linear-elastic relationship until the peak stress σ_{t0} is reached. Then, micro-cracks start to propagate in the material, a phenomenon which is macroscopically represented by softening in the stress-strain relationship.

Under axial compression, the response is nearly linear up to the value of the yield stress σ_{c0} . After the yield stress, the response is typically characterized by hardening, which anticipates compression crushing, represented by a softening branch beyond the peak stress σ_{cu} .

The compressive and tensile strength of masonry was set equal to $\sigma_{cu} = 1.4$ MPa and $\sigma_{to} = 0.093$ MPa, respectively, obtaining a ratio between the tensile and compressive strength equal to 0.066; the unit weight and the elastic modulus were assumed equal to $w = 16$ kN/m³ and $E = 1080$ MPa, respectively. As regards the masonry of the vaults, the compressive and tensile strength was set equal to $\sigma_{cu} = 1$ MPa and $\sigma_{to} = 0.066$ MPa, respectively; the elastic modulus was assumed equal to $E = 870$ MPa.

The final inelastic stress-strain relationships adopted in the constitutive model of masonry are reported in Fig. 7 for the tensile and compression mono-axial curves.

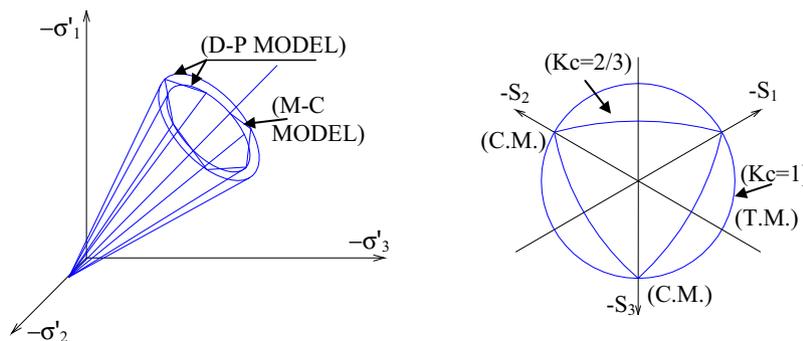
Fig. 8. 3D strength domain adopted in ABAQUS for the CDP model and meaning of K_c parameter. D-P: Drucker Prager strength criterion. M-C: Mohr-Coulomb strength criterion. C.M.: compressive meridian. T.M.: tensile meridian.

To describe the multi-dimensional behavior in the inelastic range, masonry is assumed obeying a Drucker-Prager strength criterion with non-associated flow rule, Fig. 8. A parameter $K_c = 0.667$, applied to the analytical expression for the Drucker-Prager surface in the principal stress space, allows distorting the surface, making it more similar to that of the Mohr-Coulomb criterion.

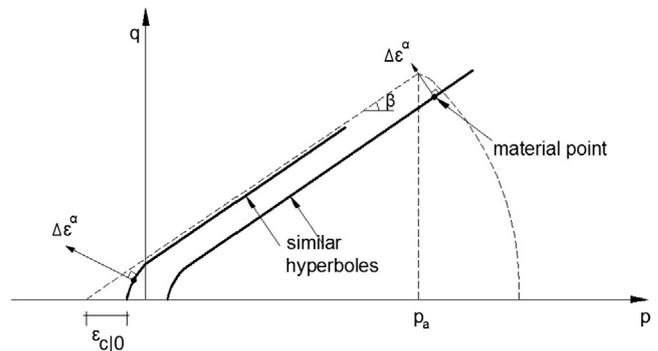
To avoid numerical convergence issues, the tip of the conical domain of the Drucker-Prager strength domain is smoothed with a function having hyperbolic shape. ABAQUS code allows ruling smoothing by means of the so-called eccentricity parameter, which represents the length of the segment between the points of intersection of the cone and of the hyperbola with the p axis in the p - q space, see Fig. 9. A value equal to 0.1 is adopted for the eccentricity parameter. Smaller values may cause convergence problems when the material is subjected to low confining pressures because of the very tight curvature [7].

Fig. 9. Smoothed Drucker-Prager failure criterion adopted in the numerical simulations, p - q plane.

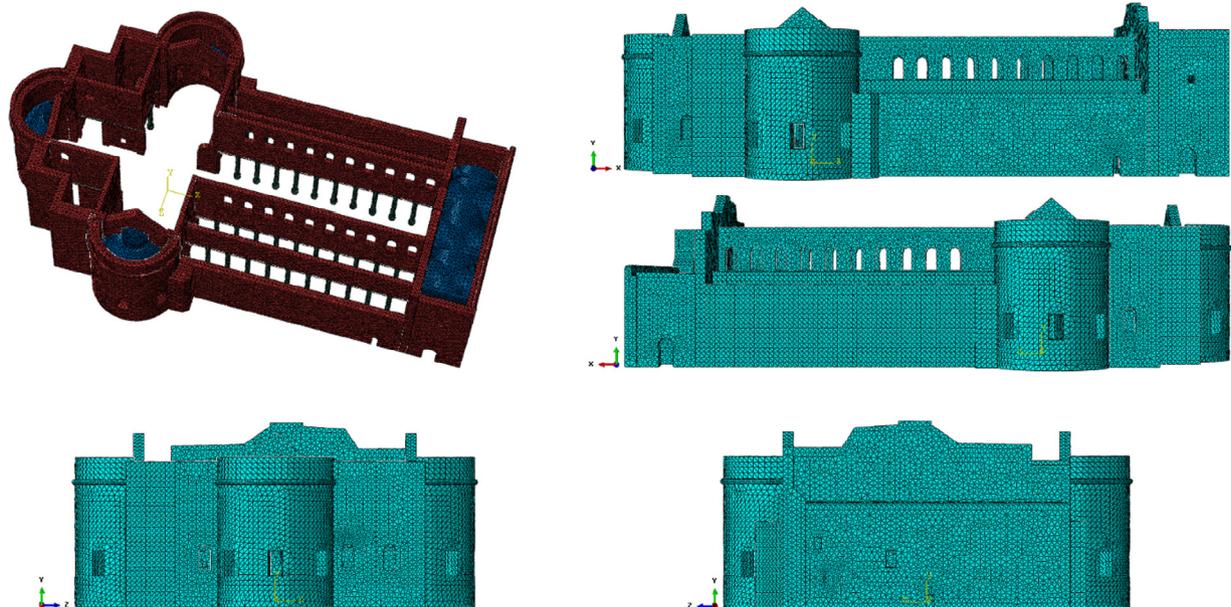
Fig. 10. Finite element model of the entire Church of the Nativity.

was equal to 131,551. In particular, the mesh was refined near the regions where the main failure mechanisms were likely to start. Since not negligible out-of-plane displacements may occur during a seismic event, large displacement effects were considered. Perfect connections were assumed between perpendicular walls. The wooden roof was not modelled and only vertical loads transferred by the roof to masonry walls were introduced in the models.

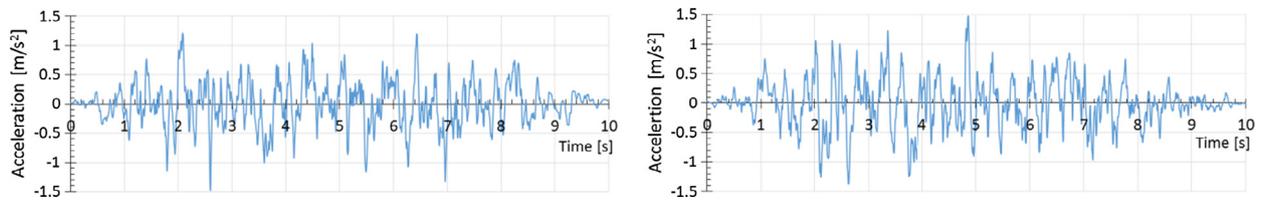
Fig. 11. Artificial accelerograms used for the bidirectional non-linear dynamic analyses of the Church.

where the Church is located (without specific seismic norms provided by Palestine state, Eurocode 8 is assumed as reference) can be considered as a medium-intensity seismic area with $a_g = 0.15 g$, where a_g is the maximum horizontal acceleration occurring in the area, with a 10% of probability of exceeding this value over 50 years. Due to the complexity of the model and the high computational time required by the non-linear dynamic analyses, the duration of the accelerograms was set equal to 10 s. The artificial accelerograms used for the bidirectional non-linear dynamic analyses are shown in Fig. 11. It is worth mentioning that artificial accelerograms are usually characterized by a large number of cycles and therefore such records may generally lead to conservative response quantities and damage distribution.

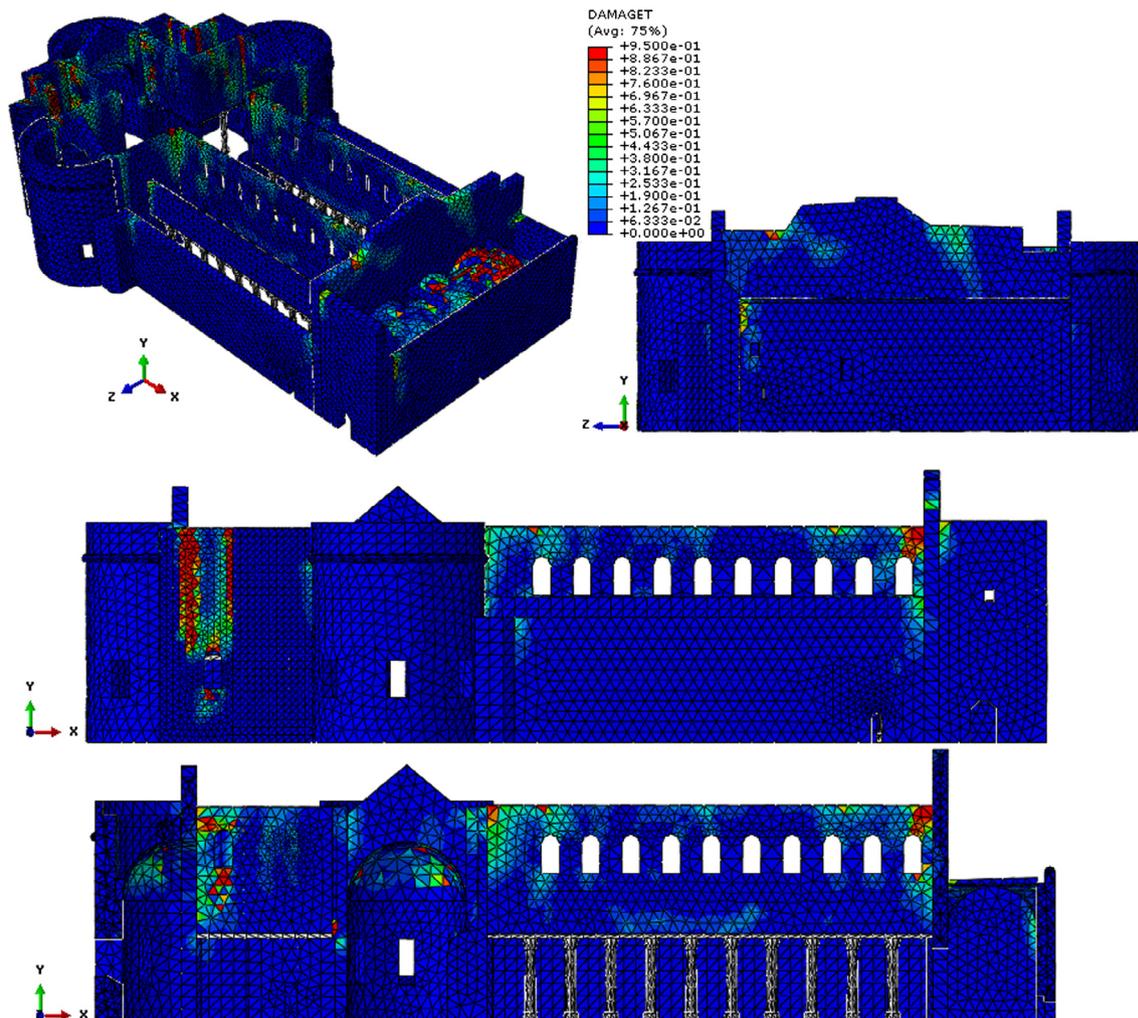
Fig. 12. Contour plots of tension damage at the end of the non-linear dynamic analysis: (red, 1: full damage; blue, 0: no damage). (For interpretation of the references to colour in this figure legend, the reader is referred to the web version of this article.)

In Figs. 12 and 13 the contour plots of tension and compression damage (red color is associated to full (1) damage and blue color to

zero (0) damage), respectively, are shown from different points of view at the end of the numerical simulation. From an overall analysis of the numerical results, it is possible to notice that the Church exhibits significant damage under the seismic excitation expected in that region. It is evident that damage spreads very quickly in the vault system, in the semi-domes and near the interlockings of the orthogonal walls. The damage in the vaults starts in the lateral right corner and then propagates towards the middle.

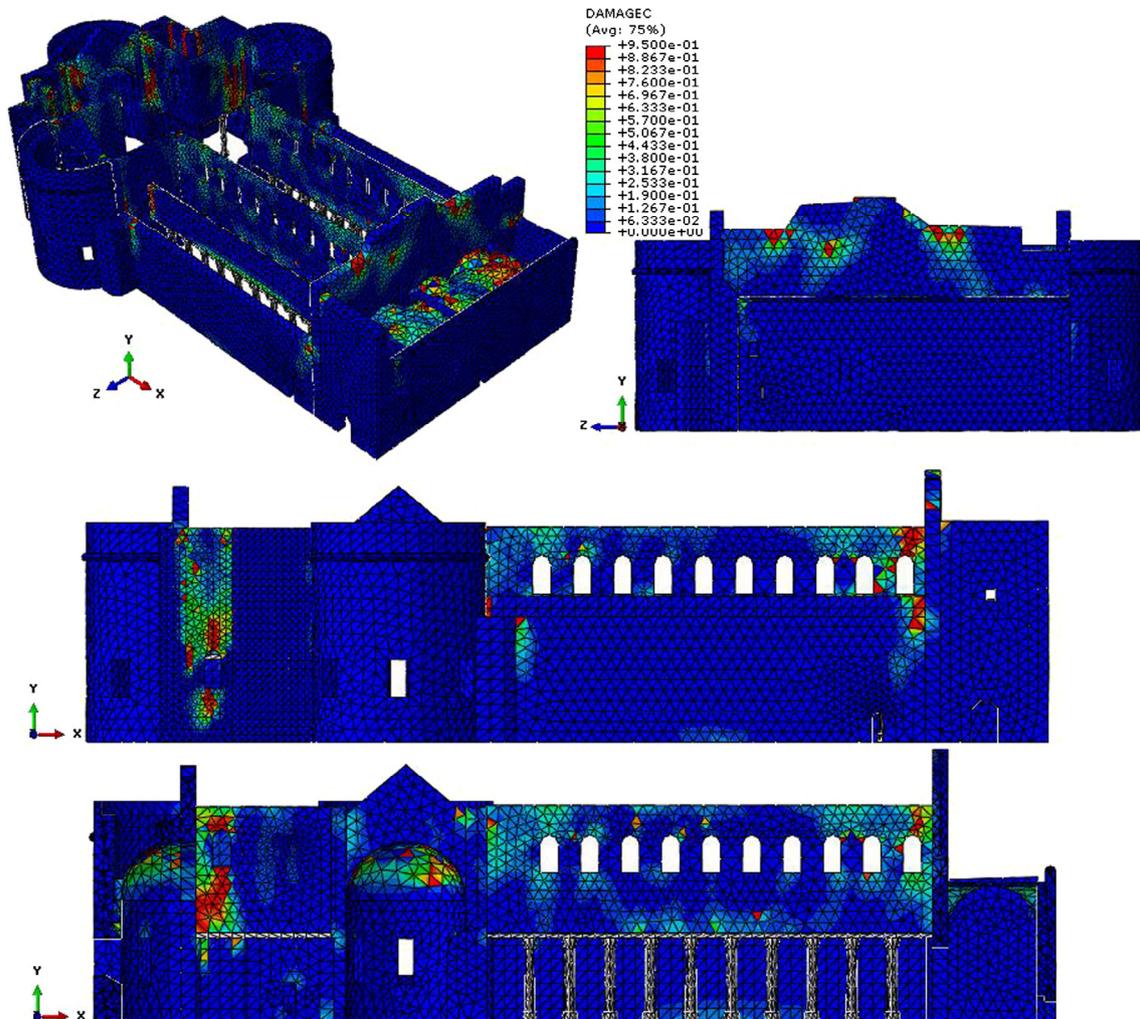
Fig. 13. Contour plots of compression damage at the end of the non-linear dynamic analysis: (red, 1: full damage; blue, 0: no damage). (For interpretation of the references to colour in this figure legend, the reader is referred to the web version of this article.)

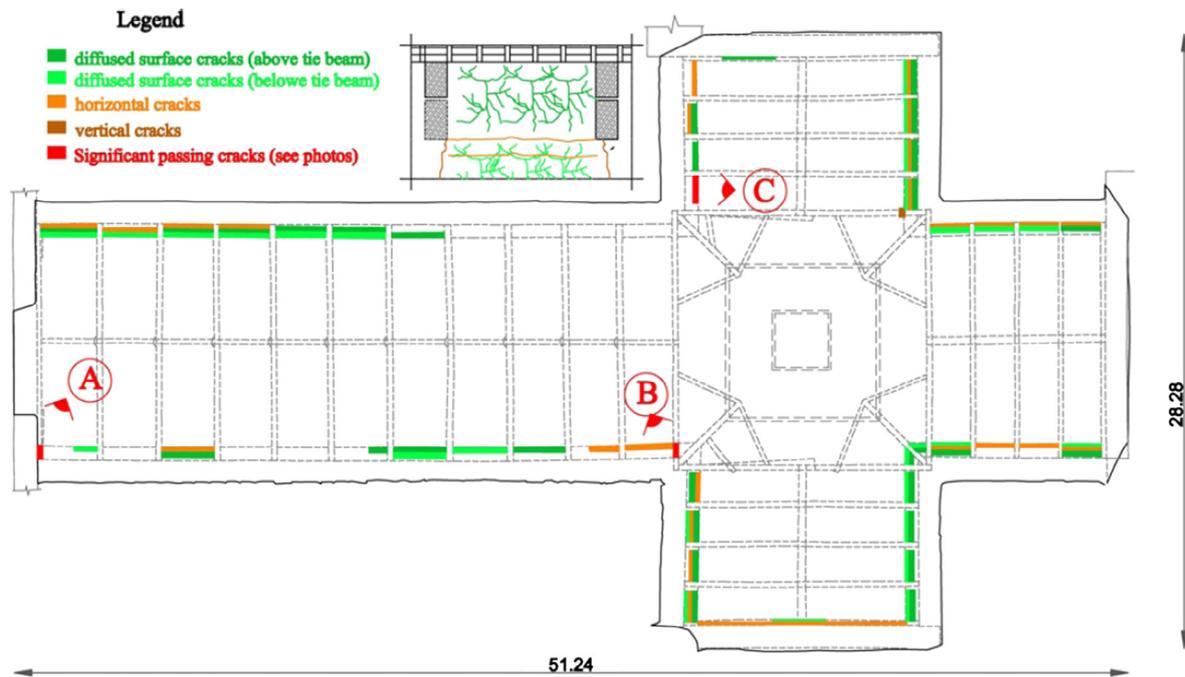
In fact, the crack pattern surveyed before starting the restoration works and visible through the XIX century plaster [6] shows some vertical cracks at the intersection of the orthogonal walls, especially those of the nave and the transept, Fig. 14.

Fig. 14. Vertical cracks at the intersection between the orthogonal walls of the nave and transept.

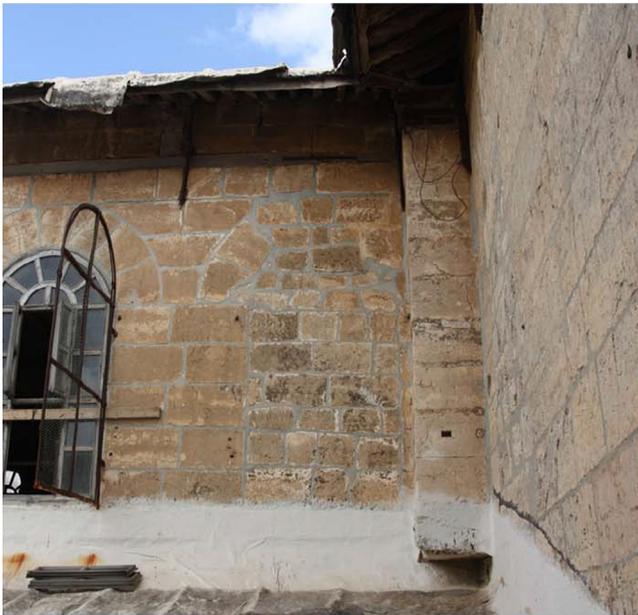
Moreover, it was known [4] that all the Eastern area, including part of the nave, the transept and the apse, had undergone significant modifications over the centuries due to events not documented historically, but that might be also related to earthquakes. Traces of such modifications can be found in the buffered windows of the upper level in correspondence with the corners between transept and apse and between transept and nave, Figs. 15 and 16.

Fig. 15. Buffered window of the nave at the intersection with the transept wall.

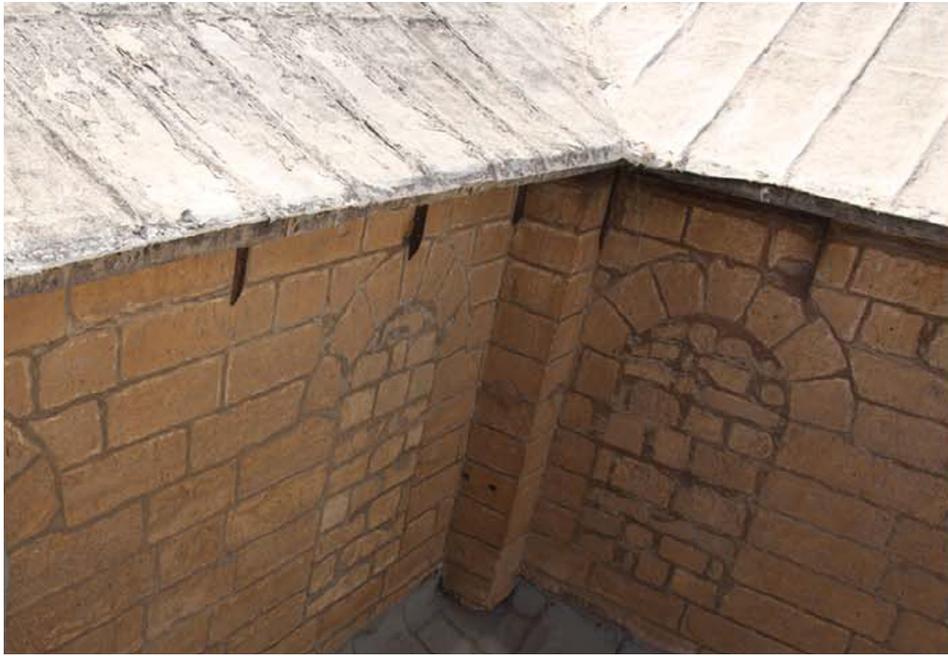
Fig. 16. Buffered windows at the intersection between the apse and transept.

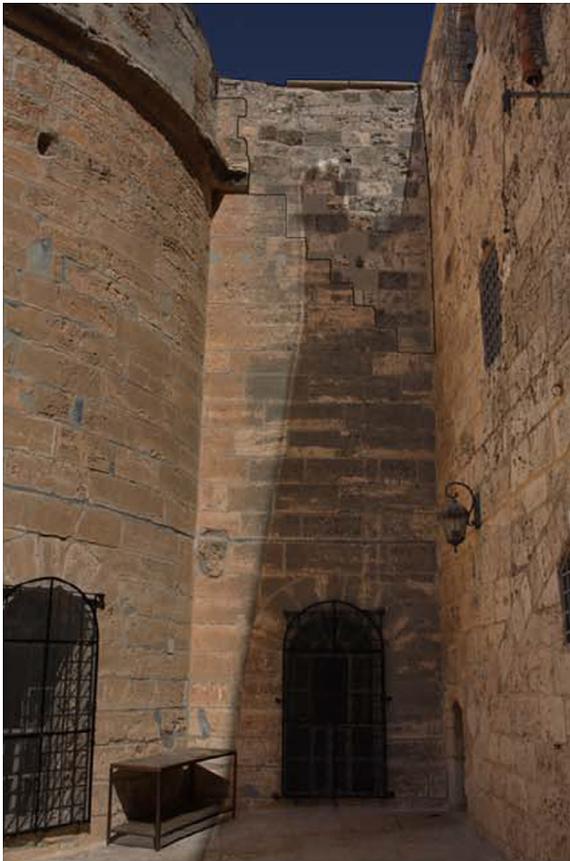
Other visible traces can be found in two opposite walls of the North and South corners in the Eastern part, where a clear change in both the type and quality of the stones, due to a re-building, denotes a dramatic event that occurred in the past, Figs. 17 and 18.

Fig. 17. Re-making in the upper part of the South corner.

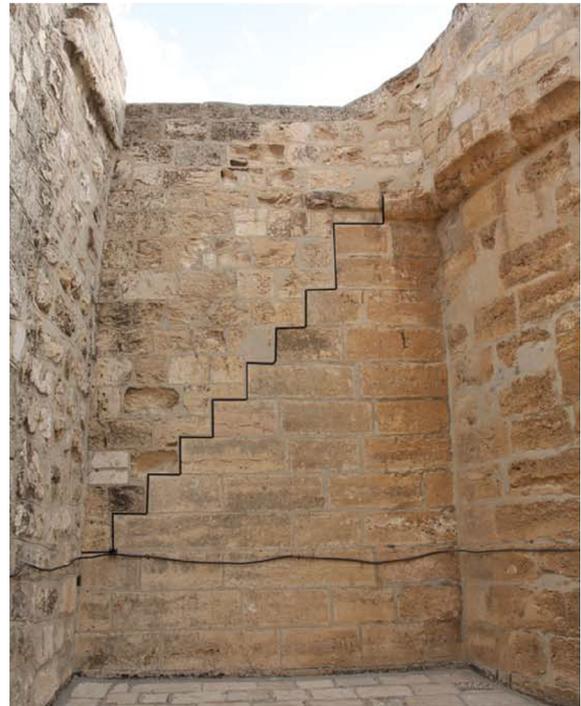
Fig. 18. Re-making of the wall of the North corner.

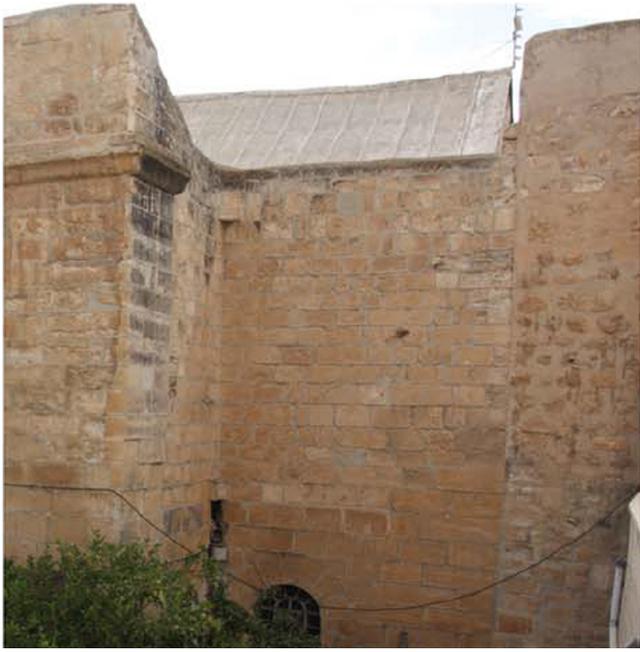
Even a buttress, added as a protection of the Western wall of the North transept, is a clear sign of some damage that occurred in that area in the past, Fig. 19.

Fig. 19. Buttress added as a protection of the Western wall of the North transept.

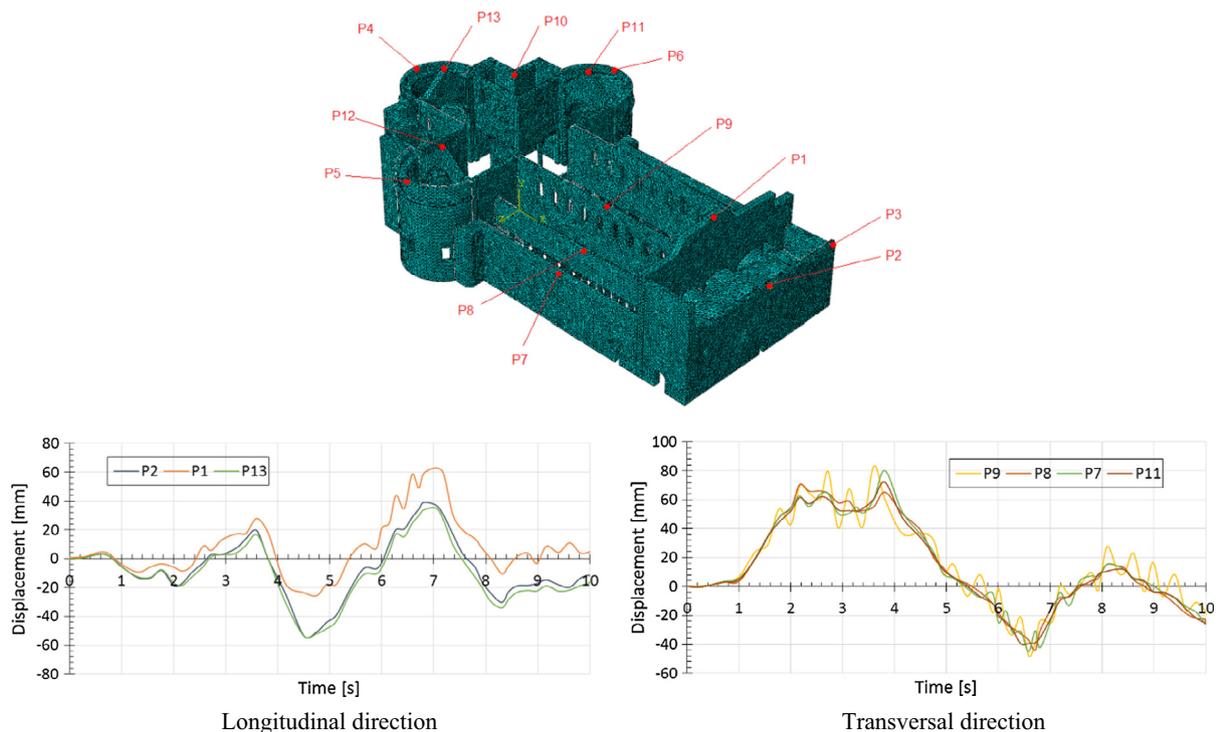
Fig. 20 indicates all the control nodes of the church model that were monitored during the numerical simulations. The same figure shows the horizontal displacement time history for some meaningful control nodes of the Church along both the longitudinal and transversal directions. In the longitudinal direction a maximum top displacement equal to 6 cm is computed at the top of the tympanum (control node P1) after about 7 s from the beginning of the ground motion. The stiffening presence of the internal walls of the narthex has the effect of reducing the out-of-plane rocking of the narthex façade during the application of the accelerograms. The maximum top displacement measured on the top of the narthex façade is about 5.5 cm, a value which is numerically far from the actual deformation level, but which suggests that the out-of-plane rocking of the front of the church could be the result of cumulated damage induced by different seismic sequences over the time (at least 4–5 moderate/high earthquakes occurred in the last 400 years in that area). The evolution of the kinetic and dissipated energy registered during the numerical simulation is shown in Fig. 21. Kinetic energy nullifies at the end of the simulations,

Fig. 20. Displacement time history of some control nodes along the longitudinal and transversal directions during the non-linear dynamic analysis.

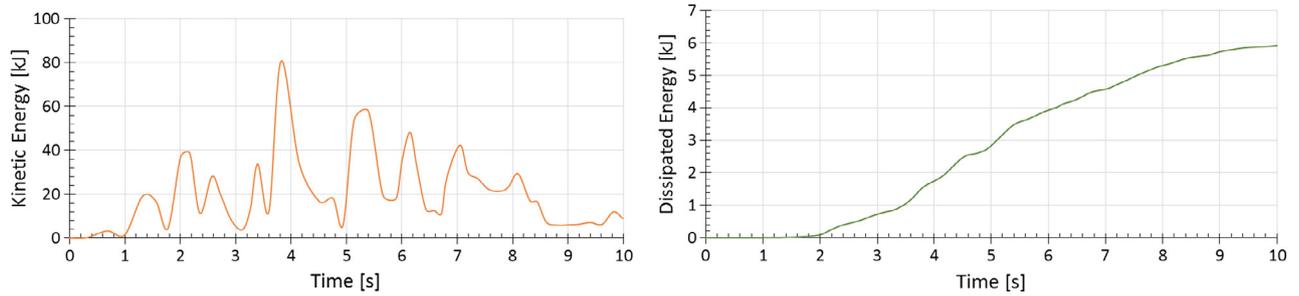
meaning that no failure mechanisms form in the model due to the application of the seismic excitation, whereas the dissipated energy is a clear indication that damage cumulates in some parts of the structure.

Fig. 21. Kinetic and dissipated energy time history diagrams.

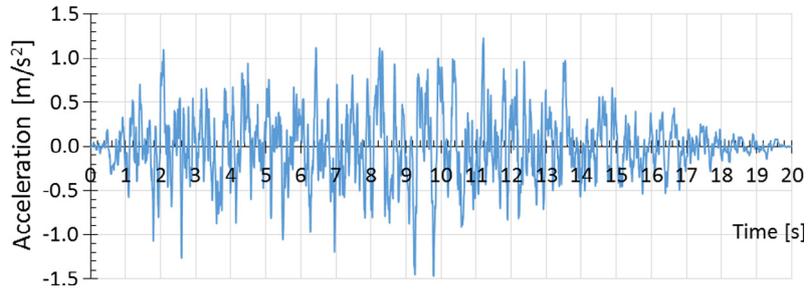
The finite element model was used to identify the possible different collapse mechanisms that can occur in the narthex. The ground motion applied in the longitudinal direction may cause significant horizontal relative displacements of the narthex façade with respect to the church façade, creating tensile stresses in the vault system. Consequently, the vault system may represent a critical element for the narthex and it is expected to undergo significant damage even at the beginning of the numerical simulation.

Fig. 22. Artificial accelerogram used for the non-linear dynamic analyses of the narthex.

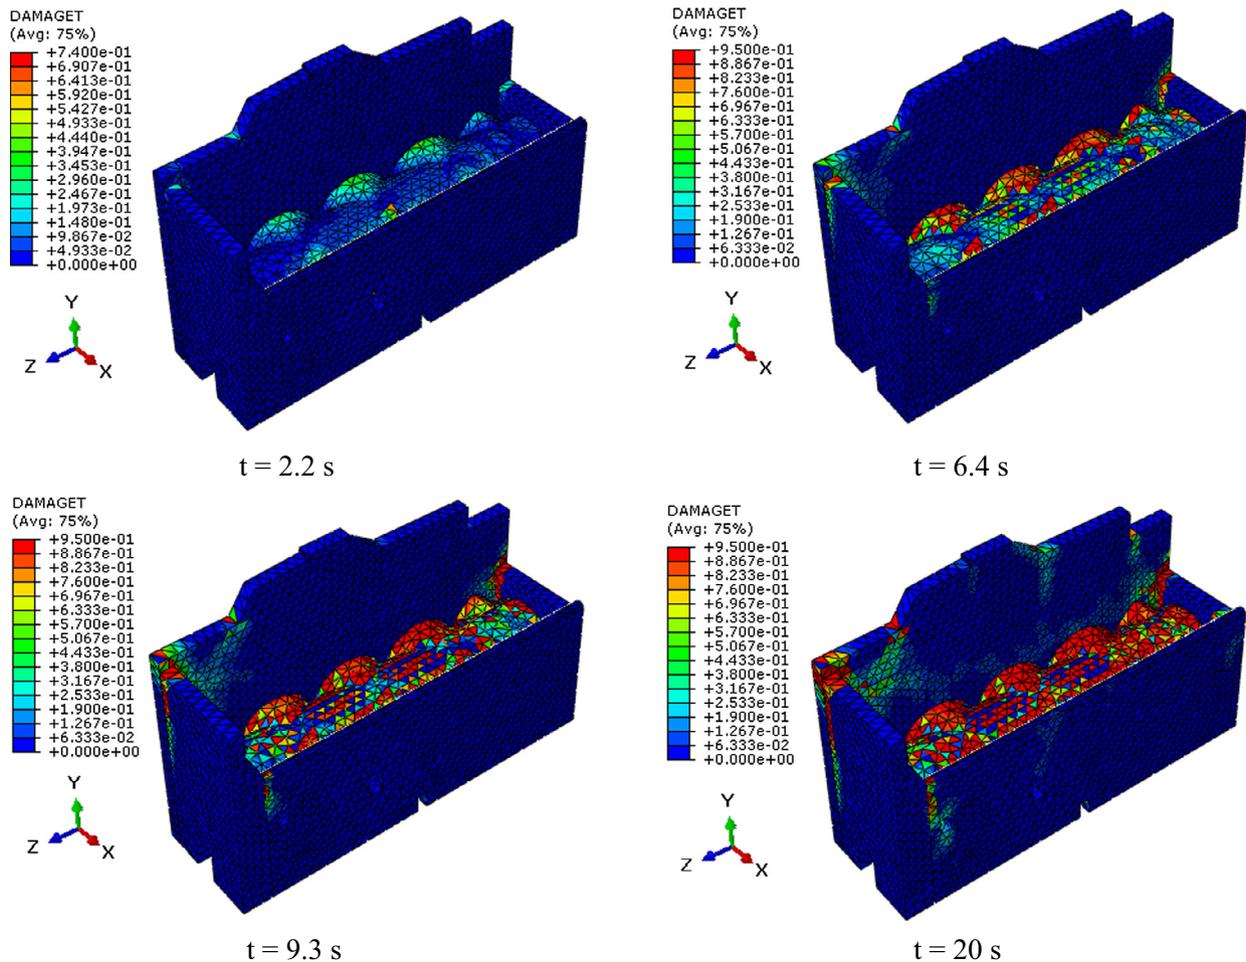
Figs. 23 and 24 describe the tensile and compression damage evolution, respectively, during the non-linear dynamic analysis. The results are reported at successive time instants (about 2.2 s, 6.4 s, 9.3 s) corresponding to the main acceleration peaks of the artificial accelerogram and at the end of the analysis (20 s). It can be noted that damage concentrates mainly in the cross vault system and, to a small extent, on both the façades. In particular, the tensile damage starts along the perimeter of the vault system and then propagates into the middle part involving the whole system.

Fig. 23. Contour plots of the tensile damage in the narthex at different time instants during the numerical simulation. (Red, 1: full damage; blue, 0: no damage.) (For interpretation of the references to colour in this figure legend, the reader is referred to the web version of this article.)

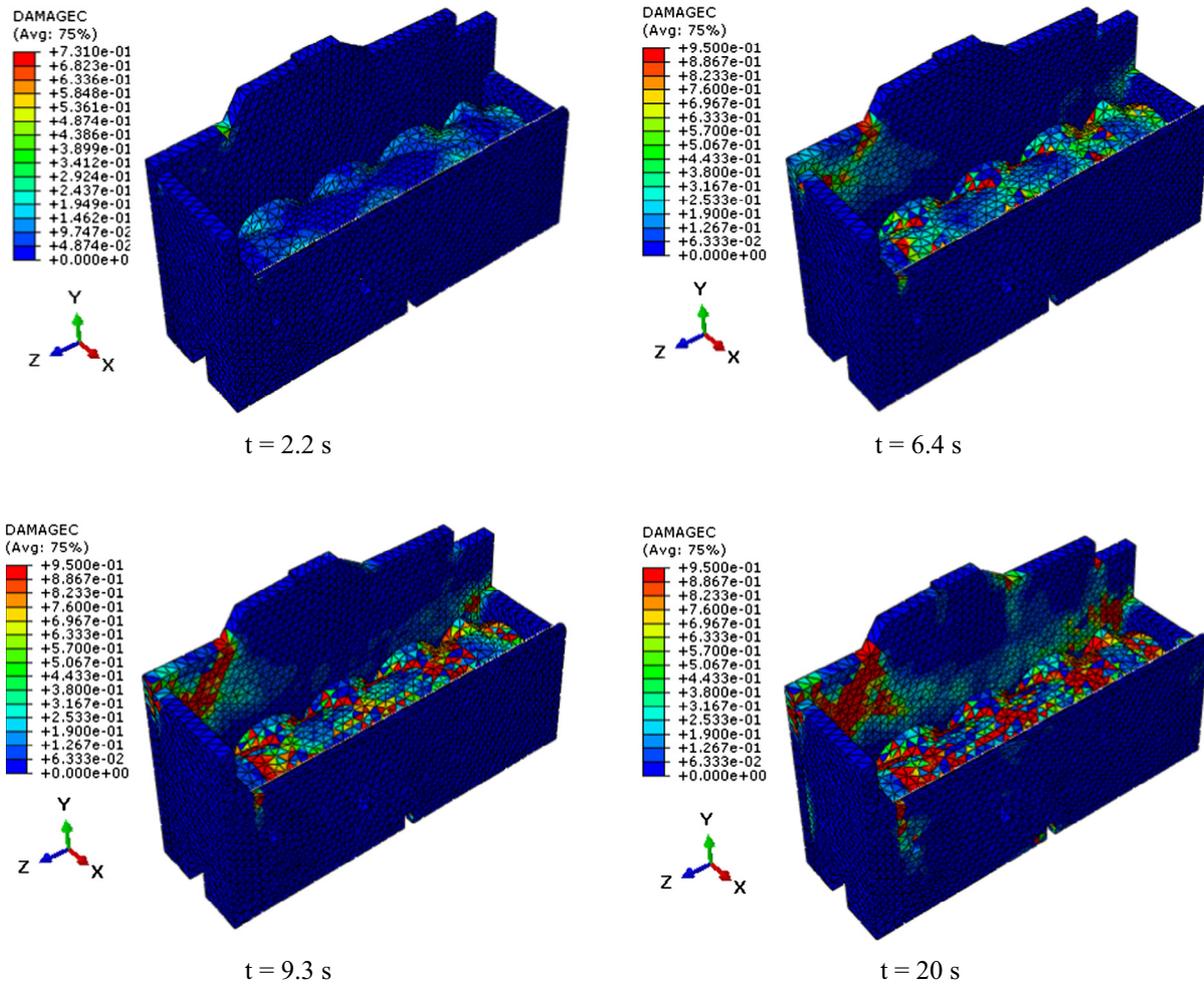
On the contrary, the compression damage starts at the top of the vault system and then propagates towards the perimeter. It can be noted that the interlocking of the longitudinal walls with the western façade of the Church tends to experience considerable

damage. The results are quite in agreement with the data surveyed, denoting wide detachments along the edges of the vaults, cracks at the extrados close to the perimeter and parallel to the façade, and cracks at the intrados, particularly concentrated in the central part.

Fig. 24. Contour plots of the compression damage in the narthex at different time instants during the numerical simulation. (Red, 1: full damage; blue, 0: no damage.) (For interpretation of the references to colour in this figure legend, the reader is referred to the web version of this article.)

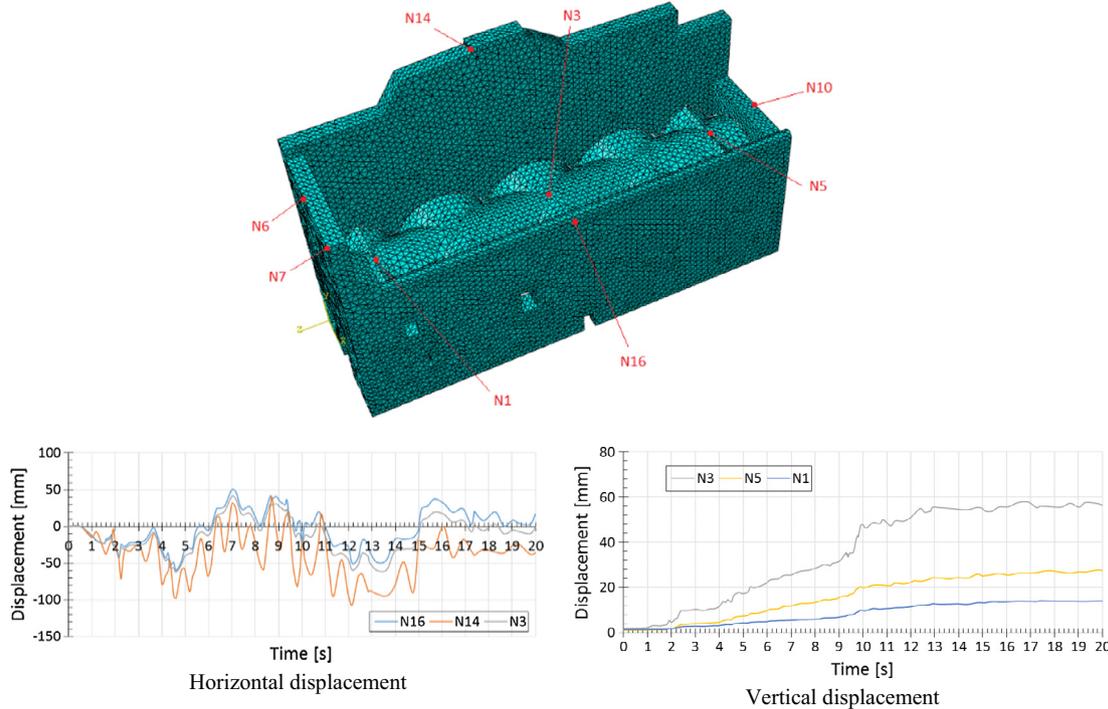
Fig. 25 indicates all the control nodes of the narthex model monitored during the numerical simulations. The same figure shows the horizontal and vertical displacement time histories for some meaningful control nodes located on the top of the narthex façade, of the tympanum and of the central and lateral cross vaults. The maximum horizontal displacement (about 10 cm) is observed

for the control node N14 at the top of the tympanum of the main entrance. The narthex façade exhibits a peak horizontal displacement equal to about 6 cm. As regards the vertical displacements, the maximum value, equal to 6 cm, is registered for the central vault.

Fig. 25. Displacement time-history of some control nodes during the non-linear dynamic analysis.

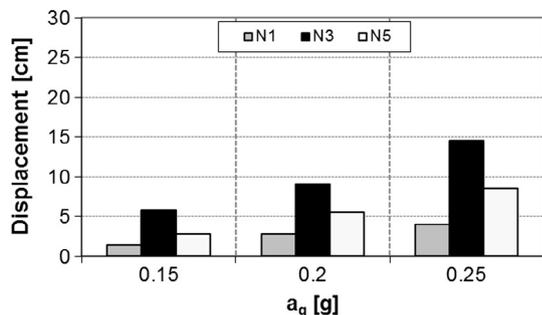
The maximum vertical displacements of the control nodes of the cross vaults are shown in Fig. 26 for different peak ground accelerations. As can be noted, the maximum vertical displacements of the central vault are always larger than those of the other vaults. For high values of seismic intensity levels ($a_g = 0.25$ g), the central vault presents a maximum value of vertical displacement equal to about 15 cm.

Fig. 26. Maximum vertical displacements of some control nodes for different peak ground accelerations.

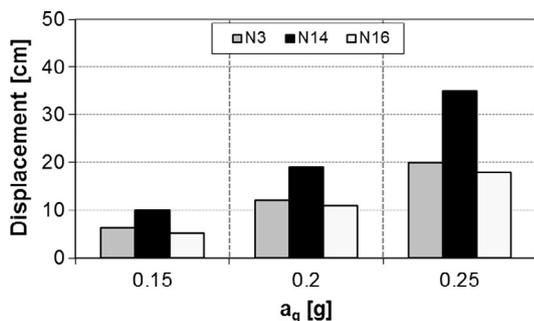
The maximum values of the horizontal displacement of three meaningful control nodes are shown in Fig. 27 for different peak ground accelerations. It can be noted that the peak values of the horizontal displacement of the narthex façade are always smaller than those of the top of the western façade tympanum. Under a seismic intensity level of $a_g = 0.25$ g the tympanum exhibits peak displacements equal to about 35 cm, whereas the maximum displacement registered for the narthex façade is about 20 cm.

Fig. 27. Maximum values of the horizontal displacement of some control nodes for different peak ground accelerations.

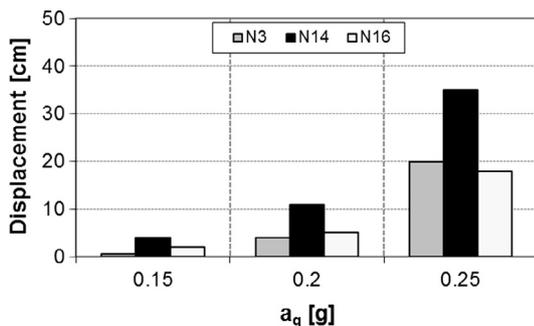
Non-linear dynamic analyses are able to provide, among other information, the residual displacements of the control nodes. Residual displacements are the permanent deformations of a structure that remain at the end of a seismic excitation. From the displacement time-history of a selected node, it can be deduced if significant residual displacements are present at the end of the numerical simulation. Typically, residual displacements are significantly lower than maximum displacements, but they can achieve significant values in the case of considerable damage. Moreover, large residual displacements can provide useful information on the damage level of the structure. Fig. 28 shows the maximum residual displacements computed at the end of the numerical simulations for different ground motion intensities. The maximum values of the residual displacements (35 cm) are registered for the western façade of the Church when subjected to seismic excitation with $a_g = 0.25$ g. As can be observed, the residual displacement found for the narthex façade is about 20 cm, still lower than the real ones, but indicating that a seismic event may be the cause of the present state of degradation. Probably, larger residual displacements might be achieved by simulating the occurrence of a sequence of ground motions, as confirmed by the chronicles of the earthquakes in that area.

Fig. 28. Residual horizontal displacements of some control nodes for different peak ground accelerations.
