2                   **ON THE DAMAGE MECHANISMS IN A CONTINUOUS CASTING MOLD:**

3                   **AFTER-SERVICE MATERIAL CHARACTERIZATION AND FINITE ELEMENT**

4                   **SIMULATION**

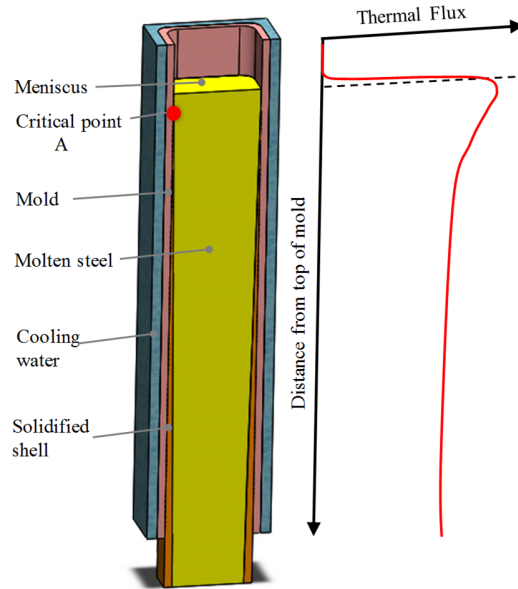
42 a high thermal gradient across the mold wall. This cyclic thermal loading promotes thermal fatigue cracks in the  
43 meniscus area, which is the most thermally-stressed and strained region of the mold.

Fig. 1. A mold under working conditions (half section) and axial thermal flux distribution when  $q=q_{max}$ .

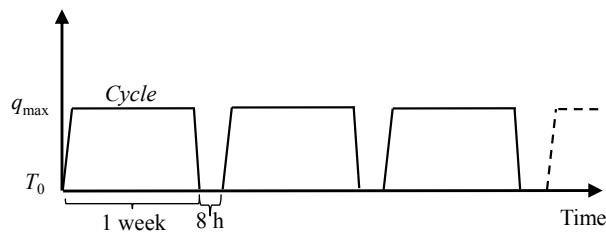
Fig. 2. Variation of the thermal flux during the service life of a mold.

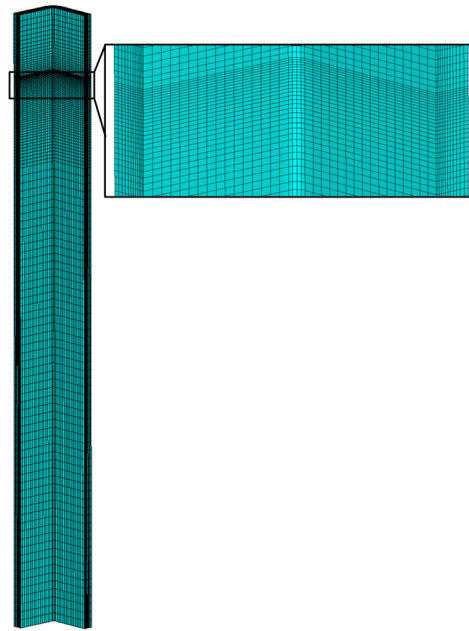
95 The thermal stress distribution occurring in the mold was studied with a thermo-mechanical analysis [4-7]. A  
96 three dimensional (3D) finite element model was required, due to the non-uniform distribution of the thermal flux  
97 through the mold length. Since the component has two planes of symmetry and is symmetrically loaded, only a  $\frac{1}{4}$   
98 model with suitable symmetry boundary conditions was considered in the analysis. The mesh was refined close to  
99 the meniscus where the maximum thermal gradient is expected, see Fig. 4.

Fig. 4. Finite element model.
