Compressor fouling detection by image analysis

A Suman, N Zanini, M Pinelli

Department of Engineering – DE, University of Ferrara, 44122 Ferrara, Italy

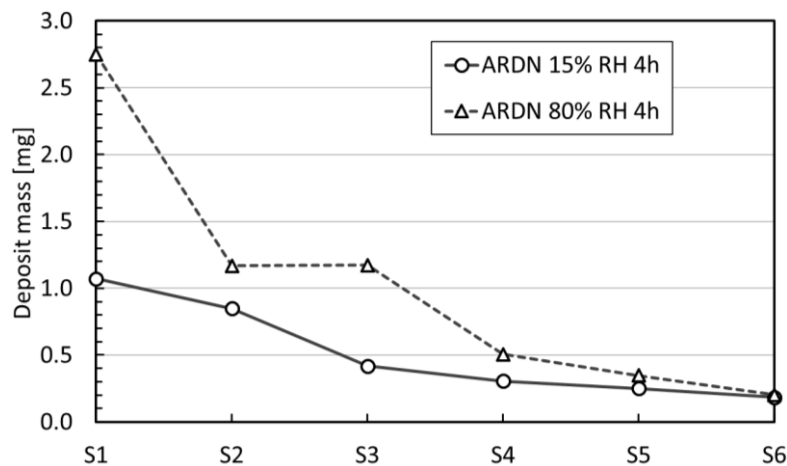
Figure 10 reports the mass of the deposits collected in correspondence to the pressure side of the stator vane surfaces. These quantitative measurements correspond to the same surfaces evaluated in Fig. 8. Comparing the analysis carried out by counting the pixel ratio and the collected mass, it can be concluded that the proposed measurement strategy allows an evaluation of the fouling phenomenon over the machine flow path. As can be seen from Fig. 10, front stages resulting from the high-humidity test are characterized by greater contaminant mass, similar to the results shown in Fig. 8. Image detection reveals the fouled area, and for this reason, comparing the deposited mass, some discrepancies could be detected. Looking at the aft stages, the deposited mass indicates that the relative humidity value does not affect the deposition process. By contrast, image detection shows greater contamination for the test with 80 % RH. In image detection, the deposited thickness is not detected, and a complete assessment of the deposited mass (i.e., volume) can not be assessed. The Shape From Shading (SFS) technique could represent a step forward in this sense. The SFS allows the obtainment of three-dimensional information starting from a two-dimensional detection. As shown in [37], this technique could be useful to estimate the deposit thickness even if, due to the mathematical constraints, the results have to be validated after a calibration procedure, reducing the applicability to on-field detection.

Figure 10. Mass deposits collected from the pressure side of the stator vanes
