Evaluation of the impact behaviour of AlSi10Mg alloy produced using laser additive manufacturing

Abstract

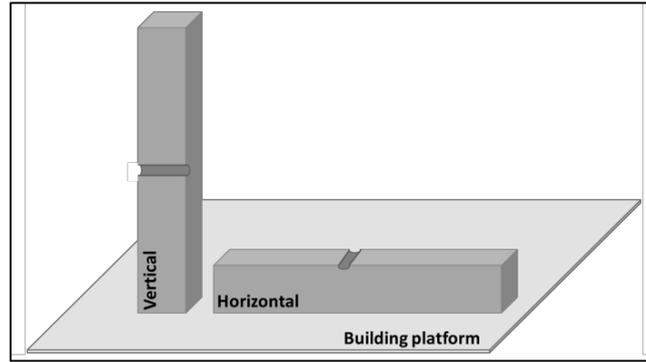
The AM specimens were produced in both horizontal (H) and vertical (V) directions (**Figure 1**) using Direct Metal Laser Sintering powder bed technology, with an EOS M290 system (400 W, Yb laser fibre; F-theta lens; 30 A and 400 V power supply; 7000 hPa, 20 m³/h inert gas supply; 100 µm focus diameter; EOS GmbH Electro Optical System [41]). Commercial EOS Aluminium AlSi10Mg powder was used and the process took place in argon atmosphere. The samples had a square cross section of 12 mm x 12 mm and a length of 57 mm.

Fig. 1. Diagram of the orientation of AM samples on the building platform in the additive manufacturing system.

After heat treatment, all the surfaces of the specimens were machined to the standard size of U-notched Charpy samples (10 mm x 10 mm x 55 mm) in accordance with ASTM E23 standard [50]. In **Figure 1**, the position of the U-notch is also shown for both horizontal and vertical samples.

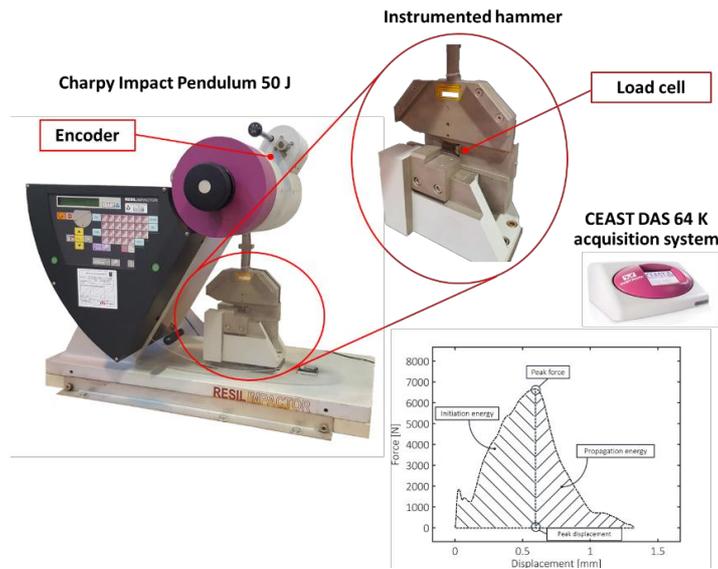
instrumented test requires that the samples, placed on the supports, are broken with a force that is measured by a load cell positioned directly on the hammer while the displacement is evaluated through an encoder. During impact, data were recorded by the CEAST DAS 64K and analysed by the Visual IMPACT software, which enabled the total absorbed energy of the impact to be computed as the area under the force-displacement curve. **Figure 2** shows a summary of the described facilities together with an example of force-displacement curve.

Fig. 2. Instrumented Charpy impact pendulum used for the impact tests.

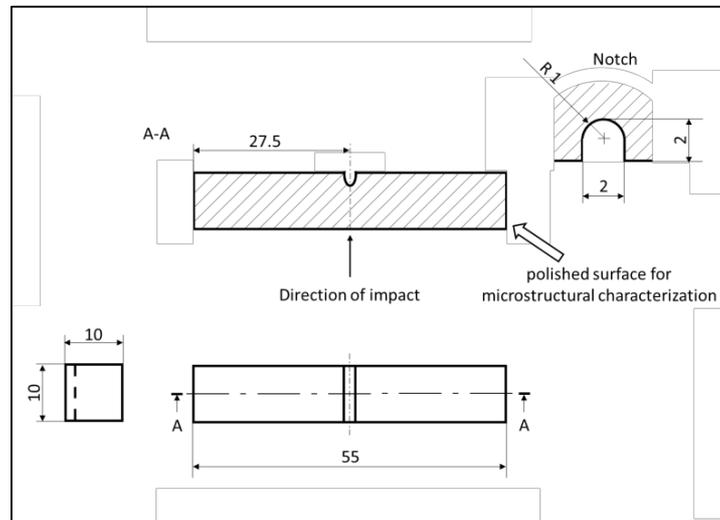
After Charpy tests, characterizations were performed using a Leica DMI 5000 M optical microscope to analyse the most important microstructural features and the fracture profiles. Microstructural investigations were carried out on metallographic sections cut out perpendicularly to the fracture surface, as reported in **Figure 3**. The specimens were polished up to mirror finishing. As-produced AM microstructure was observed after Keller etching (1 % HF, 1.5 % HCl, 2.5 %

Fig. 3. Diagram of sample geometry with indication of the surface observed for microstructural characterization.

The typical microstructure at high magnification of an as-produced AM sample (according to *Figure 3*) built both in horizontal and vertical directions is depicted in *Figure 5*. The SEM

In order to provide a detailed description of the impact behaviour of the studied materials, in accordance with *Figure 3*, the fracture profiles of sections perpendicular to the notch of AM samples in the as-produced condition were observed for both building orientations. In the AM samples the fracture mainly propagates through the hatch overlaps, which are the weaker possible path. In fact, the hatch overlap zone, compared to the inner region of the melt pool, is characterized by both a coarser microstructure and a high amount of Si which is no longer in solid solution in the α -Al phase, but instead segregated in the interdendritic regions [24, 33, 35, 60]. Both these features provide an easier path for crack propagation. From a mechanical point of view, for samples loaded perpendicularly to the layers, the fracture plane would be parallel to the layers themselves. Hence, in an attempt to keep itself as far as possible along this plane and, at the same time, along the weaker path (hatch overlaps), the fracture propagates through the interface between adjacent layers, as reported in various studies [30, 33, 35, 61]. This fracture path leads to the so-called layer-layer or inter-layer fracture, as reported in the sketch of *Figure 11*.

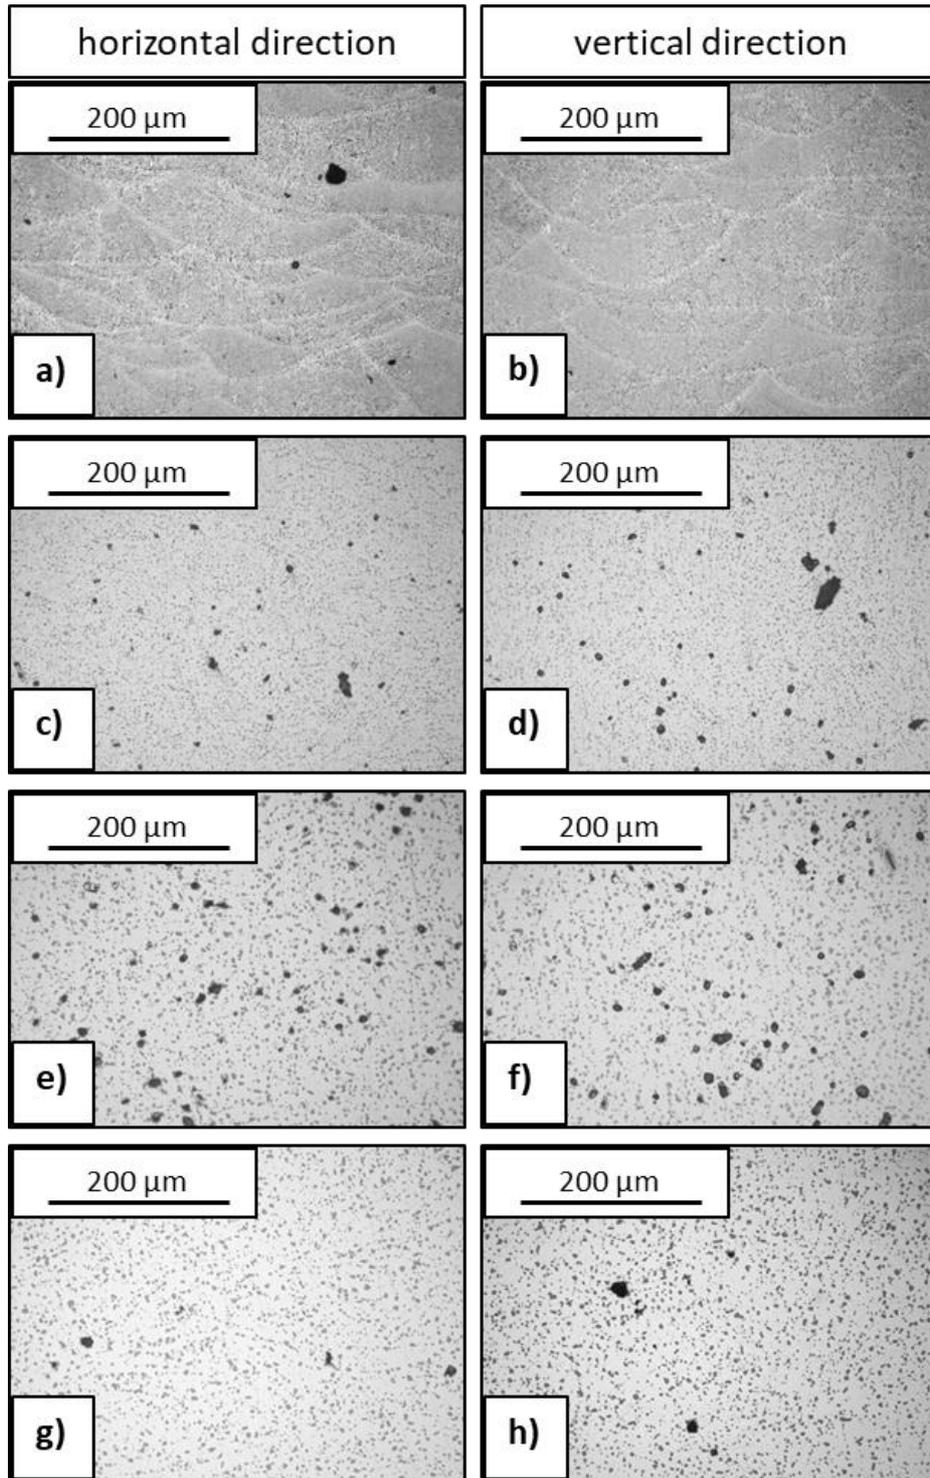
The typical AM pools, composed of semi-circular sections in the building direction, can be observed after Keller etching (**Figure 4a-b**). Small porosities were also detected along the specimens, in accordance with the analysis performed by many authors on AM products [17, 19, 46-48]. In particular, detailed analysis of the microstructures highlighted the fact that porosities are mainly located inside the melt pools, although sometimes they appear along the interface between adjacent scan tracks or at the boundary between consecutive layers. This is in accordance with the literature [48, 57]. In fact, as reported by Weingarten et al. [57], gas porosities that nucleate at the melting front, i.e. at the interface between the melting pool and the already solidified underlying substrate, can easily escape from the melt pool surface. On the other hand, pores due to gas entrapment that nucleate near the solidification front, do not have enough time to escape prior being entrapped by the solidification front itself. Thus, they will remain in the inner part of the melt pool or at its sides, i.e. at the track-track interfaces. Only rarely do they appear at the inter-layer interfaces.

After T6 treatment (**Figures 4c-f**) a coarsening of Si particles can be detected. Moreover, the melt pool boundaries that characterize the as-produced AM samples (**Figures 4a-b**) cannot be identified at the considered magnification, due to an almost complete loss of the cellular microstructure after heat treatment. In addition, a considerable increase of gas porosity is observed.

The HIP treatment, performed before the solution treatment, considerably affects the microstructure (**Figure 4g-h**) leading to a significant porosity reduction.

Fig. 4. Micrographs of AM samples in (a, b) as-produced, (c, d) 540°C 1h - 180°C 2h, (e, f) 540°C 9h - 160°C 4h and (g, h) hip - 540°C 9h - 160°C 4h conditions, in (a, c, e, g) horizontal and (b, d, f, h) vertical orientations.

On the contrary, no evident variations in density are observed for GC samples in the different tested conditions, as also confirmed by the microstructural analysis (**Figures 4e-f** vs **Figures 6c**).

For the samples in the as-produced condition, no significant difference in the peak force can be detected for the two building orientations. This may be due to the very similar cellular microstructure which characterizes both samples in horizontal and vertical orientations (see **Figures 4a-b**), as well as to the absence of a pronounced texture. In fact, it has been reported [31] that using a non-monodirectional scanning strategy enables a reduction in the texture index of the material, resulting in almost isotropic strength. On the other hand, there is a small difference in the peak displacement and the curve for vertical samples falls to zero-force value in a shorter displacement range than that for the horizontal samples. This results in slightly higher values of initiation and propagation energy for horizontal samples as compared to vertical samples, suggesting a different deformation mechanism. Fractographic evaluations, which are discussed in the following section, are required to analyse the crack propagation and the failure mode in the two cases.

inside the melt pools. In fact, as previously shown in *Figures 4a-b* for the as produced samples, it appears that the gas pores tend to be mainly located inside the melt pools and along the inter-track interfaces, rather than on the inter-layer interfaces. In the light of the previous discussion, this means that the fracture front will more probably encounter a gas pore along the fracture path of the horizontally oriented samples. Nevertheless, since in the as-produced condition the size of gas pores is quite small, there is no evident poisoning effect on the energy absorbed by the horizontally built samples as compared to the vertically built ones. Conversely, after the heat treatment, the swelling of gas pores increases the fraction of voids that the crack encounters along its path, reducing the absorbed energy to a greater extent for horizontal samples.

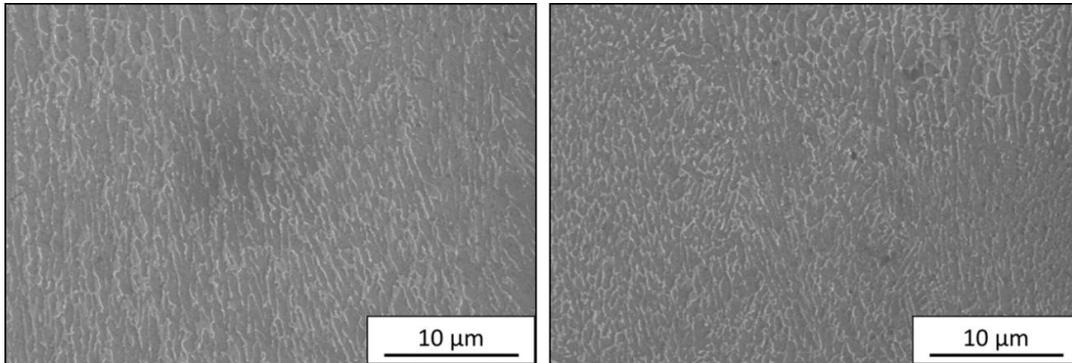
micrographs show a microstructure characterized by very fine α -Al cellular grains and by superfine Si particles at the edges [1, 27, 58].

Fig. 5. SEM microstructure of as-produced AM sample in (a) horizontal and (b) vertical orientations.

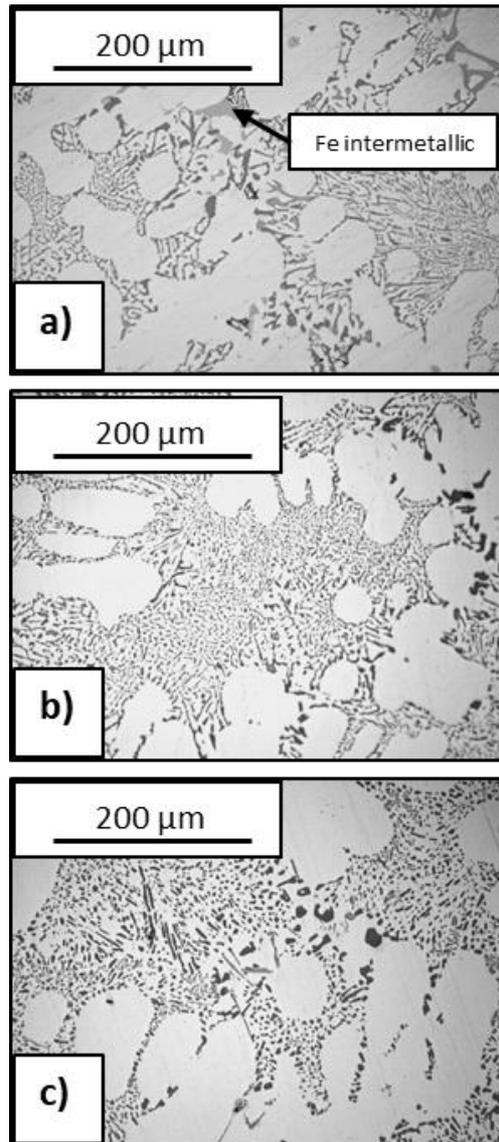
Concerning the cast samples, as-produced GC microstructure (**Figure 6a**) is characterized by the typical α -Al dendritic phase (light grey) surrounded by the eutectic structure. Fine eutectic Si lamellae are clearly visible. In addition, some coarse Fe-rich intermetallics were detected, while porosities were seldom found. The spheroidization of the eutectic Si particles during solution treatments is visible in **Figures 6b-c**, even though some small Si lamellae are still present.

Fig. 6. Micrographs of GC samples in (a) as-produced, (b) 540°C 1h - 180°C 2h and (c) 540°C 9h - 160°C 4h.

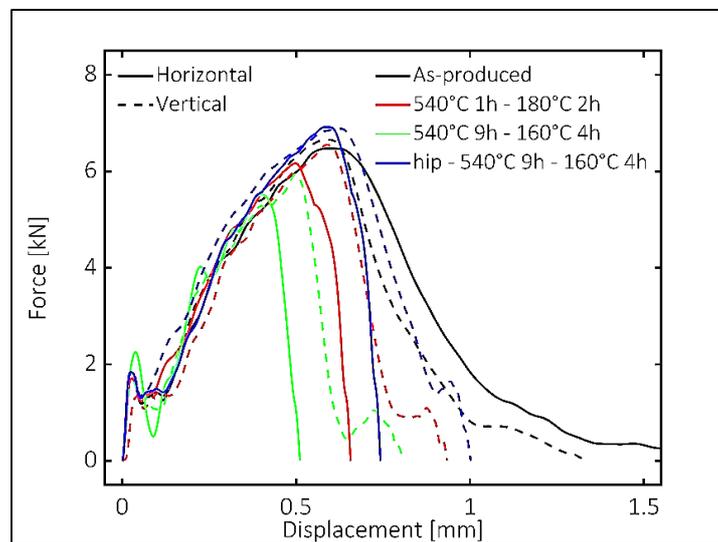
In **Figure 7**, representative force-displacement curves are shown for each investigated condition of the AM samples, while the mean values and standard deviations of peak force, peak displacement, initiation energy and propagation energy are summarized in the graphs of **Figure 8**.

Fig. 7. Force-displacement curves from Charpy impact tests for AM samples in all investigated conditions.

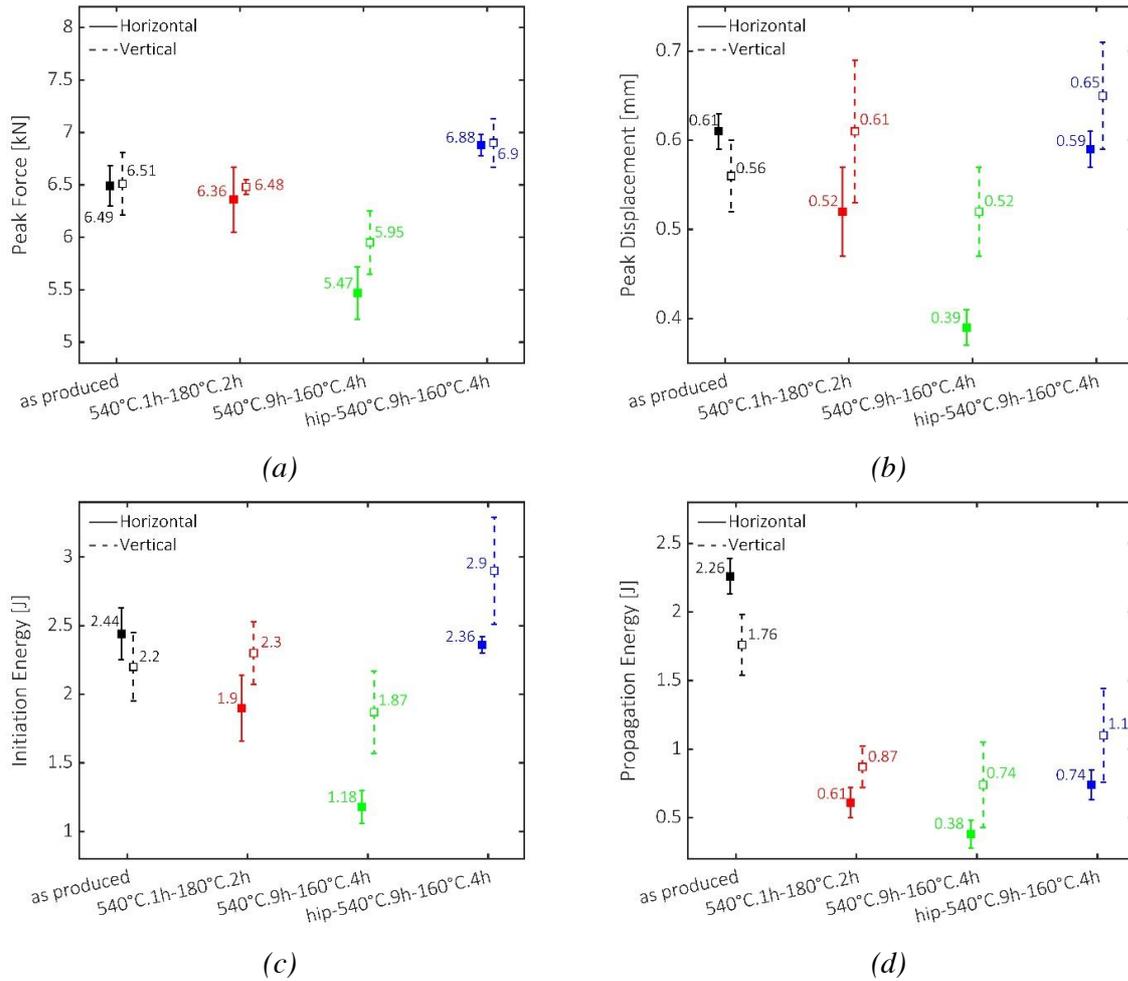
Fig. 8. Parameters from impact test for the AM samples: (a) peak force, (b) peak displacement, (c) initiation energy and (d) propagation energy. Labelled points are the mean values and deviations are showed as error bars.

The considered T6 treatments appear not to enhance the mechanical properties of the material, since peak force (*Figure 8a*) and impact energies (*Figures 8c-d*) are comparable or even lower than in the as-produced condition. As concerns the alloy in the 540°C 1h - 180°C 2h condition, no significant differences in the peak force (*Figure 8a*) and initiation energy (*Figure 8c*) are detected as compared with the performance of as-produced samples, despite the different microstructure obtained after heat treatment (*Figure 4*). On the other hand, the propagation energy of samples in this and in the other heat-treated conditions is lower than in the as-produced sample. This is probably due to the change in microstructural feature after heat treatment, including the precipitation of the Mg₂Si reinforcing phases and segregation of super-saturated Si, as well as the enlargement of the gas pores [24, 28, 35]. All these phenomena could contribute to a reduction in deformation capability of the heat-treated material.

On the other hand, for AM samples loaded parallel to the layers, the fracture plane would be perpendicular to the layers themselves. Conversely, with the previous case, the fracture path therefore involves different hatch overlaps regions, leading to a mixed inter-track/inter-layer fracture. In addition, the fracture can also advance through the track core, leading to a trans-track fracture. In accordance with the literature [30, 33, 35, 61], in the horizontally built samples tested in this study (**Figure 12b**), the fracture involves both the interface between adjacent tracks or layers and the core of the tracks themselves, resulting in a mixed fracture mechanism, but preferentially a trans-track path. It is worth noticing that the crack path of vertical samples in as-produced condition would be relatively flat due to the flatness of the inter-layer hatch overlaps. On the contrary, the mixed fracture mechanism of the horizontal samples leads to a more tortuous crack path. This means that the vertical samples are able to accommodate lower deformation compared to the horizontal samples [33, 35], which may explain their smaller peak displacement values (**Figure 8b**). On the other hand, no anisotropy was detected in the peak force, probably because of the non-monodirectional scanning strategy which reduces the possible texture of the alloy [35]. Therefore, the different fracture path seems also to be responsible for the lower initiation (**Figure 8c**) and propagation energy (**Figure 8d**) of the vertically oriented samples as compared to the horizontal ones.

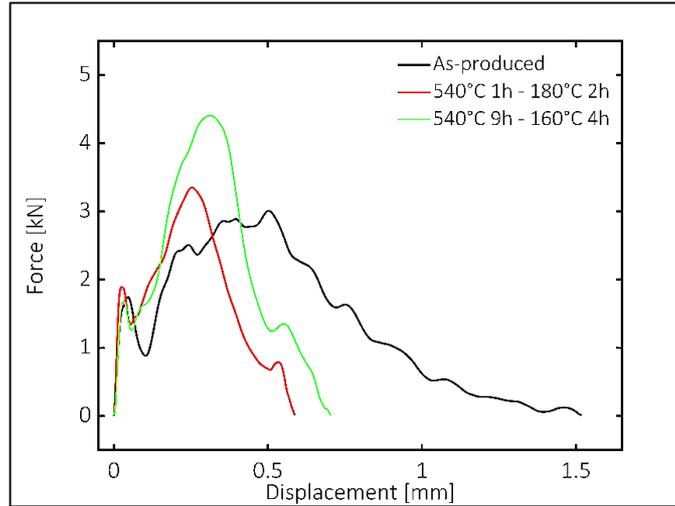
In order to evaluate the different microstructures and fracture mechanisms, tests were also performed on samples produced by GC. *Figure 9* displays the representative force-displacement curves for the GC samples, under all test conditions. All the parameters calculated from the Charpy impact tests are summarized in *Figure 10*.

Fig. 9. Force-displacement curves from Charpy impact tests for GC samples under all investigated conditions.

The peak force (*Figure 9*) for the alloy under the as-produced condition is lower compared to the others, implying lower mechanical properties. At the same time, the whole curve appears flatter, involving a greater range of displacements than for the GC heat treated ones and thus a higher amount of energy absorbed (*Figures 10c-d*), before and after the beginning of the fracture.

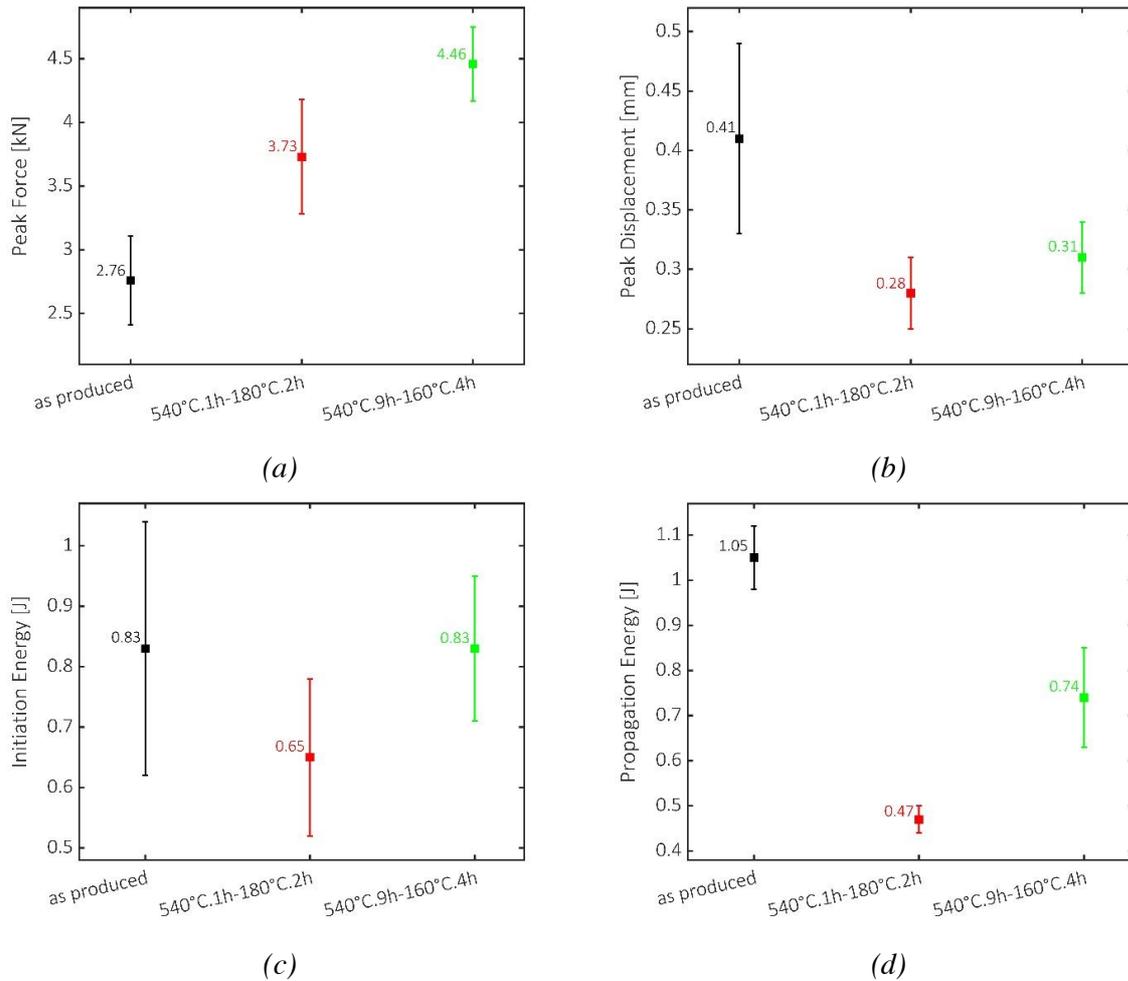
Fig. 10. Parameters from impact test for the GC samples: (a) peak force, (b) peak displacement, (c) initiation energy and (d) propagation energy. Labelled points are the mean values and standard deviations are showed as error bars.

Taking into account the alloy in the 540°C 9h - 160°C 4h condition (**Figures 18e-f**), there is a visible combination of the previously described failure mechanisms, since either the inter-dendritic fracture of α -Al dendrites or the cleavage of eutectic grains appears on the fracture surface. In addition, at higher magnification, the more ductile behaviour of the alloy compared to the others can be detected. In fact, many large-dimples areas are visible on the surface, meaning that the 9 h heat treatment led to improved spheroidization of the Si particles. This promotes alloy deformation, leading to a higher amount of the energy absorbed up to fracture (**Figure 10d**). The different

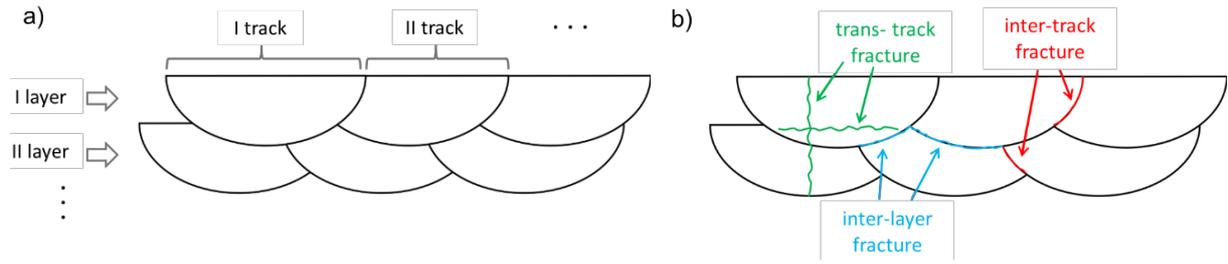
Fig. 11. Diagram of the fracture mechanisms

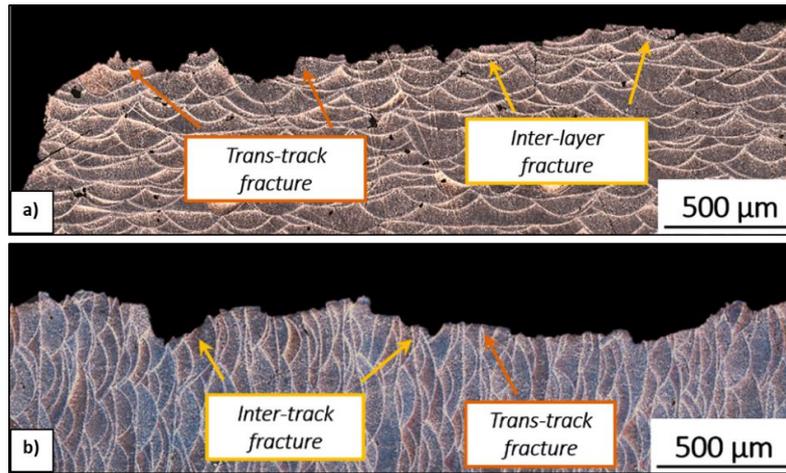
Such behaviour conforms to our vertically built samples (**Figure 12a**) even if sometimes the crack can also propagate through the inner part of the melt pool, causing a trans-track fracture. However, this mechanism is less commonly detected.

Fig. 12. Fracture profiles for AM samples in as-produced condition, perpendicular to the notch, in (a) vertical and (b) horizontal orientations.

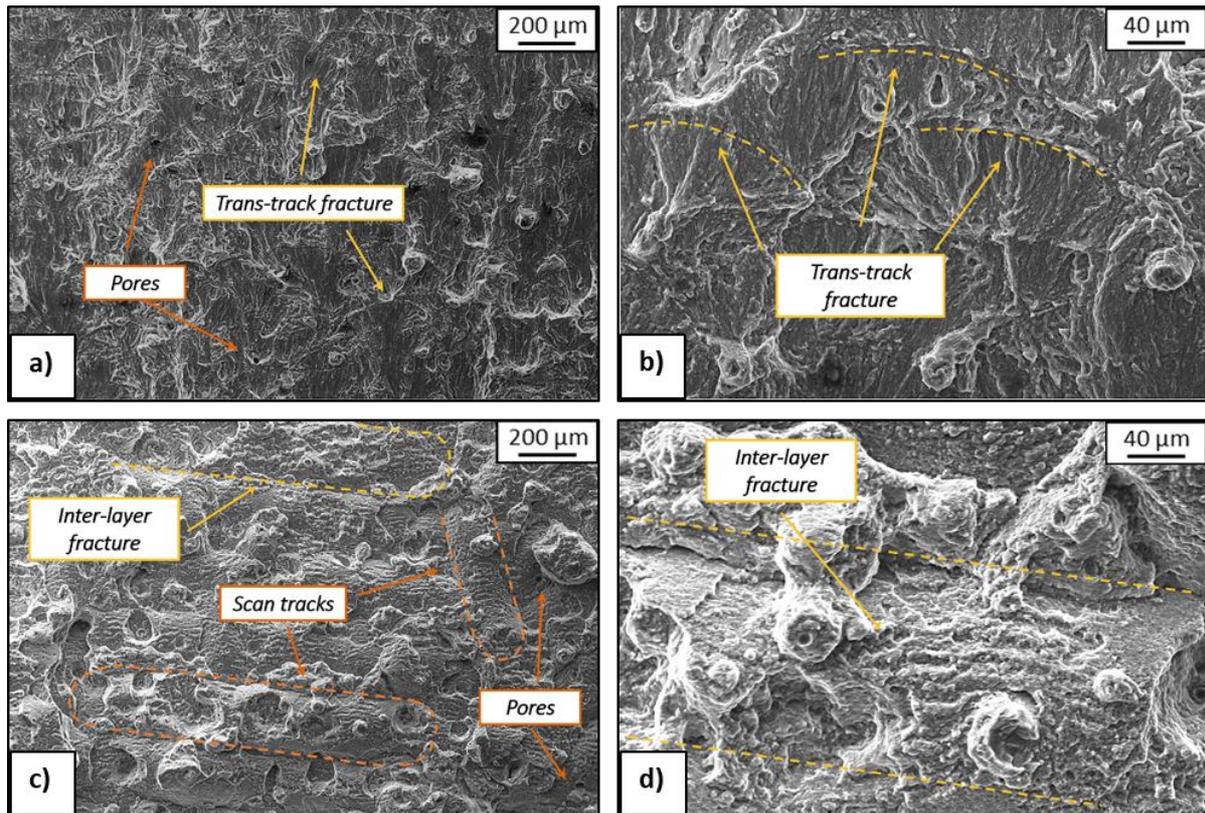
Figure 13 shows the fracture surfaces of samples in as-produced condition for both horizontal and vertical orientations. The fracture surface of horizontally oriented samples (**Figure 13a**) is characterized by a ‘step-like’ morphology, with the presence of many variations in depth of the fracture plane together with other flatter areas. This can be attributed to a mix of inter-track and trans-track paths. The former enables the crack front to move both upward and downward with respect to the nominal fracture plane. The latter leaves on the fracture surface the characteristic semi-circular traces corresponding to the scan tracks, also detectable at higher magnification in **Figure 13b**. Some pores are also evident on the fracture surface (**Figure 13a**).

Figures 13c-d show the fracture surface of the vertically orientated sample. Some small pores can be also detected in this case, but the overall aspect of the fracture surface is quite different and clearly flatter as compared to the previous one. In fact, given the inter-layer fracture path, some semi-cylindrical traces, corresponding to scan tracks detached during fracture propagation, are visible. Observation of these features also reveals the original scanning strategy.

Fig. 13. Fracture surface for AM samples in as-produced condition, in (a, b) horizontal and (c, d) vertical orientations, at different magnification.

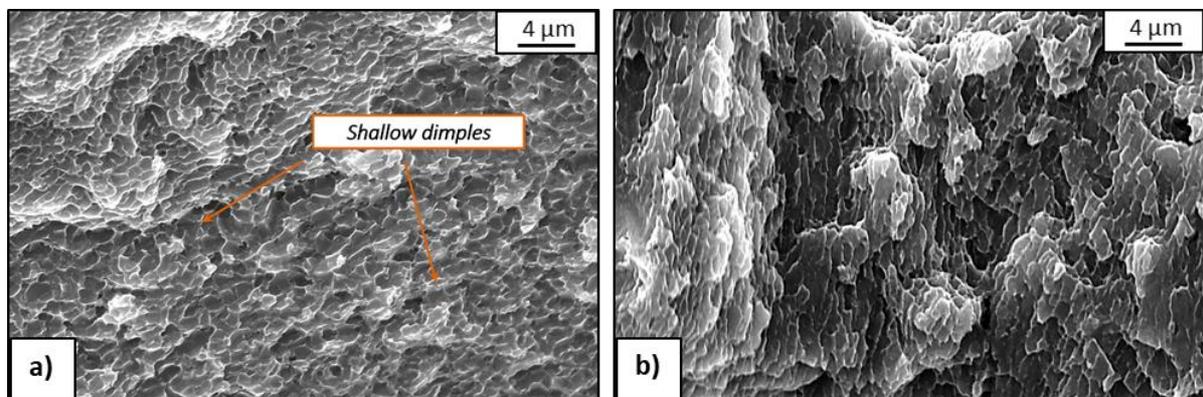
At higher magnification (**Figure 14**), it is possible to detect a micro-dimples structure, with a very shallow morphology [62-63], and thus quite different from that typical of a cast alloy. The presence of this feature indicates a ductile behaviour for the alloy and thus a reasonable amount of energy absorbed during fracture.

Fig. 14. Fracture surface for AM samples in as-produced condition, in (a) horizontal and (b) vertical orientations, at high magnification

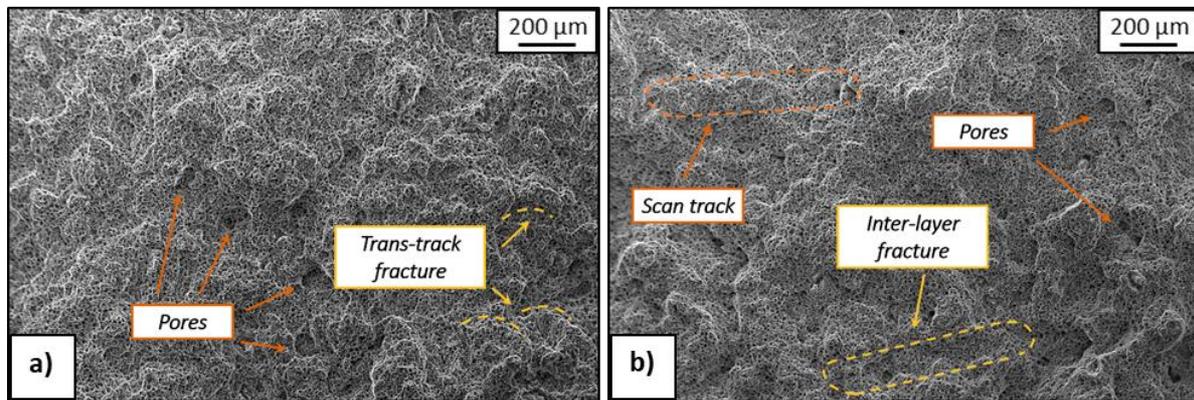
Figure 15 shows the fracture surfaces of samples in 540°C 1h - 180°C 2h condition, for both horizontal and vertical orientations. In comparison with the as-produced samples, after heat treatment, the typical features of the AM fracture surfaces are barely detected. This is because the heat treatment causes the spheroidization of Si particles, thus leading to a rough appearance of the fracture surface. In addition the heat treatment causes also the enlargement of the gas pores and the interdendritic segregation of super-saturated Si, no longer merely in hatch overlap regions, as in the as-produced condition, but also in the inner region of the melt pool. Both these outcomes cause the crack to deviate easily from its usual path, contributing to the formation of such an irregular surface. Nevertheless, some of the above-mentioned features, namely trans-track as well as some inter-layer fracture paths and scan lines, are still discernible in horizontal and vertical orientations, respectively.

As shown in *Figures 15a-b*, both horizontal and vertical samples exhibit a ductile fracture mode, as suggested by the presence of dimples.

Fig. 15. Fracture surface for AM samples in 540°C 1h - 180°C 2h condition, in (a) horizontal and (b) vertical orientations.

The microstructural changes induced by the heat treatment, i.e. the fragmentation and spheroidization of Si particles, as well as the formation of larger gas pores, could cause the fracture to deviate from its usual path, as previously observed in **Figure 15a**.

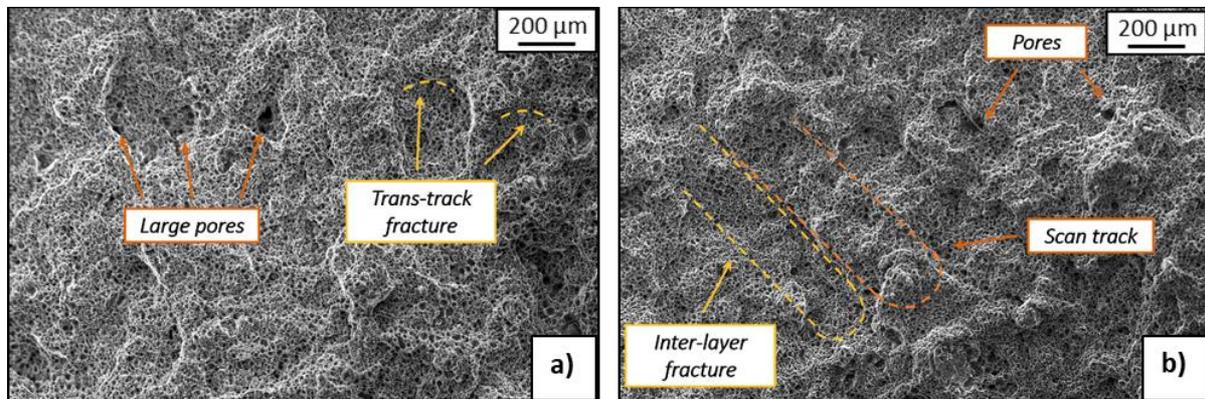
Figure 16 shows the fracture surfaces of samples in 540°C 9h - 160°C 4h condition, for both horizontal and vertical orientations. As in the previous case, some typical features of the as-produced condition are still detectable, as well as the higher number of gas pores emerging on the surface of horizontally oriented samples. In any case, as compared to samples subjected to 1h-lasting treatment, the unevenness of the fracture surface further increases. As reported above, this is probably due to the longer duration of the heat treatment, which promotes further swelling of both the Si particles, leading to the larger dimples detectable on the surfaces in *Figure 13*, and the gas pores, facilitating possible large deviations in the crack path. The enlargement of the gas pores clearly visible in *Figure 16* conforms to the density analysis shown in *Table 3* where, among the considered samples, the sample in the 540°C 9h - 160°C 4h condition has the lowest value. Since no other remarkable differences were highlighted in comparison with the previous case, the swelling of the gas pores is recognized as the main cause for the worsening of the impact properties in the case

of long-time treated alloy. In fact, it reduces the bearing section area of the specimens and creates very favourable sites for crack propagation, resulting in the further decrease of peak force, initiation energy and propagation energy respectively.

Fig. 16. Fracture surface for AM samples in 540°C 9h - 160°C 4h condition, in (a) horizontal and (b) vertical orientations.

This suggests that the fracture behaviour of the heat-treated samples is not significantly different from that of as-produced ones. Despite this, both initiation and, even more so, propagation energy decrease after heat treatment. Although not directly observable on the fracture surfaces, it has been already shown that heat treatment causes both the segregation of Si from aluminium phase [24, 28, 35, 60] and the precipitation of strengthening Mg₂Si intermetallic compounds [24, 28]. These occurrences, together with the swelling of the gas pores detectable on the fracture surfaces in **Figure 16**, could explain the reduction of absorbed energy.

This suggestion may also explain the additional increase in the fractal dimension in the case of the 9 h - treated alloy, which exhibits larger dimples and gas pores on its fracture surface, as shown in **Figures 16a-b**. The fractal dimension does not change after HIP. This can be explained by considering the fracture surfaces in **Figure 18**. In fact, even though the HIP treatment caused a reduction of most of gas and lack-of-fusion pores, several smaller pores are still detectable on the surfaces. Such small pores together with the spheroidization of Si, contribute to the fractal dimension remaining comparable to the 9 h - treated alloy. It is worth noting that, for each alloy condition, the fractal dimension of the horizontally built specimens is always higher than for the vertically built ones. Since in the as-produced condition this can be explained by the different fracture path in the two cases, it suggests that, in the heat-treated samples, the main fracture path remains the same, even if it sometimes deviates from its usual path.

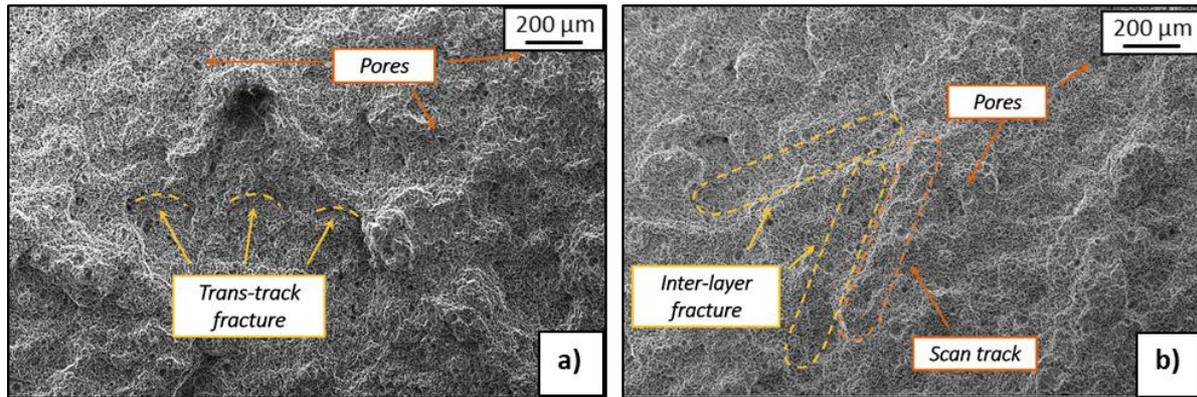
In **Figure 17**, the fracture surfaces of samples in HIP - 540°C 9h - 160°C 4h condition, for both horizontal and vertical orientations, are shown. The overall unevenness of the surfaces is comparable to that of the alloy in the 540°C 9h - 160°C 4h condition, whose larger gas pores are however no longer visible, suggesting that the HIP treatment successfully led to their enclosure. Detailed analysis of the fracture surfaces of these samples highlights the fact that the main difference with regard to the specimens that underwent different heat treatments is the nearly total absence of large gas pores, even if some very small pores are still detectable in both samples. In the light of these observations it could be suggested that the enhancement of impact properties of HIP-treated samples is therefore mainly related to the disappearance of the previously observed gas pores. It is worth noting that, even if both the peak force and the initiation energy benefit from the HIP process, thanks to the recovery of the bearing section area, this is no longer valid for the propagation energy. In fact, it remains largely lower than in the as-produced condition, because of the embrittlement effect of both the precipitation strengthening of the Mg_2Si and the interdendritic segregation of Si.

Fig. 17. Fracture surface for AM samples in hip - 540°C 9h - 160°C 4h condition, in (a) horizontal and (b) vertical orientations.

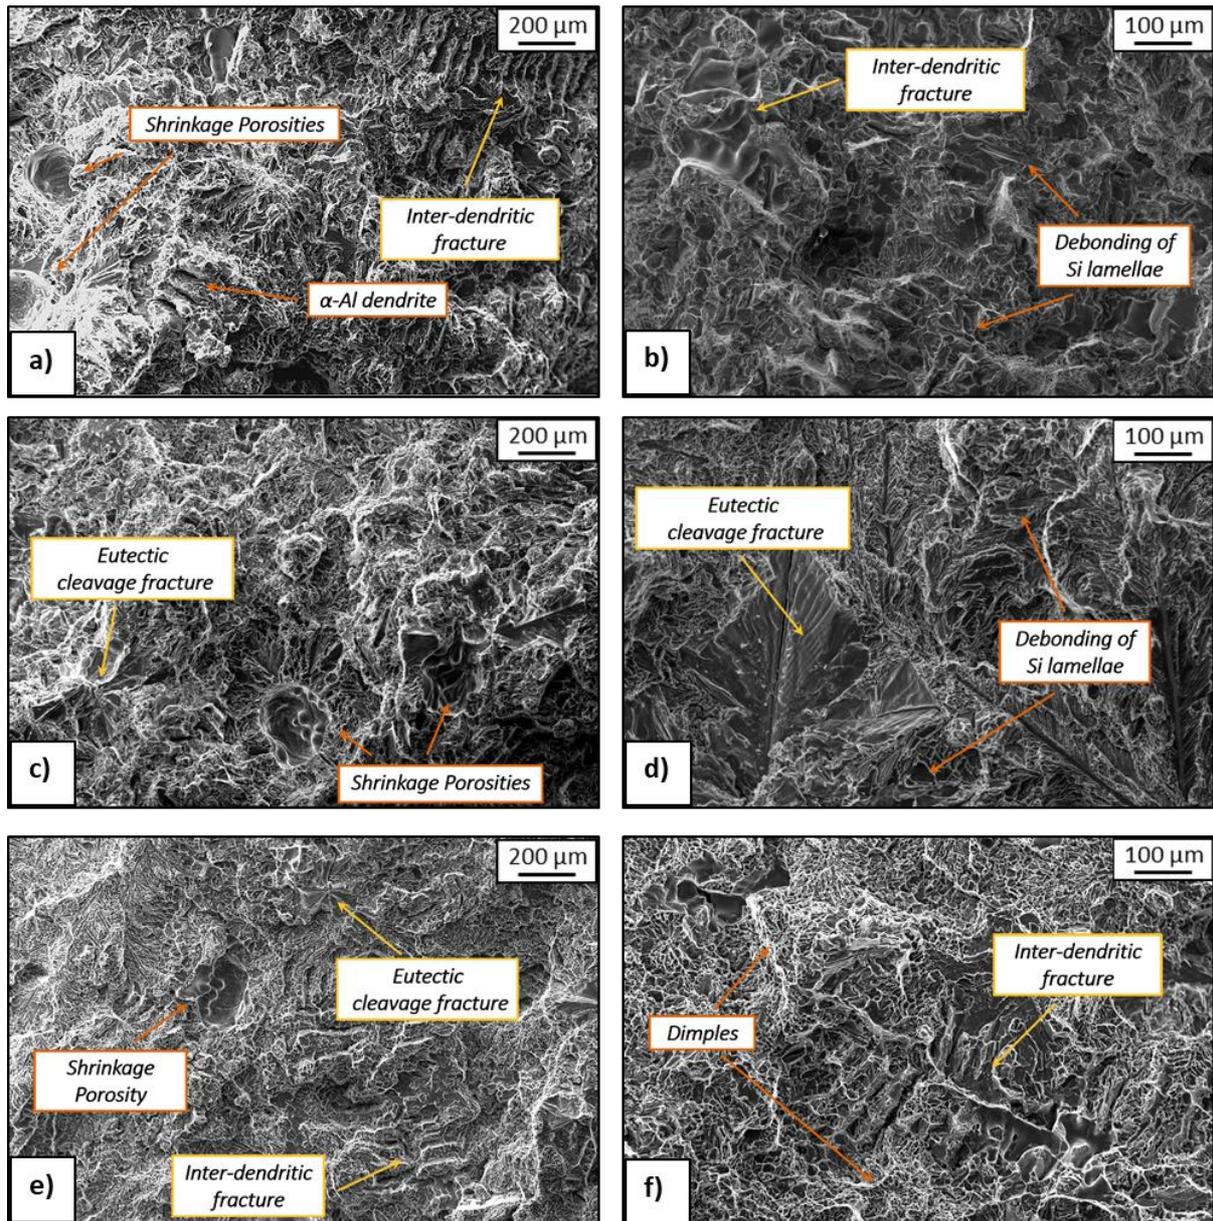
Figure 18 shows the fracture surfaces of the GC samples. In the as-produced condition (**Figures 18a-b**), fracture occurs mainly at the interface between the primary α -Al dendrites, sometimes detectable on the fracture surface, and the eutectic phase, leading to an inter-dendritic fracture mode. In addition, shrinkage porosities, including the emerging tips of the dendrite arms, are visible on the fracture surface. At higher magnification (**Figure 18b**), the debonding of the aluminium phase from the platelet-like Si particles can be detected. Besides this, the overall aspect of the fracture surface is clearly ductile, thus explaining the high amount of energy absorbed before and after fracture.

Considering the alloy in the 540°C 1h – 180°C 2h condition, the precipitation of the reinforcing intermetallic compounds strengthens the aluminium phase and makes it more prone to cleavage, as detectable in **Figures 18c-d**, where some eutectic grains appear to be fractured along specifically oriented planes. The embrittlement of the material due to the ageing treatment seems therefore to be responsible for the decrease in initiation energy and even more so in propagation energy as compared to the as-produced condition (**Figure 10c-d**). In addition, the presence on the fracture surface of some Si particles still exhibiting lamellar morphology suggests that they have not undergone complete spheroidization during the 1h heat treatment. Such evidence could reasonably explain the lower amount of absorbed energy compared to the other heat-treated condition.

Fig. 18. Fracture surface for GC samples in (a, b) as-produced, (c, d) 540°C 1h - 180°C 2h and (e, f) 540°C 9h - 160°C 4h conditions, at different magnification.

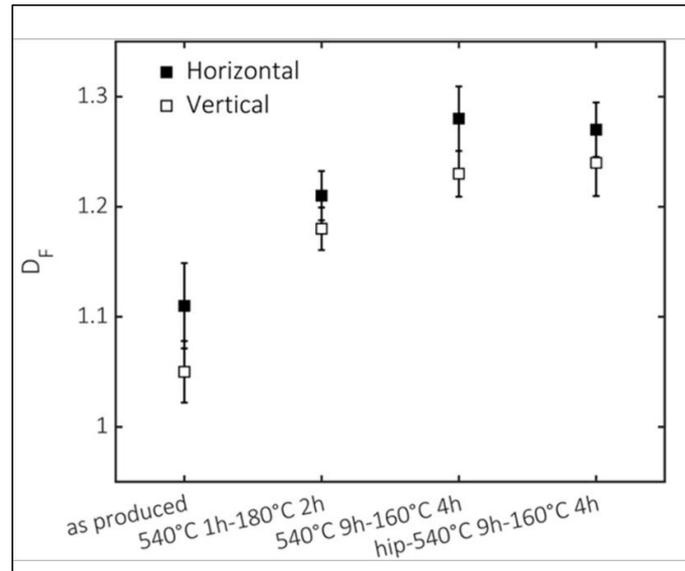
Fig. 19. Fractal dimension of the fracture profiles perpendicular to the notch, for each tested condition of AM alloys. Standard deviations are shown as error bars.

In order to carry out a quantitative evaluation of the fracture surfaces of the AM samples, the fractal dimension of the surfaces themselves was calculated using a non-contact 3D optical profilometer and a tailored Matlab[®] code. **Figure 19** shows the mean values and the standard deviations (expressed as error bars) of the fractal dimension for specimens in both horizontal and vertical directions, for each treatment condition of the alloy. The fractal dimension for the alloy in the as-produced condition is higher for horizontally oriented specimens, as compared to vertical ones. This may be due to the different crack path in the two cases. In fact, as previously shown in **Figure 12**, for horizontally built specimens, the fracture occurs along the interfaces between adjacent tracks and through the track core, while it occurs at the interface between consecutive layers and sometimes through the track core for vertically built specimens. The former, as reported in the literature [30, 33, 35, 61], is characterized by a greater unevenness than the latter, thus leading to a higher fractal dimension. Considering the alloy in the 540°C 1h - 180°C 2h condition, it can be seen that the fractal dimension increases as compared to the previous one, regardless of the building direction.
