On the damage detection of a laboratory scale model of a tripod supporting structure by vibration-based methods

The paper presents a comparison of two vibration-based methods for the damage detection of a laboratory scale model of a tripod. Tripods are a part of the supporting structures for offshore wind turbines. The tripod model structure allows the investigation of the propagation of a circumferential representative crack in one of the cylindrical upper braces of the tripod itself. The first damage detection method addresses the use of acceleration signals in a genuine experimental modal analysis (i.e. input-output modal analysis) while the second one is based on operational modal analysis (i.e. output only modal analysis). The progressive damage is monitored by the calculation of the modal parameters and following their deviations. Both methods were performed on the undamaged and damaged structure for different support conditions and excitations (shaker, hammer, in water basin under wave excitation). The results suggest that both the methods can be considered useful tools for damage detection in dry and in-water conditions for offshore support structures. The presented techni

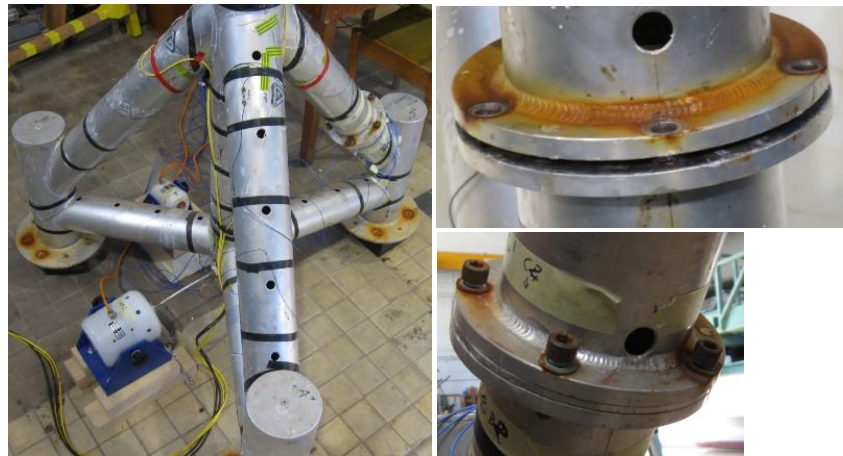
Figure 1. Laboratory scale model of the tripod supporting structure (left) and detail of the flange with model of the circumferential crack (lower right) and total failure (upper right) configurations of screwed flanges.

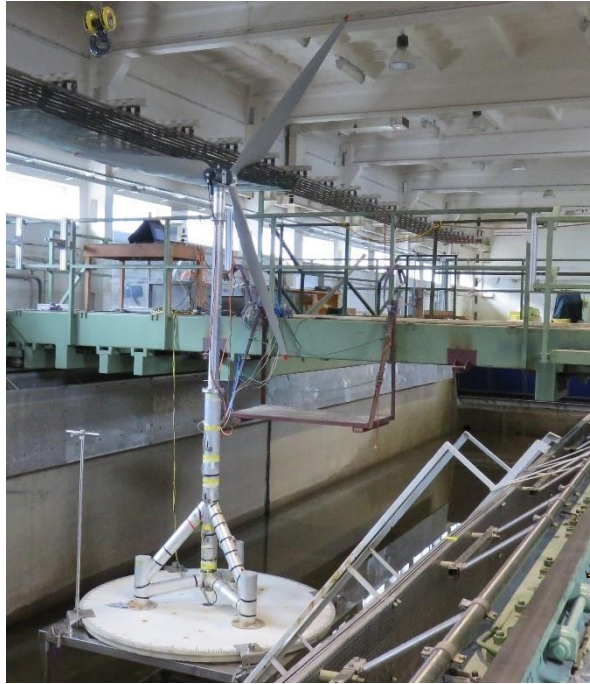
Figure 9. Assembled test setup in the towing tank mounted on the rotary plate table.

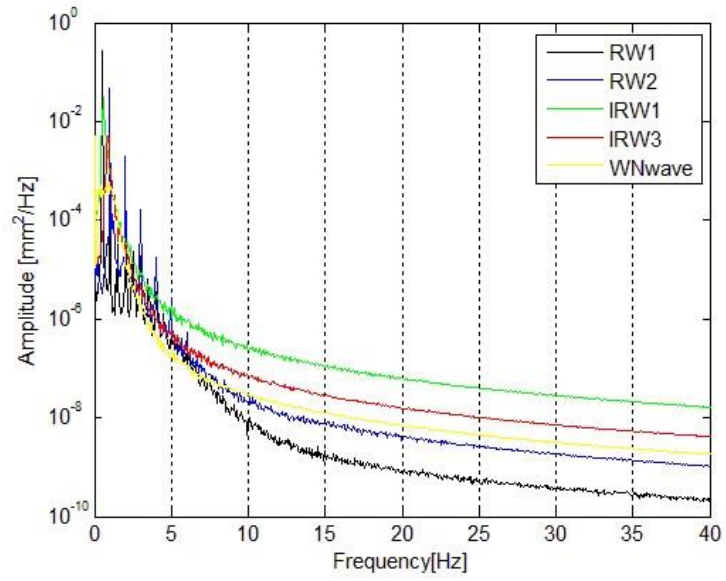
Figure 14. Power spectral density (PSD) of the wave motion used to excite the structure: in black line the RW1 motion; in blue line the RW2 motion; in green line the IRW1 motion; in red line the IRW3 motion and in yellow line the WNwave motion.

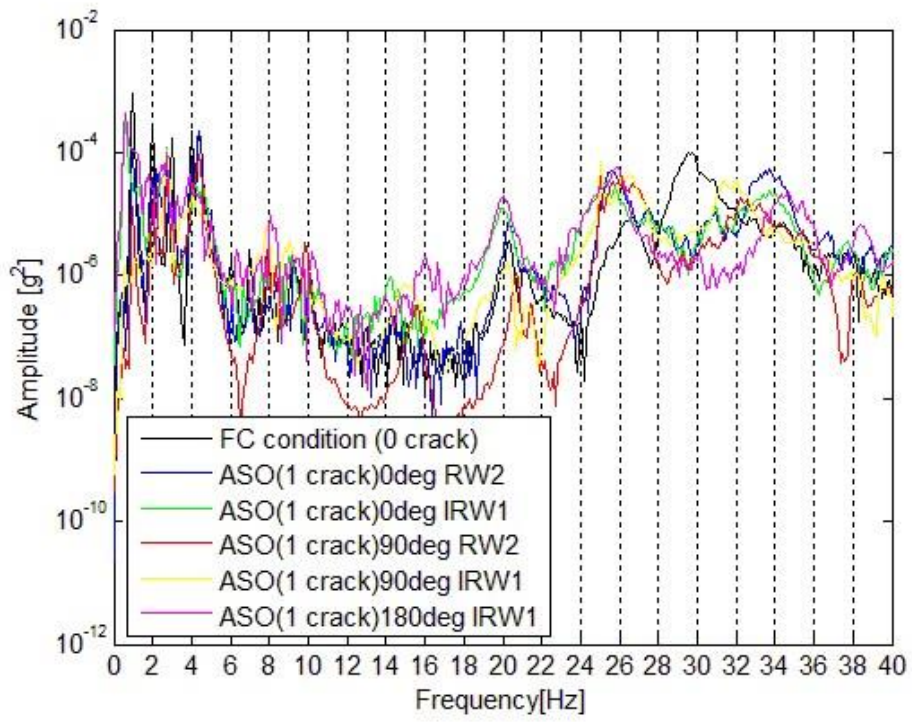
Figure 16. Cross-power spectra of the five cases reported in Table 7.

Table 7 shows the comparison of the natural frequencies in the five cases of interest: on the left hand side of the table, the natural frequencies of the intact structure (FC or 0-crack condition) are reported, comparing the EMA results obtained with roving hammer excitation in calm water, and OMA results obtained with the RW2 wave pattern excitation (which was taken as reference case for the intact structure): a good correlation can be noticed between the listed frequencies. On the right hand side of the table, the natural frequencies yielded from OMA on the damaged structure (ASO or 1-crack condition) are shown: each column represents a test condition (combination of orientation and wave pattern). The five cases in the table are considered the most representative in terms of results: in all these cases, the frequency shift of the 6th mode (from 29 Hz in the 0-crack condition to 25 Hz in the 1-crack condition) appears to be consistent and clearly observable. As mentioned before, the remaining test configurations did not permit to obtain significant results in terms of quality of the poles selected in the LSCE method. Figure 16 depicts the cross-spectra of the five remarkable cases, overlapped in a single graph.

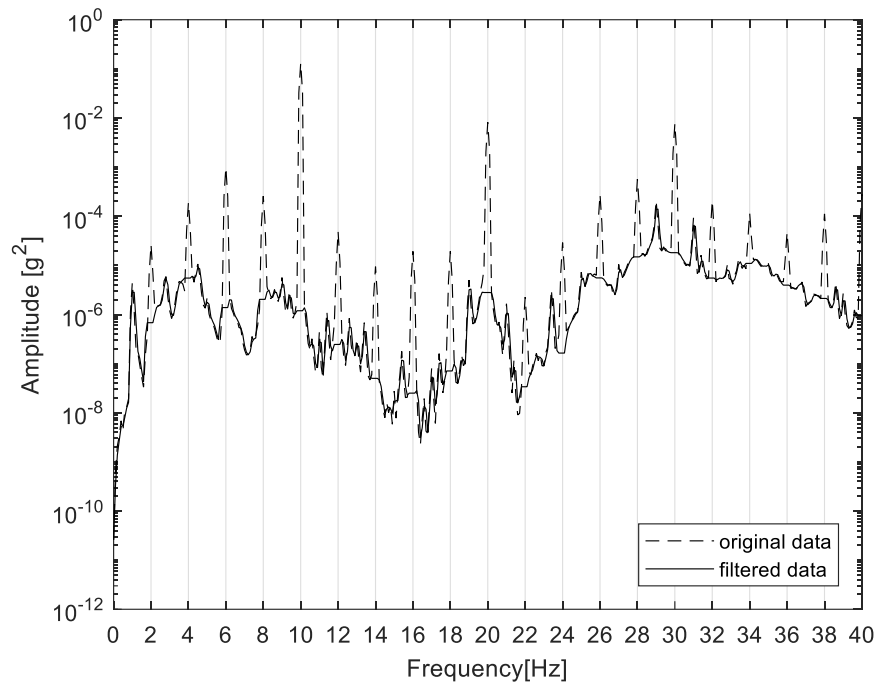
Figure 17. Cross-power spectra of the acceleration measured in Node 1, Direction X in case of original data and application of the harmonic filter in case of rotor rotating at 120 rpm.

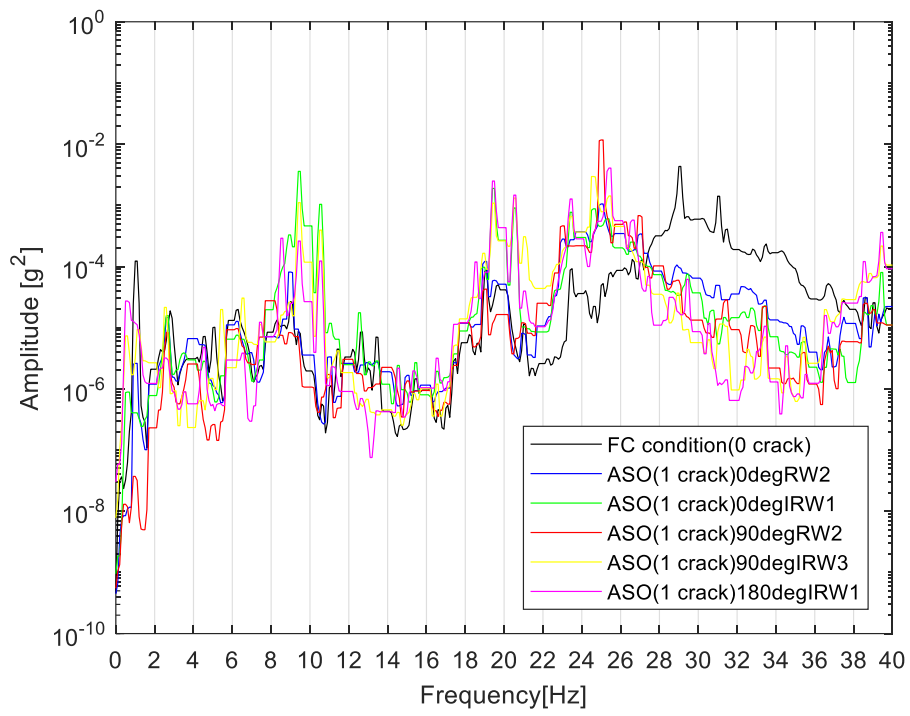
Figure 18. Crosspower spectra of the five cases reported in Table 8.
