# **GELMON 2020**

5<sup>th</sup> International Workshop  
on Geoelectric Monitoring

# Electrical and electromagnetic monitoring for engineering applications: a lab test for evaluating the concrete curing phenomenon with 4D-ERT

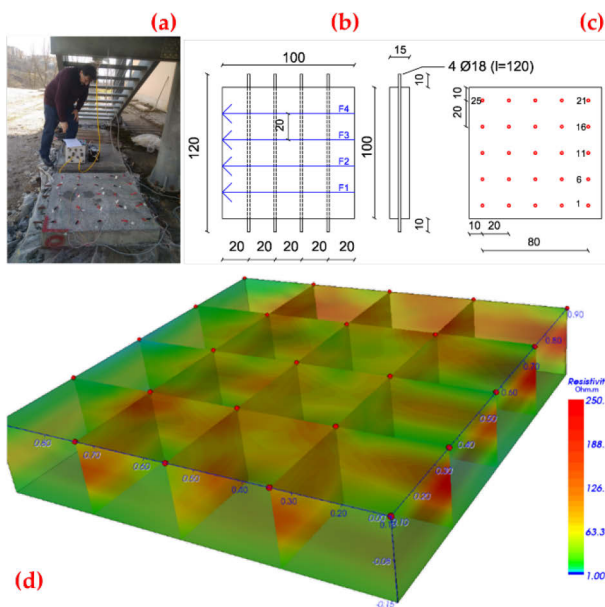
The experiment consists in the evaluation of potentialities and limits of 4-D non-destructive geophysical techniques for monitoring the concrete curing phenomenon for a month immediately following placing and finishing. In particular, time-lapse 3-D ERT and GPR surveys have been applied to a RC (Concrete C28-35, Steel B450C) panel of sizes 1 x 1 x 0.15 m, as showed in fig. 1.

25 electrodes placed every ten centimetres and distributed on five rows have used to perform geoelectrical measurements using dipole-dipole array and the Syscal Pro (red circles in fig. 1c). The electrical resistivity measurements were repeated every day for one month and measured resistivity data were inverted using the ERTLab 3D software.

Simultaneously, GPR data (2 GHz antenna coupled to SIR 3000 GPR system) were acquired (blue arrows in fig. 1b). The hyperbolas generated by the presence of four rebars of the panel are automatically picked for estimating the dielectric permittivity of the concrete; moreover, the time of the first arrivals was monitored for 30 days.

A diffuse increase of the resistivity values due to the curing of the concrete has been detected for the entire volume investigated, except for the lower zones where there is, likely, the accumulation of water (fig. 1d). This is in accordance with the dielectric permittivity variations showing a negative trend related to the evaporation of the water.

**Figure caption:** behavior of the panel recorded with ERT. As expected, the continuous decrease of the water content in the panel monitored for 30 days, caused a constant increase of the electrical resistivity values and EM velocity.
